Project Name: DFI Rivers_GobbinsRoad_Islandmagee2024_07_25

Inspection Standard: MSCC5 Sewers & Drainage GB (SRM5 Scoring)

Street: Gobbin Road
Town or City: Islandmagee
County: Antrim

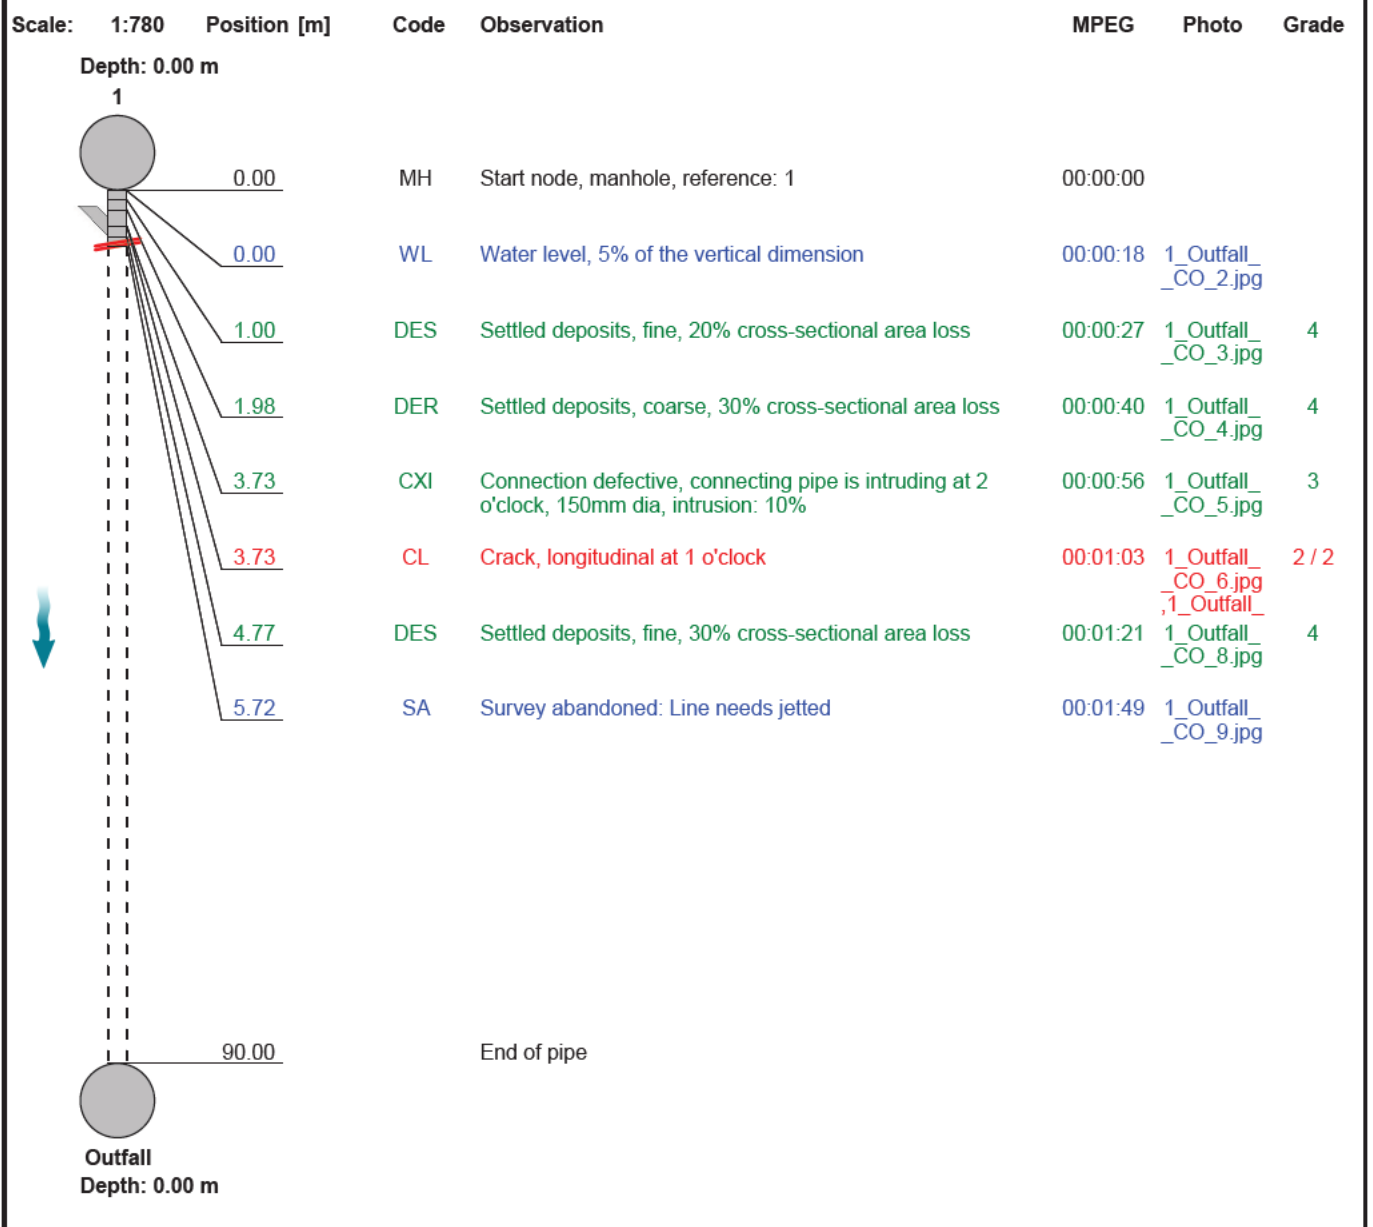
Item No. 1	Insp. No. 2	Date 25/07/24	Time 9:16	Client's Job Ref 1	Weather No Rain Or Snow	Pre Cleaned Yes	PLR 1X
Operator [Redacted]		Vehicle [Redacted]		Camera Ipek	Preset Length 1.00 m	Legal Status Watercourse	Alternative ID Not Specified

Town or Village:	Islandmagee	Inspection Direction:	Downstream	Upstream Node:	1
Road:	Gobbins Road	Inspected Length:	5.72 m	Upstream Pipe Depth:	0.000 m
Location:	Verge	Total Length:	90.00 m	Downstream Node:	OUTFALL
Surface Type:	Grass	Joint Length:	1.00 m	Downstream Pipe Depth:	0.000 m
Use:	Culverted watercourse	Pipe Shape:	Circular		
Type of Pipe:	Gravity drain/sewer	Dia/Height:	375 mm		
Flow Control:	No flow control	Material:	Concrete		
Year Constructed:	Not Specified	Lining Type:	No Lining		
Inspection Purpose:	Investigation of operational problems	Lining Material:	No Lining
