# BROADWATER

Reservoirs Act 1975 – Section 10 Report

**Broadwater (DARD Rivers Agency Ref No X0301)**  
**Inspecting Engineer's Certificate Inspecting Engineer's Certificate**

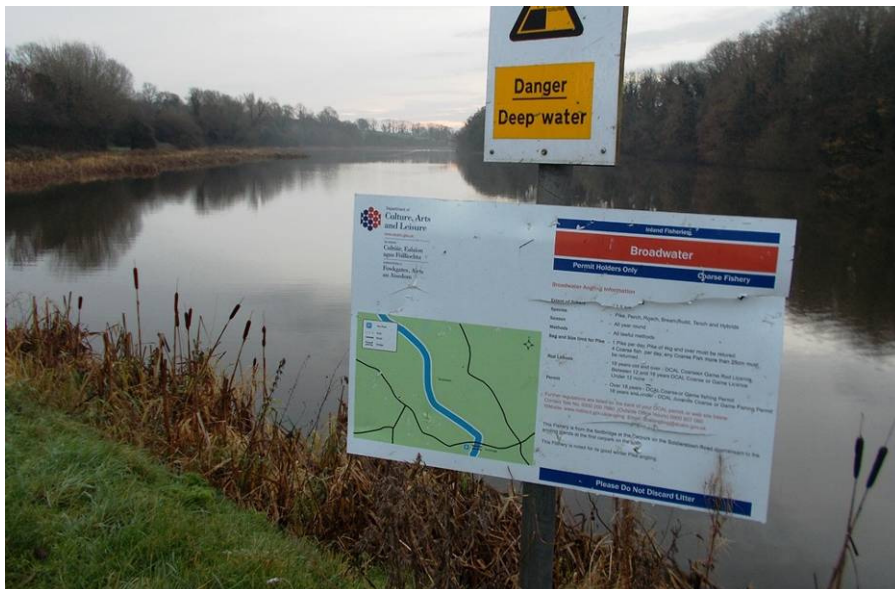
Photograph 8.1.1 General view of reservoir (looking South)

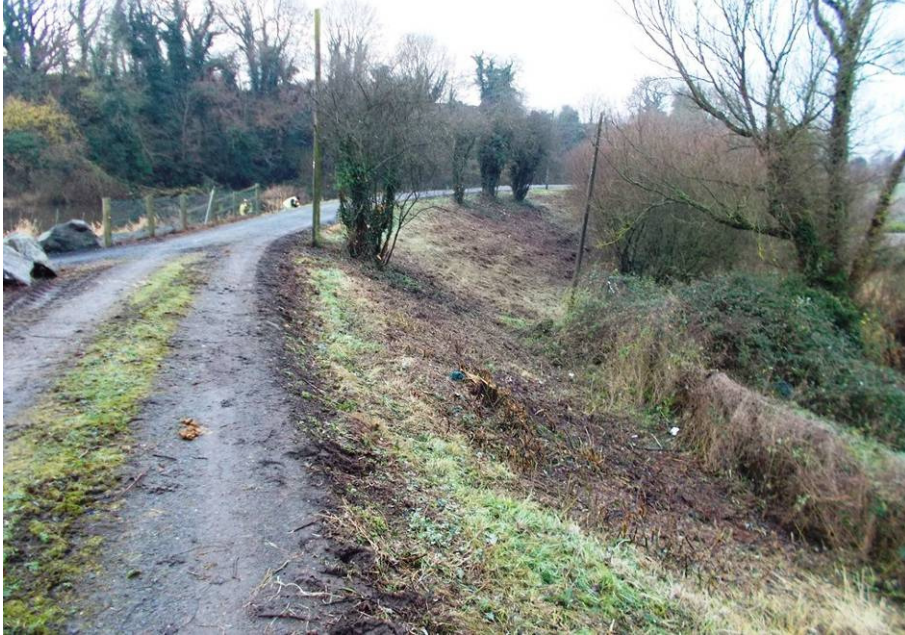
Photograph 8.4.1.1 General view of Reservoir Embankment looking East

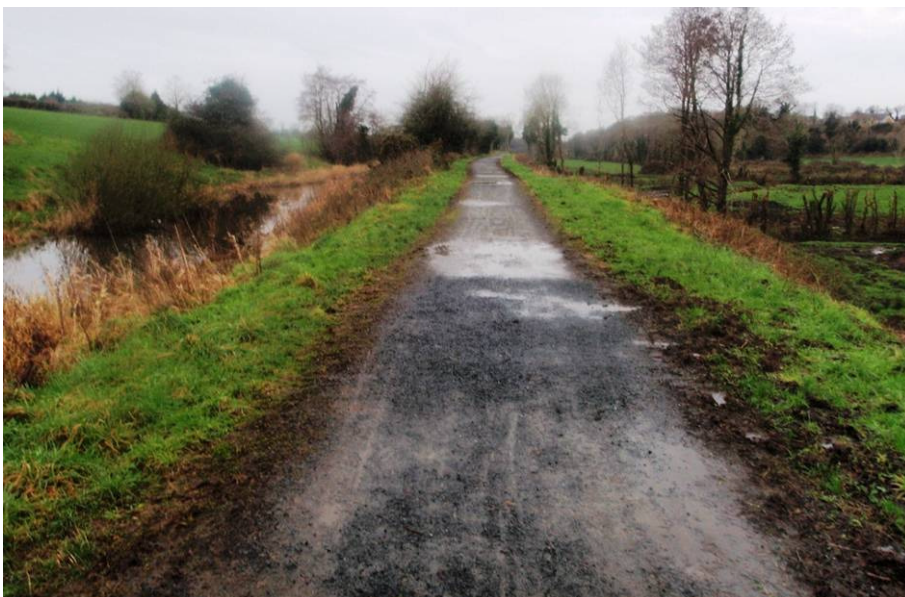
Photograph 8.4.1.2 General view of Canal Embankment looking North

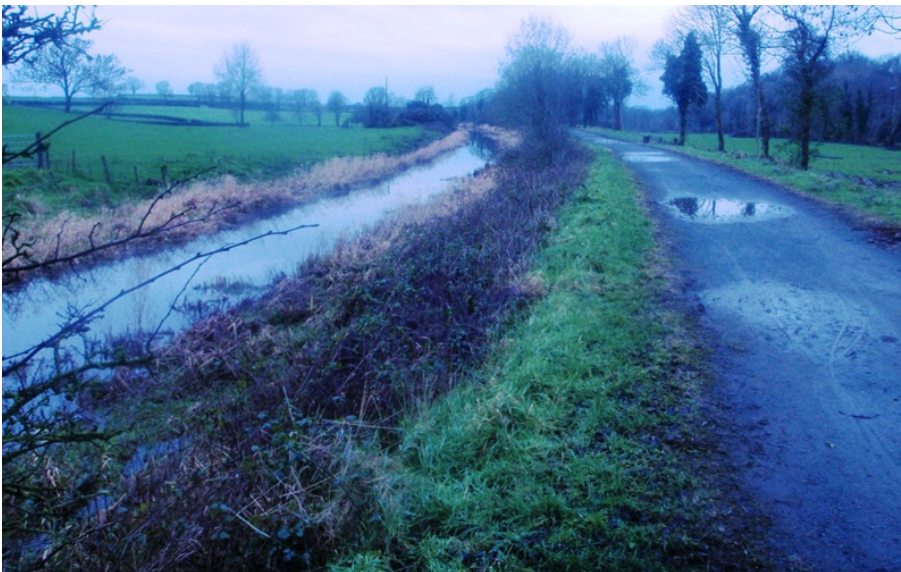
The canal embankment extended from Ch150-1805m and comprised an overgrown slope at an approximate gradient of 1v:2h. Numerous trees and vegetative cover were observed along the majority of the length, Photograph 9.3.1.2.

Photograph 9.3.1.2 Canal embankment upstream slope

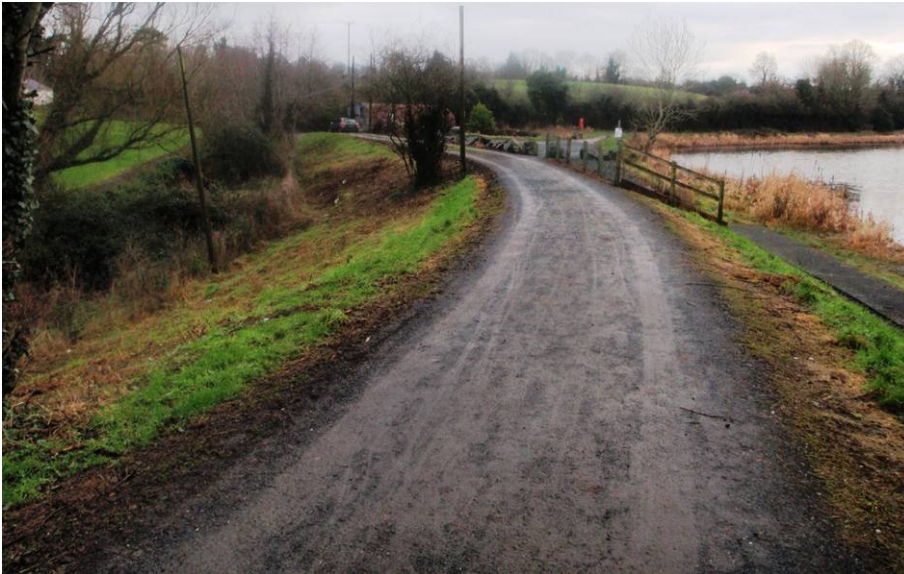
The remainder of the reservoir embankment crest (Ch40-150m) consisted of a 5.5m wide waterbound access road which was well maintained, Photograph 9.3.2.1.

Photograph 9.3.2.1 Crest of dam, Ch40-150m

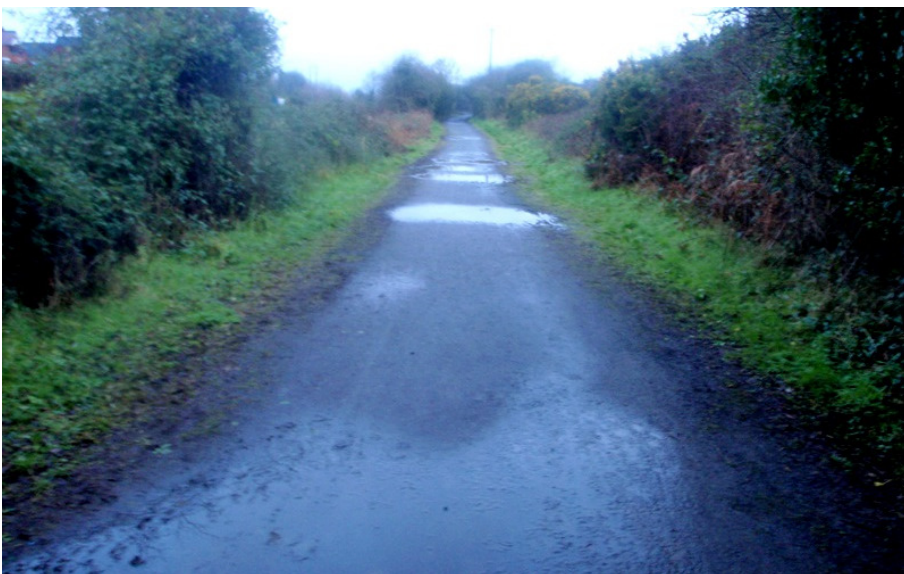
The canal embankment crest was typically 4.5m wide with a central 2.5m wide waterbound gravel access path. Some areas of localised ponding were observed but the condition was considered satisfactory, Photograph 9.3.2.2.

Photograph 9.3.2.2 Canal embankment crest

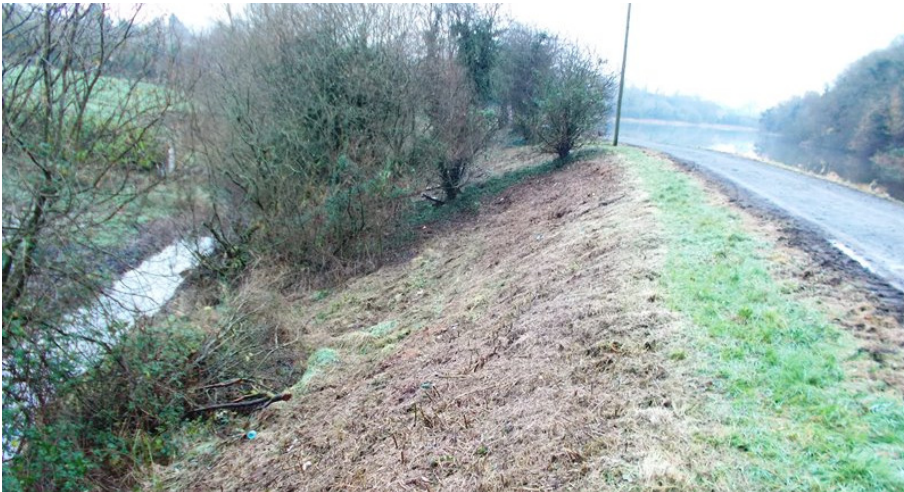
The downstream slope had been cleared of groundcover prior to the visit. [REDACTED]

Photograph 9.3.3.1 Reservoir embankment downstream slope

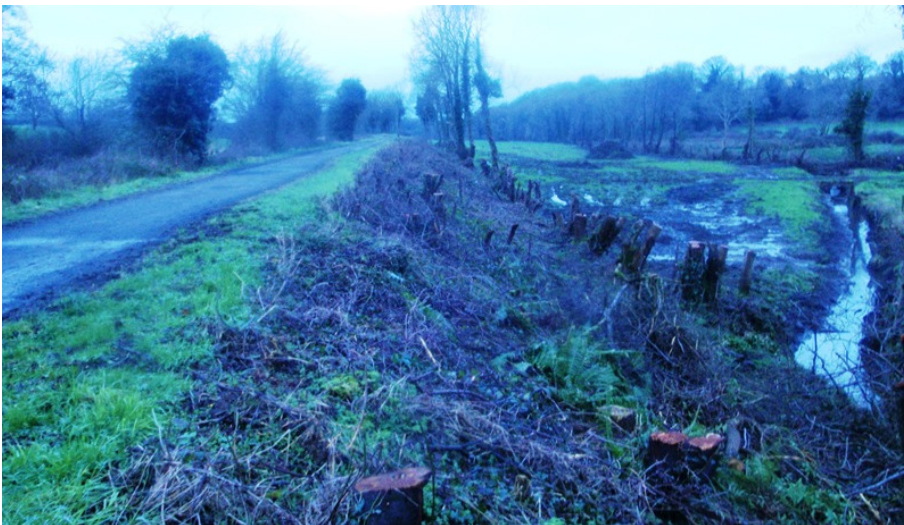
The downstream face had been partially cleared from Ch150-750m and the slope was of reasonably consistent profile, typically 1v:2h, Photograph 9.3.3.2. [REDACTED]

Photograph 9.3.3.2 Canal embankment downstream slope (Ch150-750m)
