Risk Review, Risk Assessment & Risk Management Plan

40062 Moylinn East Footbridge

CO402011-AMEY-SBR-XX-RP-CB-000001 Rev 1

18/08/2022

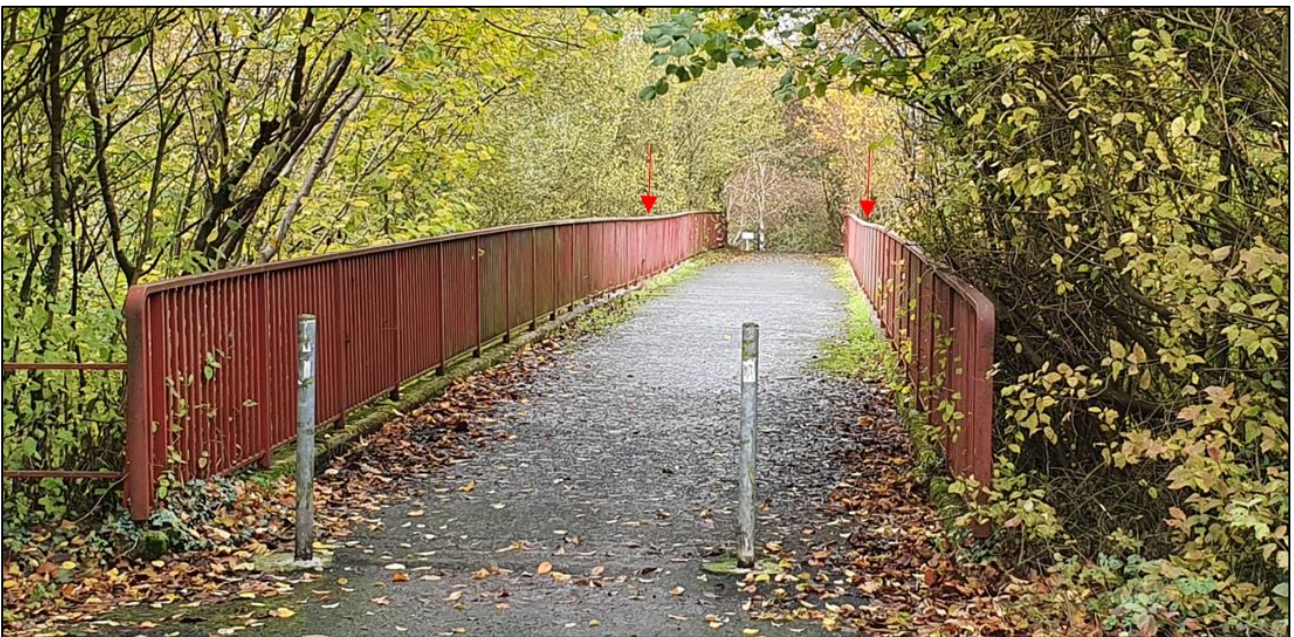
- 2.7.3 The suspended span of the of the footbridge exhibits a pronounced 'sag' which has been a cause for concern. The May 2006 Half Joint Special Inspection Report referenced an inspection completed in 1980 to investigate the sag in the centre span. A series of level surveys were carried out by Roads Service in the early 1980's confirmed that the whole of the centre span, including the post-tensioned cantilevers, was sagging by 175 mm below design level at midspan. In 1998, a level survey of the central span was completed as part of the PTSI Phase 2 and confirmed the sagging profile of the cantilever and in situ reinforced concrete suspended

span and indicates that the sag at midspan has increased from a maximum of 175 mm in 1980/82 to 200 mm presently in 1998. In addition, the report stated that the gradients along the structure increase rapidly from the piers along the cantilevers to the scarf joints, suggesting there is a loss of residual prestress over the piers.

Figure 12: Overall view of parapets with visible deflection noted - November 2021

2.7.4 In November 2021, Amey Consulting conducted a point cloud survey of the bridge deck to assess the deflected shape – See Appendix A. It was noted from the point cloud that the curvature of the soffit of the main spine beam (from pier to pier) generally follows a uniform arc, which suggests that the main spine is not sagging locally at mid-span. The scan shows that the profile of the parapet upstand/cantilevers is irregular, however, and sags at mid-span, causing water ponding on the top of the deck. It is possible that the top slab and

cantilevers were cast with a sag, possibly due to poor workmanship or deflection of the formwork during placement. Previous report has stated that loss of prestress is the likely issue; however, it would be likely if the cantilever deck started to deflect vertically due to loss in prestress, the suspended span would rotate about the half joint. There is no clear signs of rotation about the half joint and the deflection appears to be concentrated to the parapet upstands. Furthermore, loss of prestress would likely lead to cracking of the prestressed elements. The guard rail and base plates do not exhibit signs of buckling, twisting, or cracking due to deck deflection which raises further uncertainty of the cause of the deflection.

- 2.7.5 There is much uncertainty surrounding the cause of the sagging. It is clear however, that it is a long-standing issue since at least 1980, therefore it is not of immediate concern.

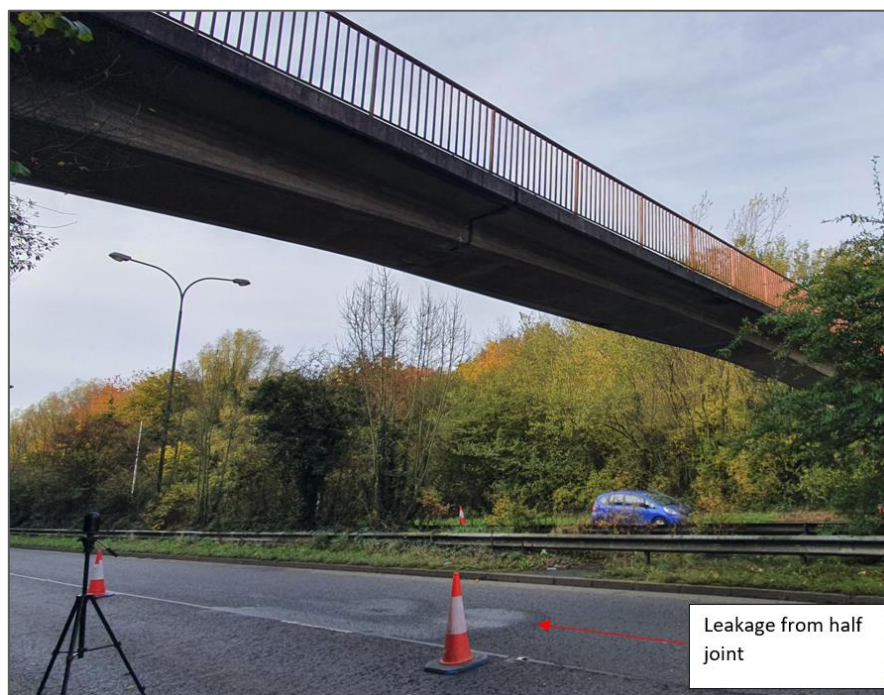
- 2.7.6 The majority of previous inspection reports noted active leakage with stalactites from the suspended span half joints. The 2006 Half Joint Special Inspection Report noted that active leakage at both half joints was recorded as far back as the 1998 visual inspection, therefore, it is a longstanding issue. The formation of stalactites suggests that de-icing salts has been used on the footbridge which increases the risk of chloride induced corrosion to the half joint. Leakage at the half joint location also increases the risk of chloride induced corrosion of the post-tensioned end anchorages which are located within the ends of the cantilever deck. There is also a risk of chloride rich water entering the poorly grouted post-tensioned ducts via the anchorages, increasing the risk of corrosion to the tendon strands.

- 2.7.7 A site visit undertaken by Amey Consulting in November 2021 confirmed that the leakage through the half-joint over the Southbound carriageway was active, with evidence of ponding on the carriageway below, thus confirming the leakage as significant.

Figure 13: Active leakage from half-joint at Southbound carriageway

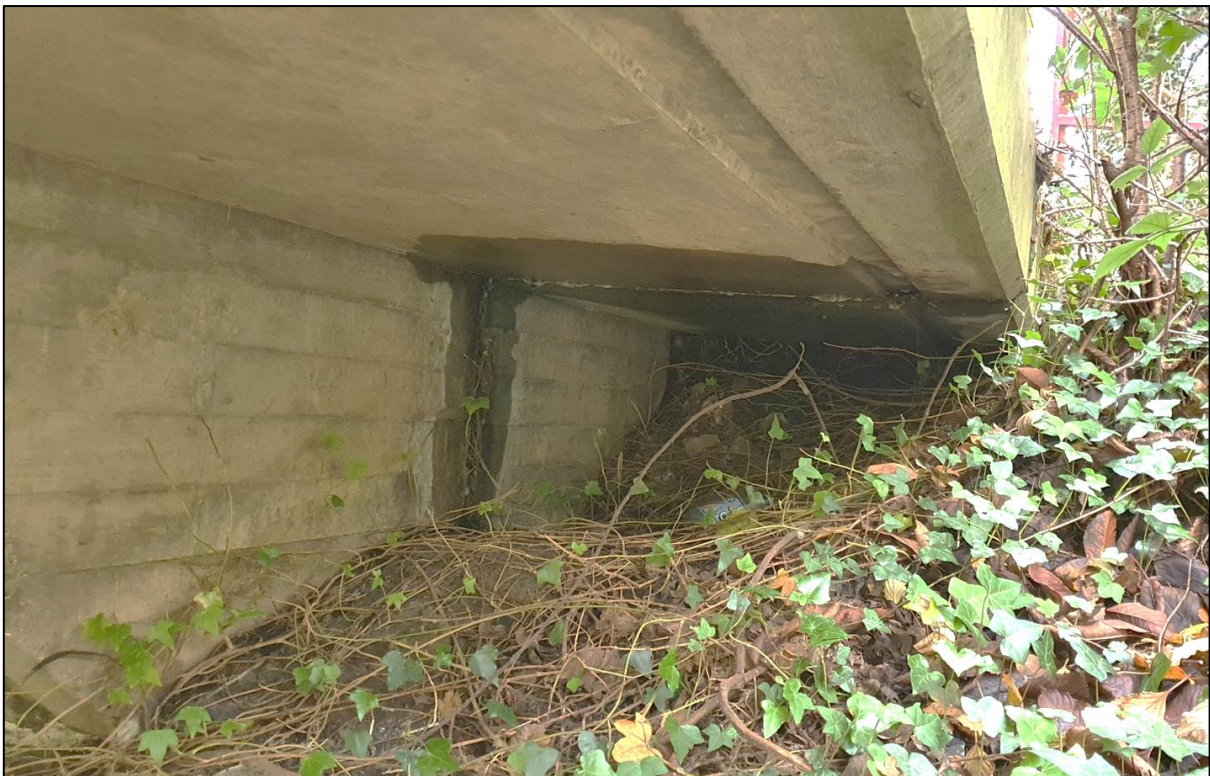
- 2.7.8 The site visit undertaken by Amey Consulting in November 2021 confirmed active leakage at both abutment movement joints. Stalactite formation was evident which suggest the presence of de-icing salts from the deck run-off. Prolonged leakage at the abutment joints which chloride laden deck run off increases the risk of chloride induced corrosion of the reinforced concrete half joint nib; which is critical in preventing rotation and subsequent collapse of the post-tensioned deck.
- 2.7.9 Leakage at the deck ends also increases the risk of chloride induced corrosion of the post-tensioned end anchorages which are located within the ends of the deck. There is also a risk of chloride rich water entering the poorly grouted post-tensioned ducts via the anchorages, increasing the risk of corrosion to the tendon strands.

Figure 14: Active leakage at abutment joints – November 2021

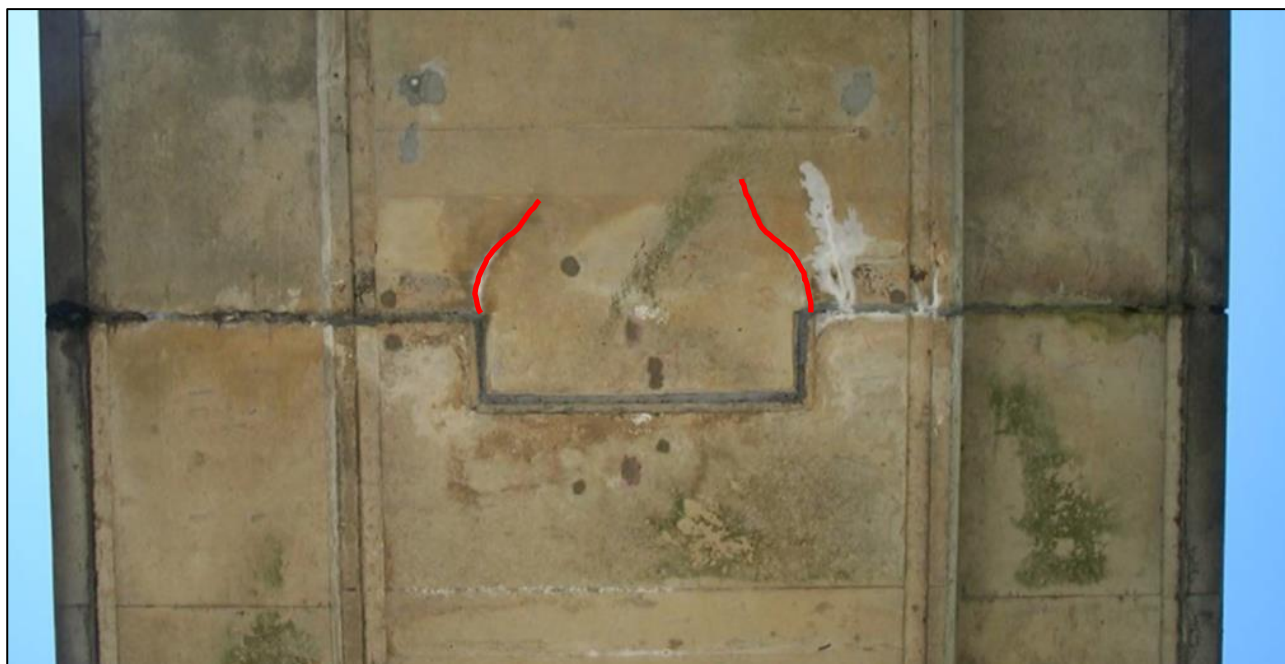
- 2.7.10 Fine horizontal cracks have been noted to the soffit of the box beam at the corners of both half joint lower nibs – this is evident in Figure 15. Evidence of effloresce has also been noted along the cracks. Furthermore, vertical cracking to the sides of the deck box section has been noted adjacent to the half joint. The cracks appear to be long standing as they were noted in a 1998 inspection and have not appeared to have increased in extent or severity at the time of writing this report.
- 2.7.11 It is possible that the fine cracking to the corners of the half joint are a result of high localised tensile stresses at the re-entrant corner.

Figure 15: Fine cracks to half joint

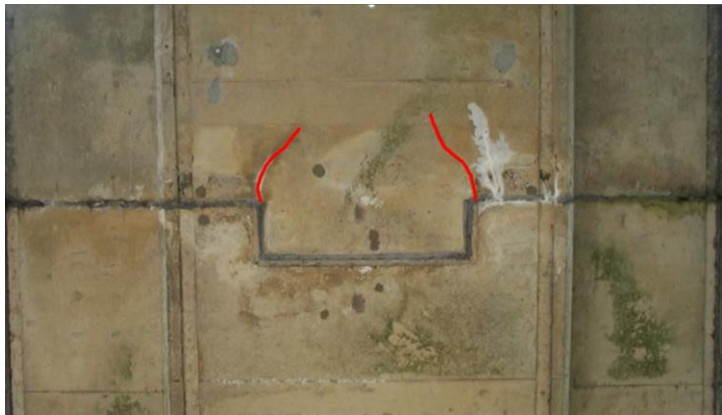
Half Joint Defect Identification		
Half Joint Defect	Description	Photo
Cracking	Fine cracking to lower nib soffit, re-entrant corner. Width of crack has not been verified but assumed to be <0.3mm based on description in previous reports.

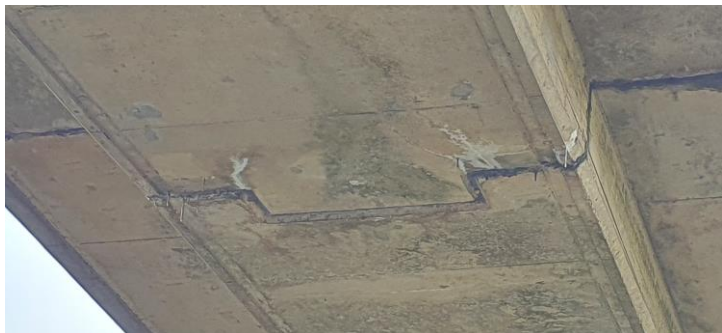
Active water leakage	Longstanding active water leakage and stalactite formation from half joints.

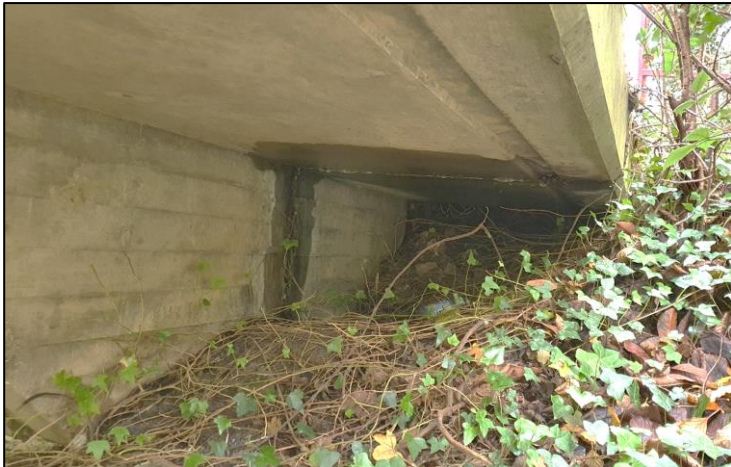
Half Joint Defect Identification		
Half Joint Defect	Description	Photo
Active water leakage	Longstanding active water leakage and stalactite formation from half joints.

6.2.2 From the Defects decision diagram Figure 24, there are no signs of defects to the abutment half joint. However, as the half joint is concealed, the presence of concrete defects is uncertain.
