### Enquiries (By Road Section)

Road Section: 7035U0812\_14 CUSSICK ST1: LISBURN RD3 TO END

**Defect Inspections (By Road Section) Report**

**Section:**  
 7035U0812\_14 CUSSICK ST1: LISBURN RD3 TO END

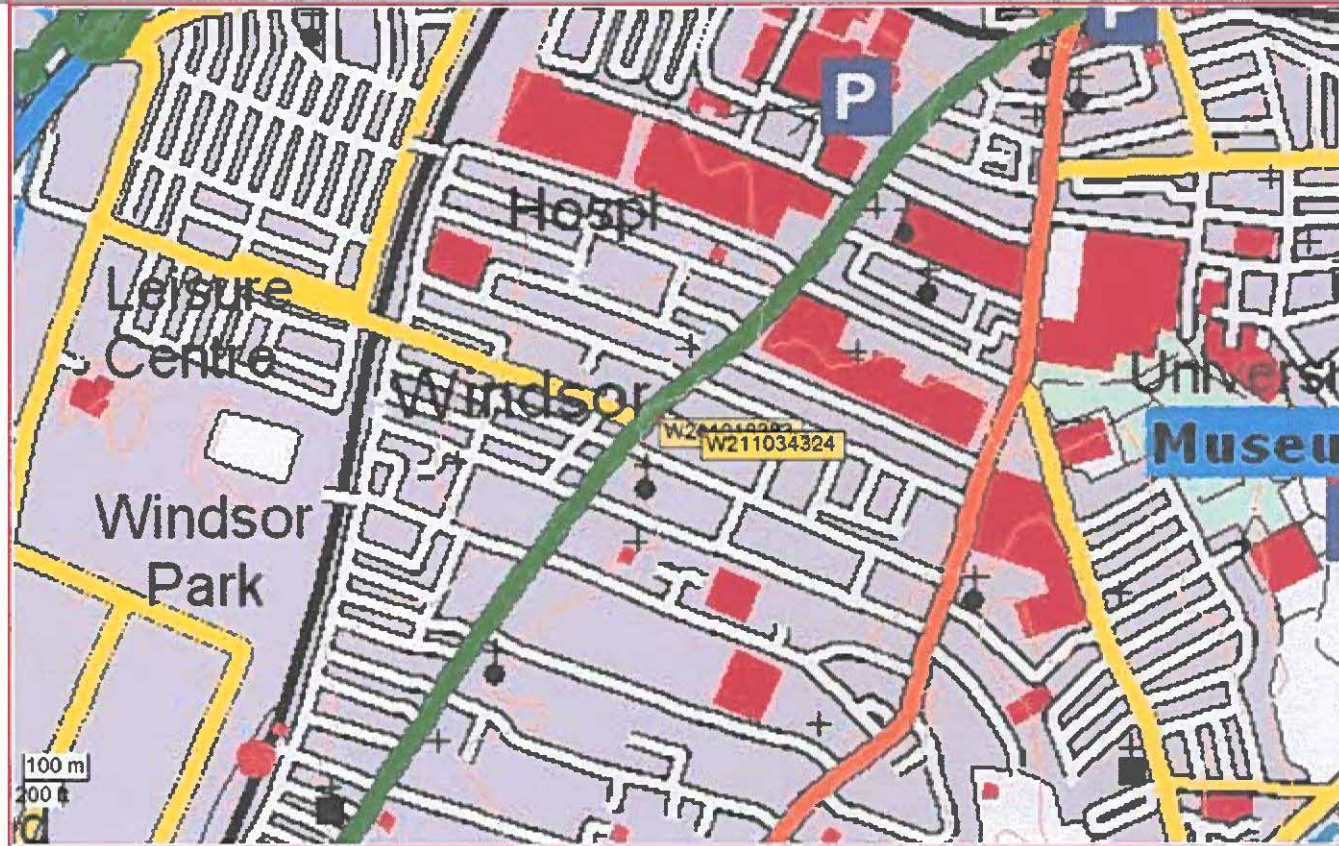
Enquiry ID:	Date/time Received:	Enquirer Name:	Input Type:	Enquiry Type:	Comments to Customer:	Location / Description:	Enquiry Received By:	Assigned to:	Date/time assigned	Internal Action Comments:	Status:
<a href="#">W211034324</a>	10/7/21 12:23 pm	(1)	Public Enquiry	Pothole	an inspection has been carried out on 27-7-21 and an area of uneven paving has been marked for repair.	?	PIP		10/7/21 12:23 pm	Not connected to NIE excavation. It seems bad ground, needs test hole.	Standard - In Progress
					<b>Regards</b>						
					Date/time inspection:	Inspector Name:	NFA Category:	NFA Comments:	Item Details:	Defect Reference:	
					27-Jul-2021				PAVIORS MISSING (FPMI)	<a href="#">D218439672</a>	
<b>PIP Comments:</b> Brickwork paving sinking into the ground following recent work by NIE to lay cable. ;This is outside a disabled mans home, at a disabled parking space and poses a significant risk to the public. A child has already nearly fallen off his bike when his wheel went over the hole.
