### Enquiries (By Road Section)

**Road Section:** 7020U3140\_14 **KINGS RD1: CABLE RD TO EDWARD RD** **Date Range:** From 21/03/2021 00:00:00 until less than 21/03/2023 23:59:59  
 7020U3140\_15 **KINGS RD1: EDWARD RD TO WINDSOR AVENUE**  
 7020U3140\_16 **KINGS RD1: WINDSOR AV1 TO CHESTER AV2**

# Inspection Report

| <b>Section Code:</b><br>7020U3140_14 | <b>Section Description:</b><br>KINGS RD1: CABLE RD TO EDWARD RD |

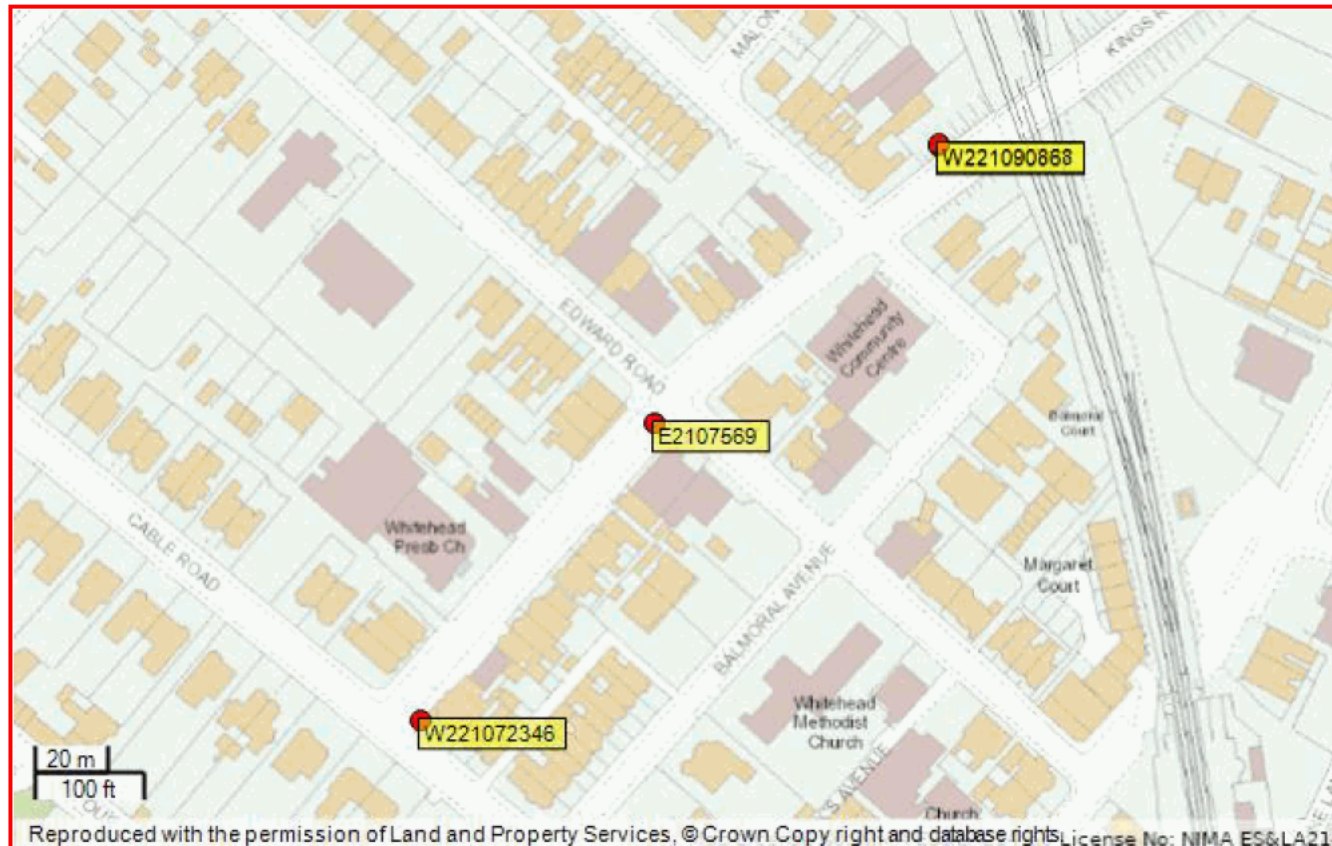
| Enquiry ID: | Date/time Received: | Enquirer Name: | Input Type: | Enquiry Type: | Comments to Customer: | Location / Description: | Enquiry Received By: | Assigned to: | Date/time assigned: | Internal Action Comments: | Status: |
|--|---|---|---|---|--|---|---|---|---|--|---|
| <a href="#">W221090868</a> | 24/6/22<br>2:41 pm | (1) [REDACTED] | Complaint | Hedge / Tree | Hedge cutting letter to be issued to property. | ? | PIP | [REDACTED] | 24/6/22<br>2:41 pm | Hedge cutting letter issued to property. | Standard - Completed Enquiries |
| <b>PIP Comments:</b> Overgrown hedges blocking pedestrian footpath. Very nearly impassable with a pram | | | | Date/time inspection: | Inspector Name: | NFA Category: | NFA Comments: | Item Details: | Defect Reference: | | |

| Enquiry ID: | Date/time Received: | Enquirer Name: | Input Type: | Enquiry Type: | Comments to Customer: | Location / Description: | Enquiry Received By: | Assigned to: | Date/time assigned: | Internal Action Comments: | Status: |
|--|---|---|---|---|--|---|---|---|---|--|---|
| Photographs or Documents attached: | | | | 28-Jun-2022 | All Users | Private Owner notified | ? | No | | | |
