# Hydromorphology Assessment Owenkillew and Owenreagh Rivers

**Gortin, Co. Tyrone, Northern Ireland**

**Dalradian Gold Ltd**

24 November 2025

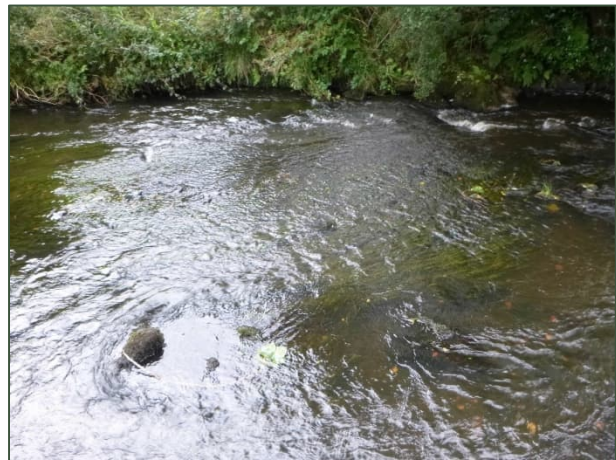
**Photograph 4:**  
**In Channel vegetation**

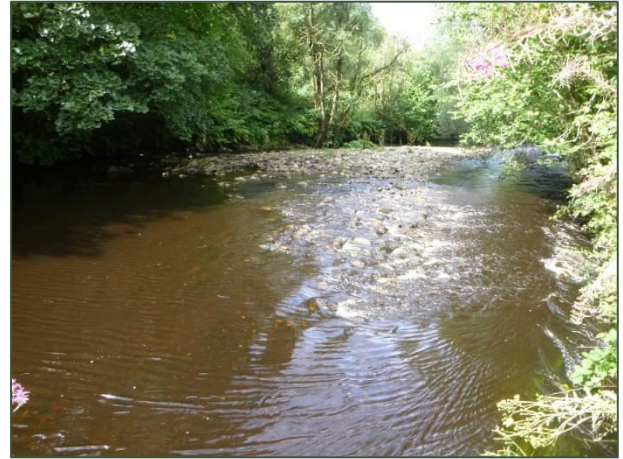
**Photograph 2:**  
Channel Bar and flow

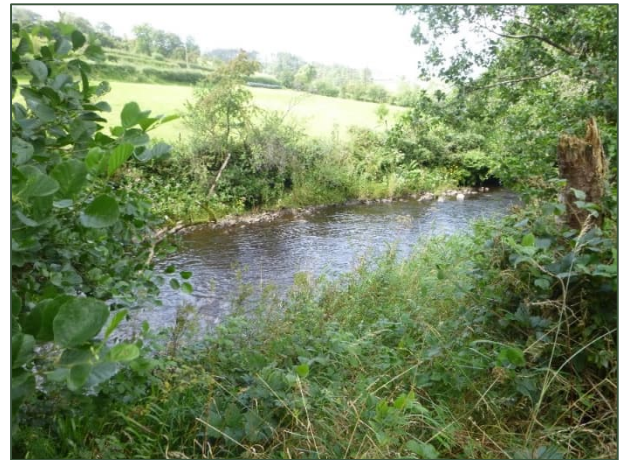
**Photograph 4:**  
Channel profile

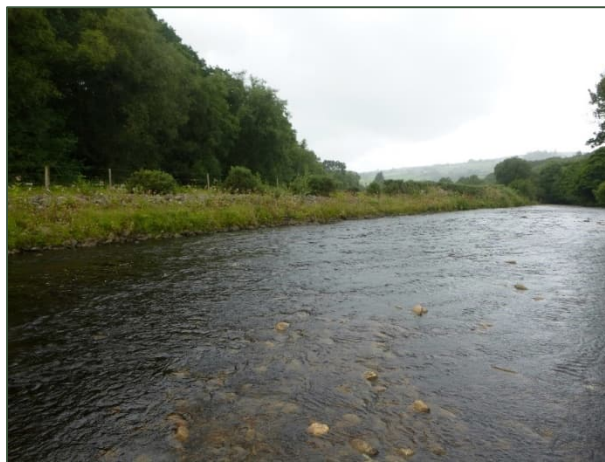
| ATTRIBUTE | SCORE <sup>a,b</sup> | NV | COMMENTS |
|---|---|---|---|
| <b>4. Barriers to continuity</b><br>Sheet 1. Desk top GIS observations, B. Channel substrate artificial or silt, channel modifications, and L. Resource use (Mill, DAM or HEP). | 2 | | <p>The boulder weir has raised the water level upstream. There was a significant cascade at the weir under current flow condition (January 2016).</p> |

**Photograph 4:**  
**Channel riffle and bedload with bank protection**

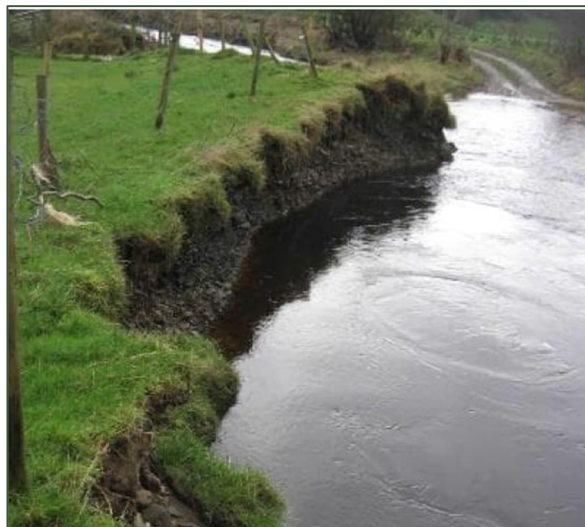
**Photograph 3:**  
Bank erosion and pool

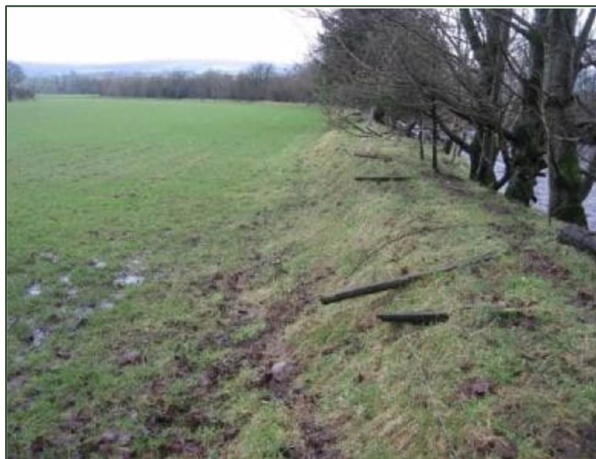
**Photograph 4:**  
Bank protection on LHB

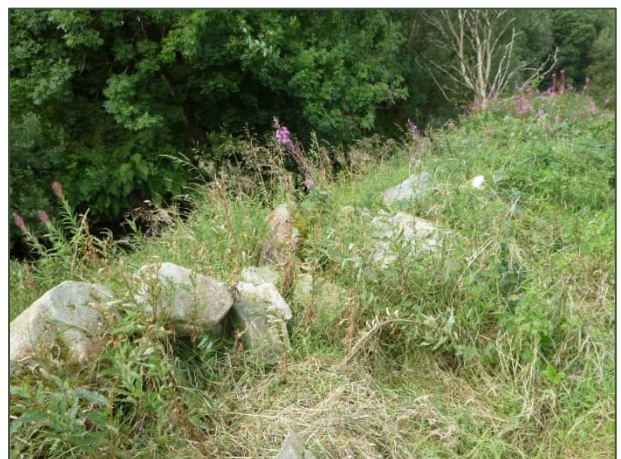
**Photograph 4:**  
Bank top with placed material for flood protection

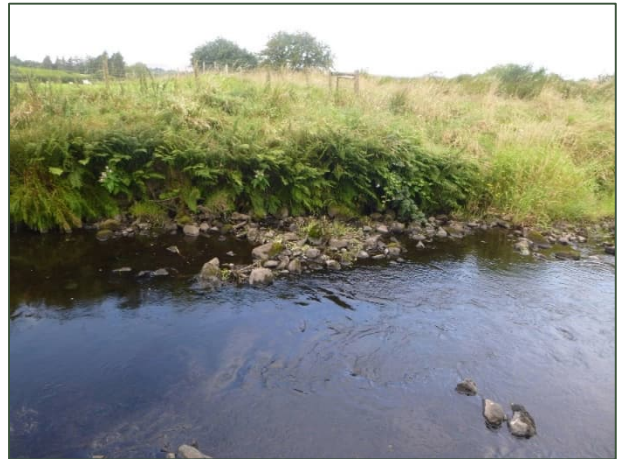
**Photograph 4:**  
Gravel bar substrate at riffle

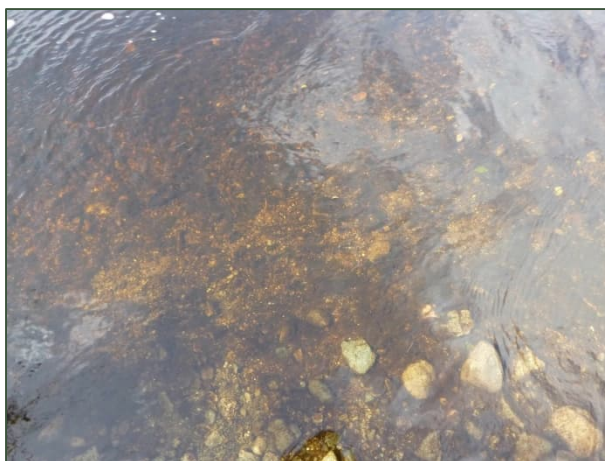
**Photograph 4:**  
Bed substrate gravels and cobbles with brown filament algae in slack flows.

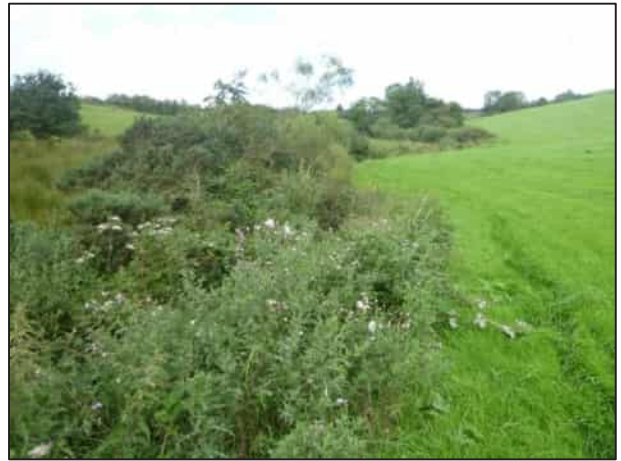
**Photograph 2:**  
Channel with grazing up to bank top

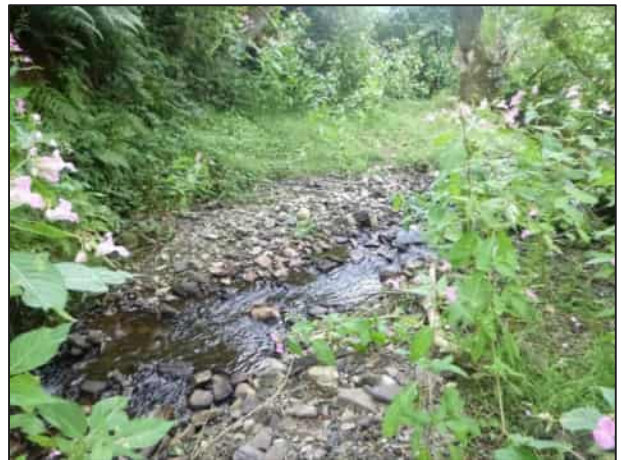
**Photograph 4:**  
Natural planform, bedload and woody habitat with invasive plant species

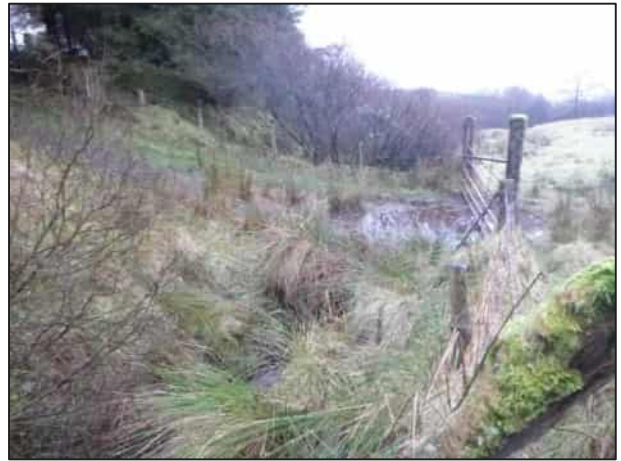
**Photograph 2:**  
Farm access culvert over channel

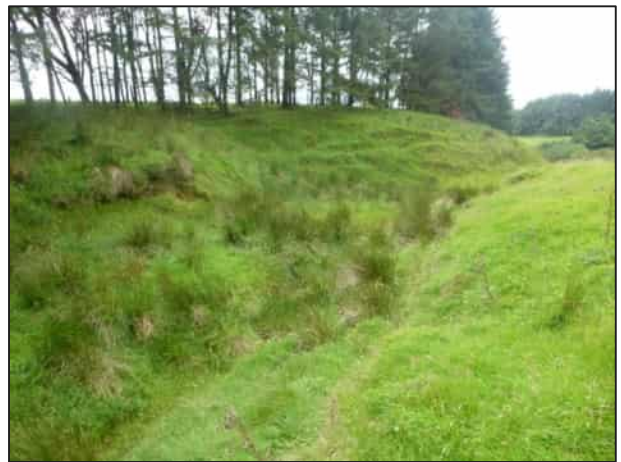
**Photograph 4:**  
Grazed land to channel

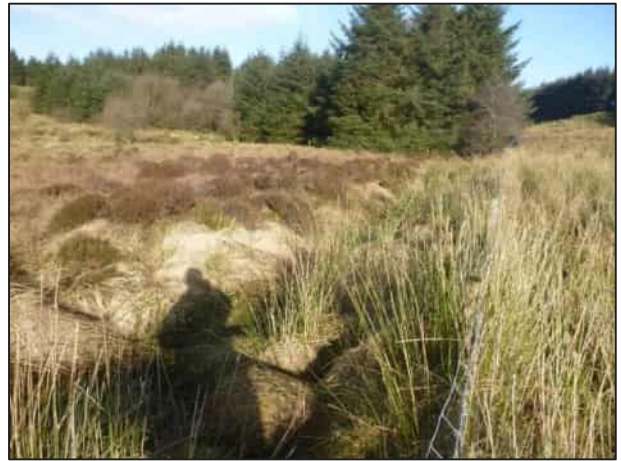
**Photograph 2:**  
**Straightened channel below plantation**

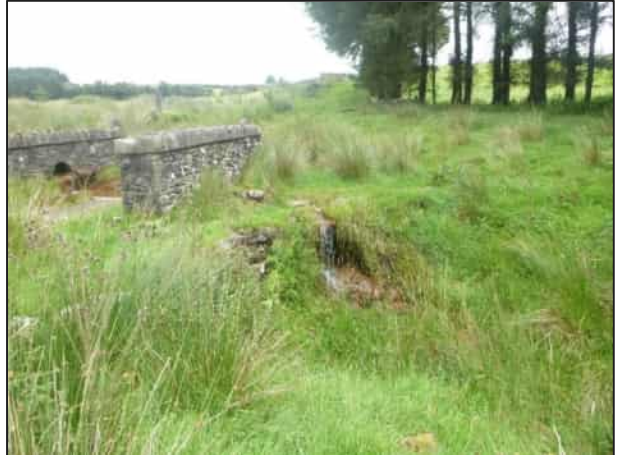
**Photograph 6:**  
**Ford and culvert at downstream end of reach**

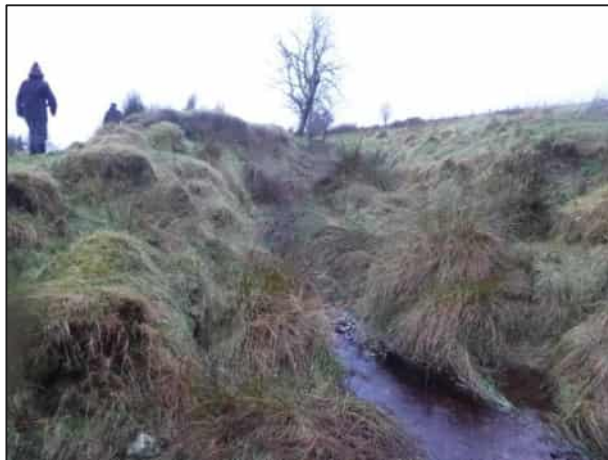
**Photograph 3:**  
**Straighten section of burn**

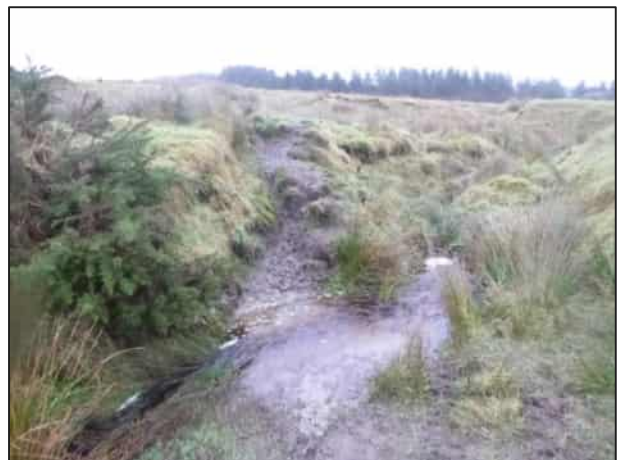
**Photograph 4:**  
**Animal poaching on straightened section of Burn**

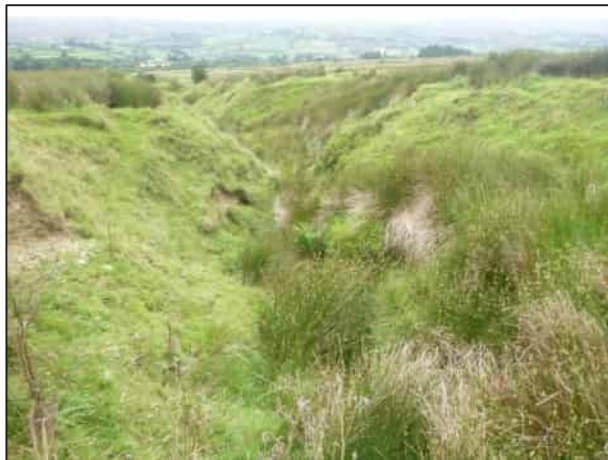
**Photograph 3:**  
Steep valley sides to burn with eroding materials to channel

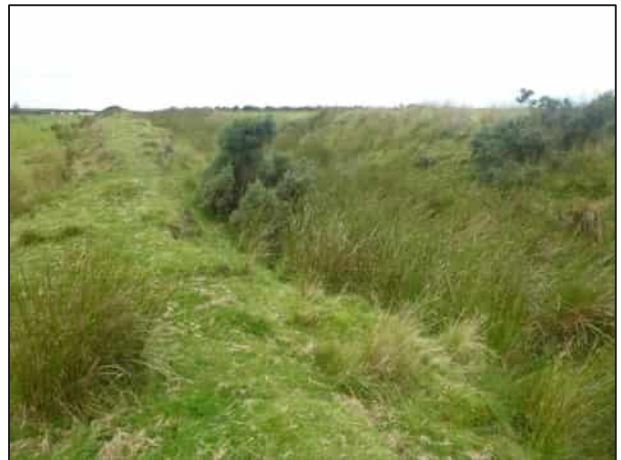
**Photograph 4:**  
Top section of burn with straightened channel

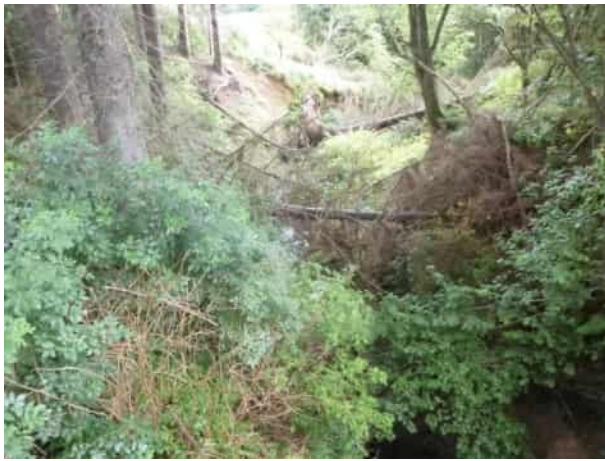
**Photograph 4:**  
Channel in ravine section with coniferous plantation and valley side erosion

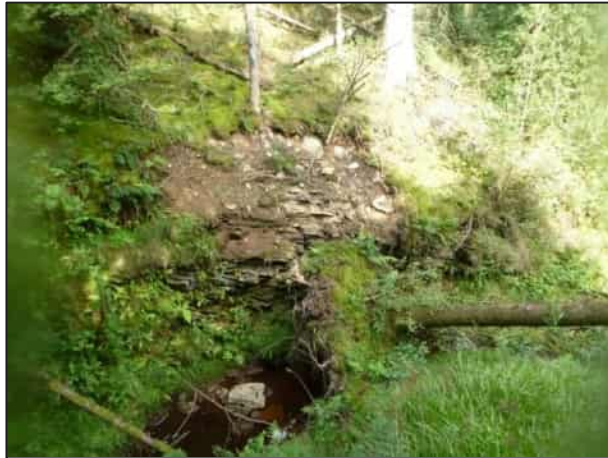
**Photograph 1:**  
Ravine section of burn with sediment input from ravine sides

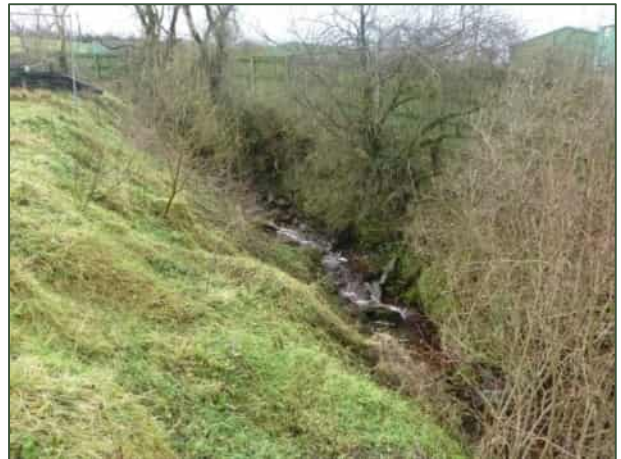
**Photograph 4:**  
Modified channel bank to farmyard

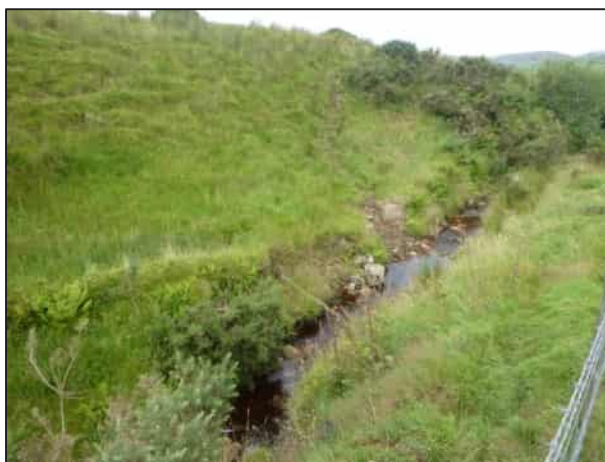
**Photograph 4:**  
**Channel in ravine with livestock poaching at bank**

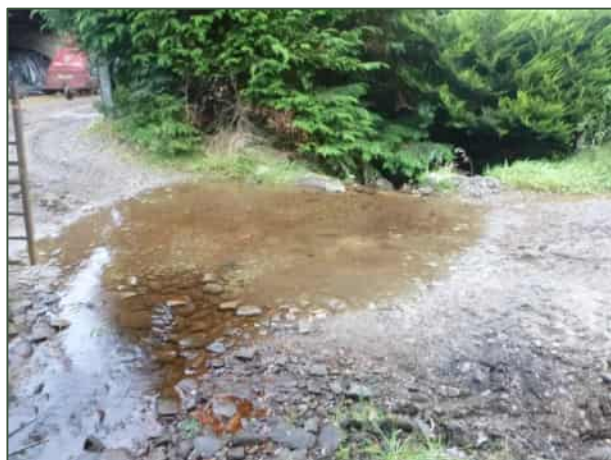
**Photograph 1:**  
Burn ford at farmyard with cascade on downstream side

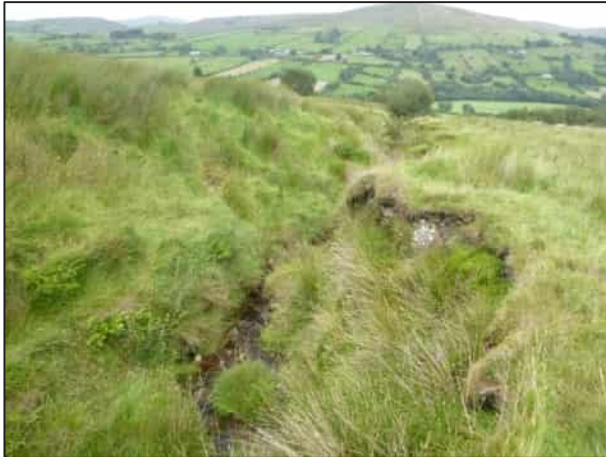
**Photograph 3:**  
Channel with eroded banks and sediment input to channel

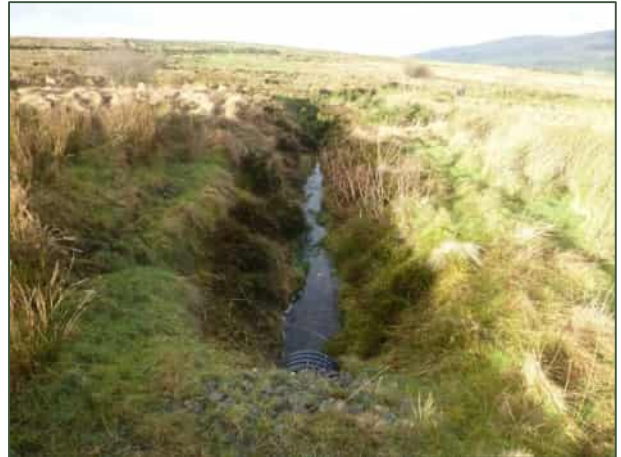
**Photograph 4:**  
Straightened section of burn channel with small, piped culvert
