## **APPENDIX 7.6 PRELIMINARY ROOST ASSESSMENT & PRF INSPECTION SURVEY BATS**

### **PRELIMINARY ROOST ASSESSMENT OF TREES & POTENTIAL ROOST FEATURE INSPECTION SURVEYS**

**Table 1: Results of Preliminary Roost Assessment for Trees and PRF Inspection Surveys**

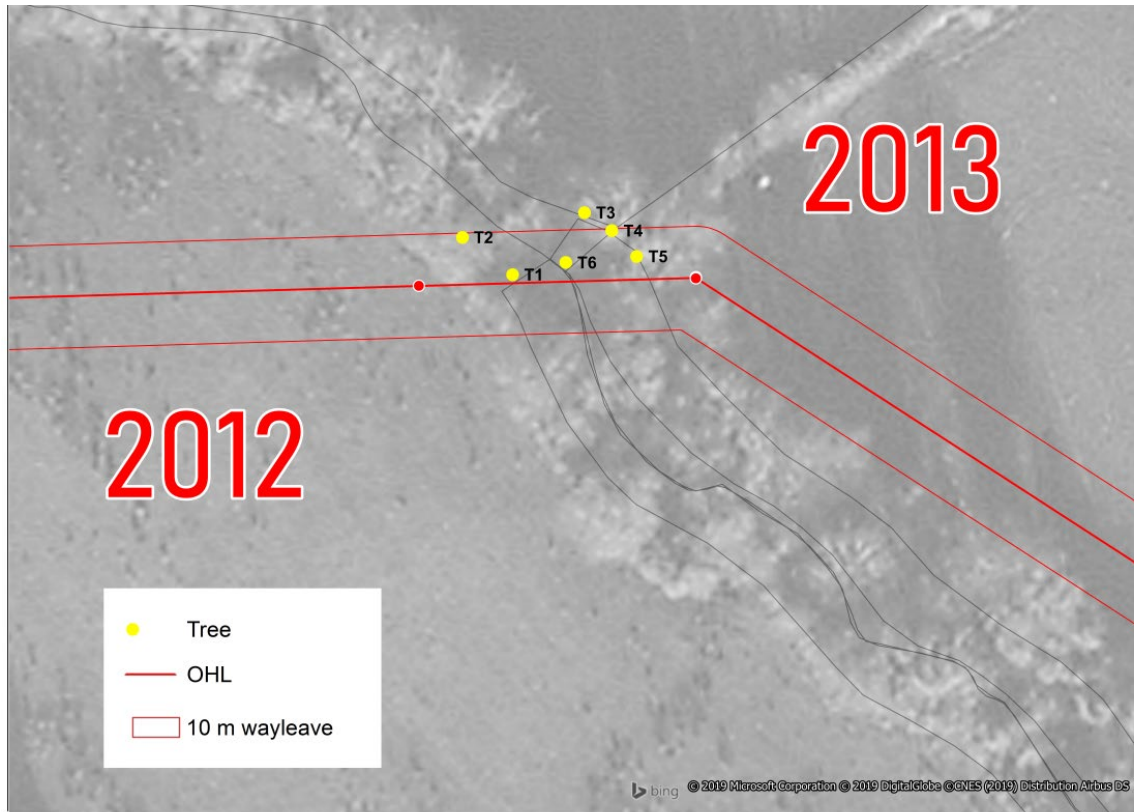
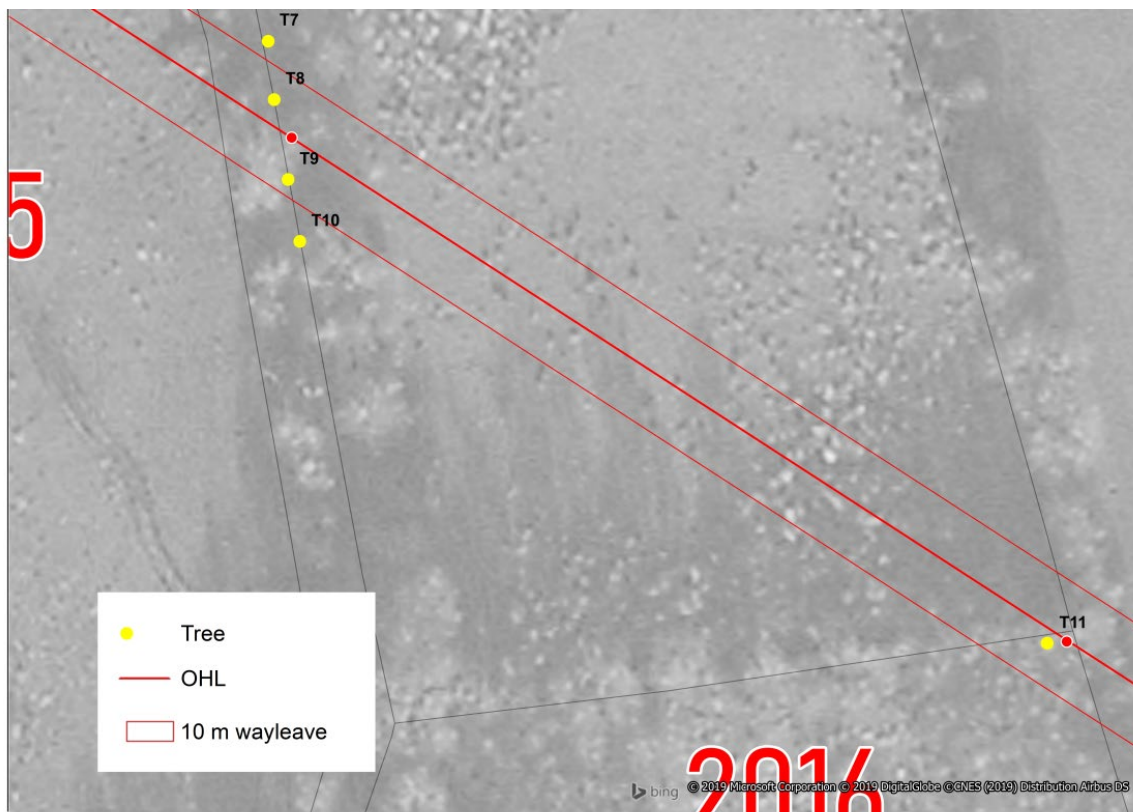
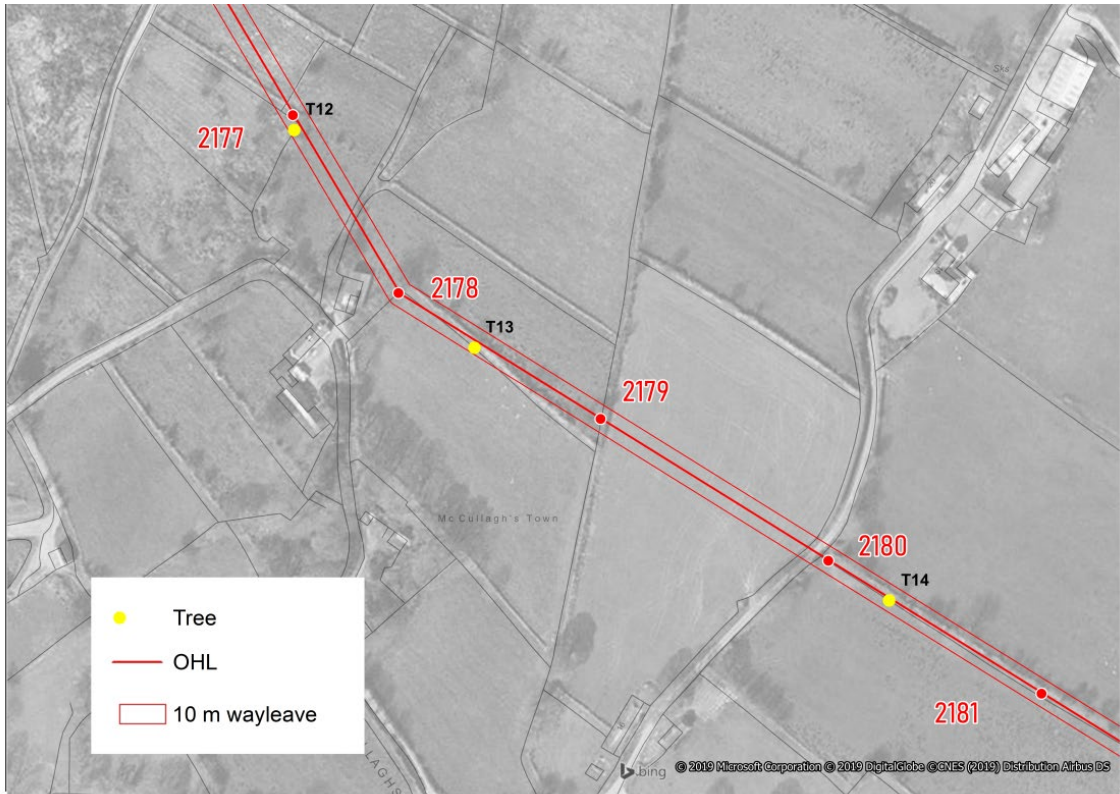
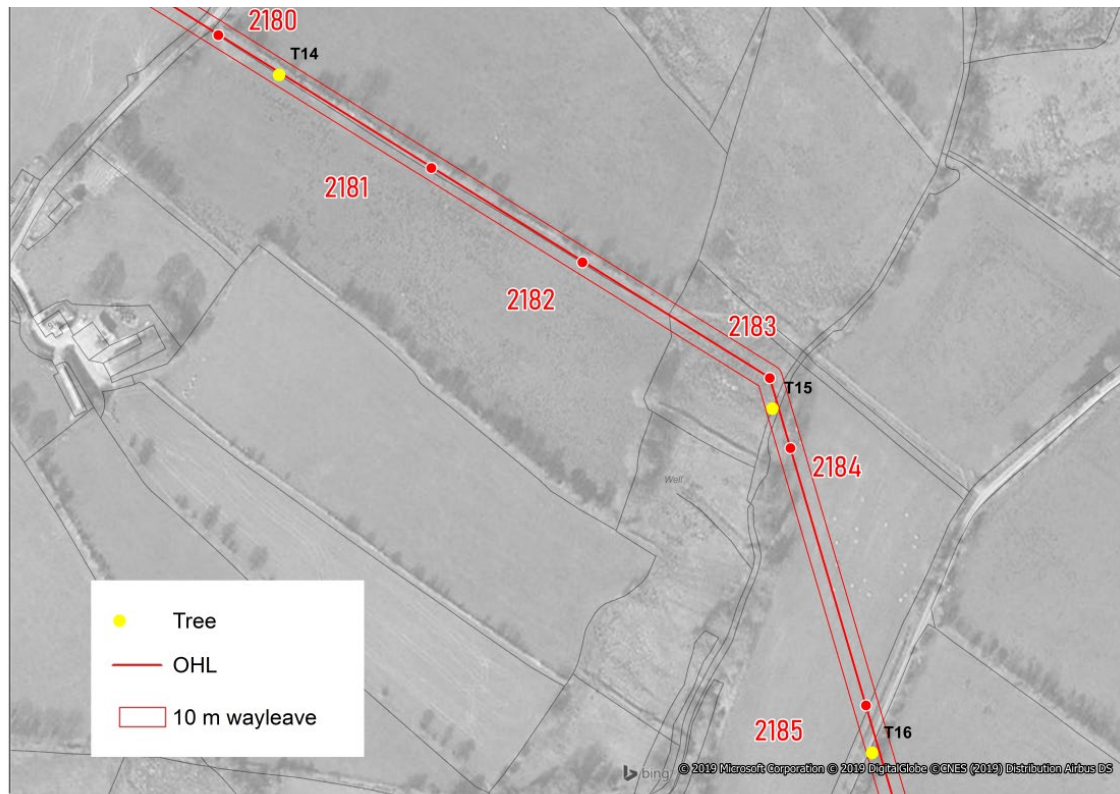
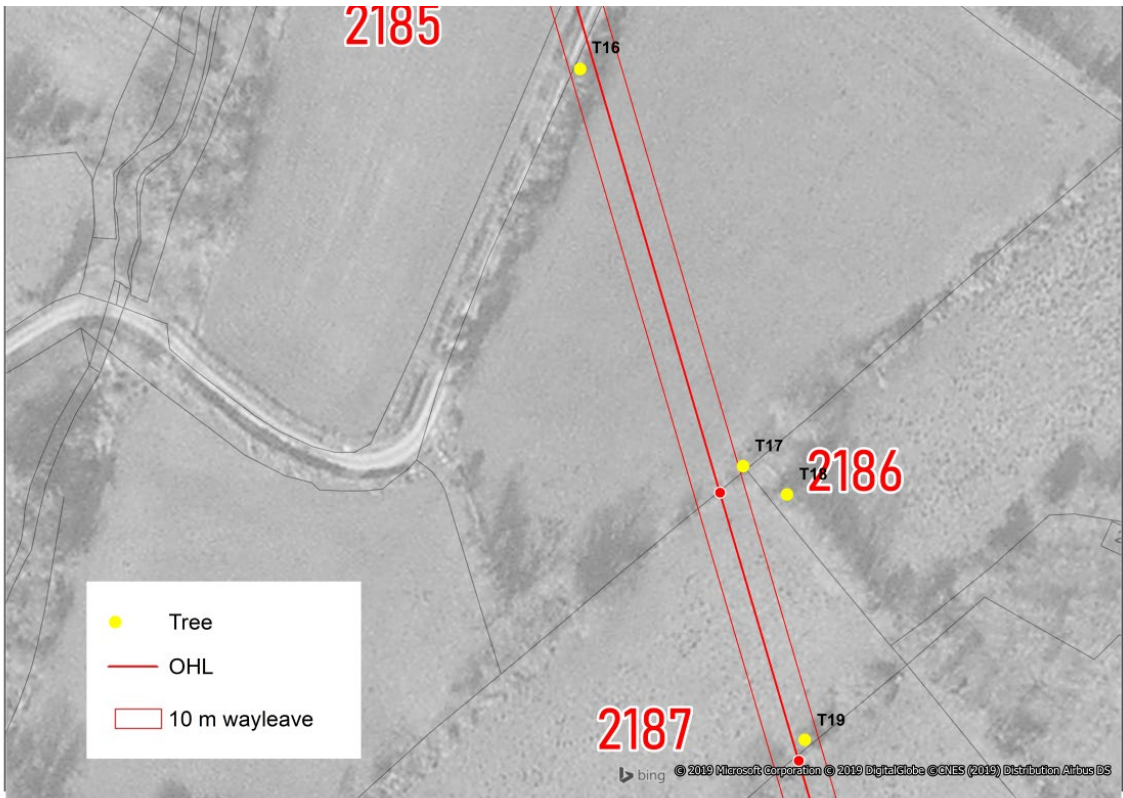
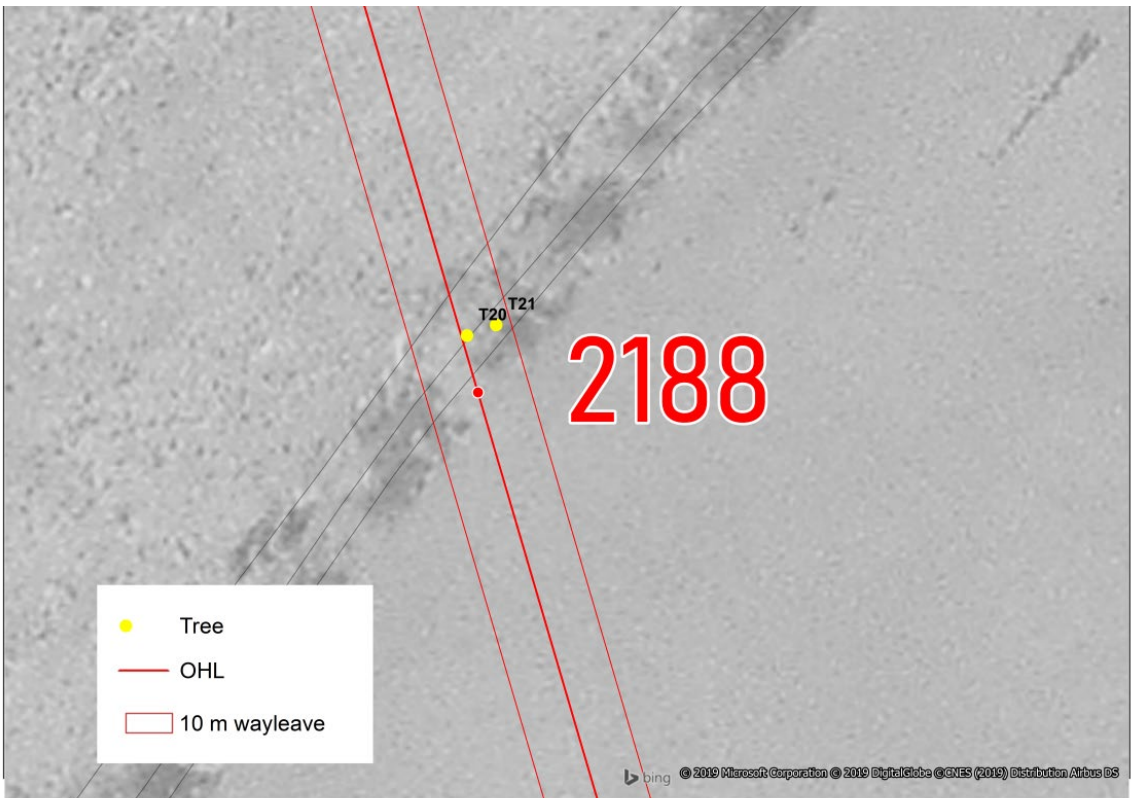
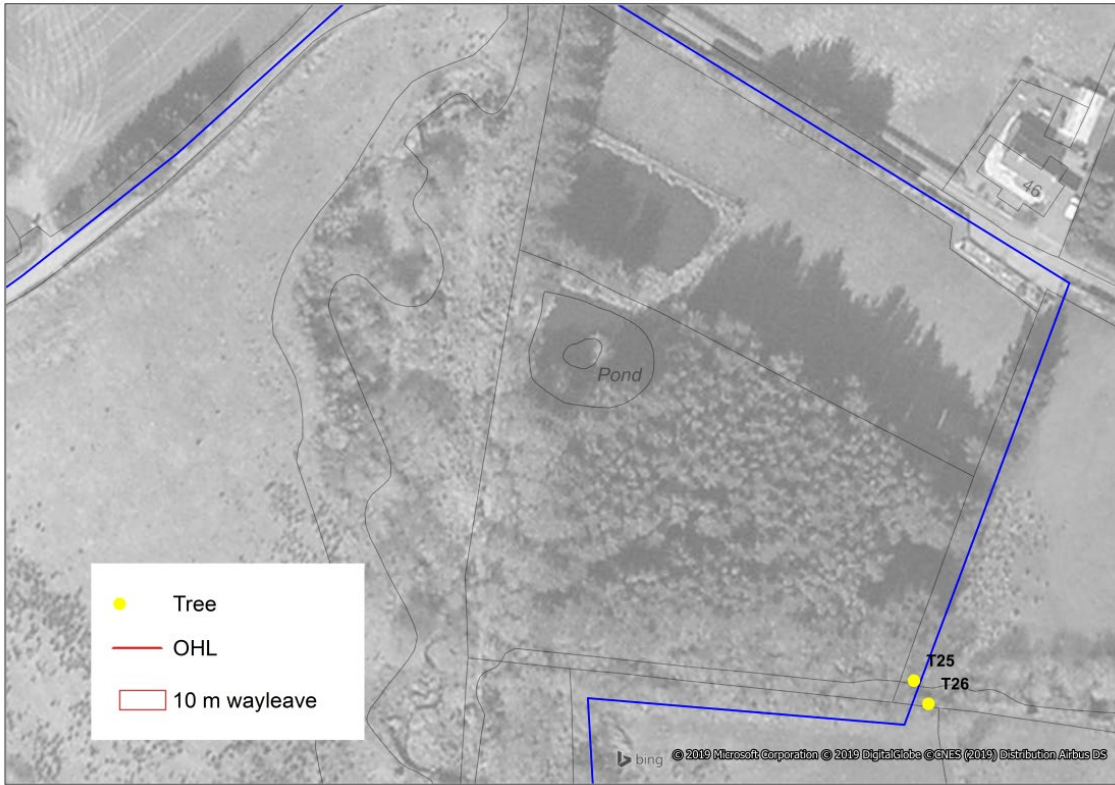
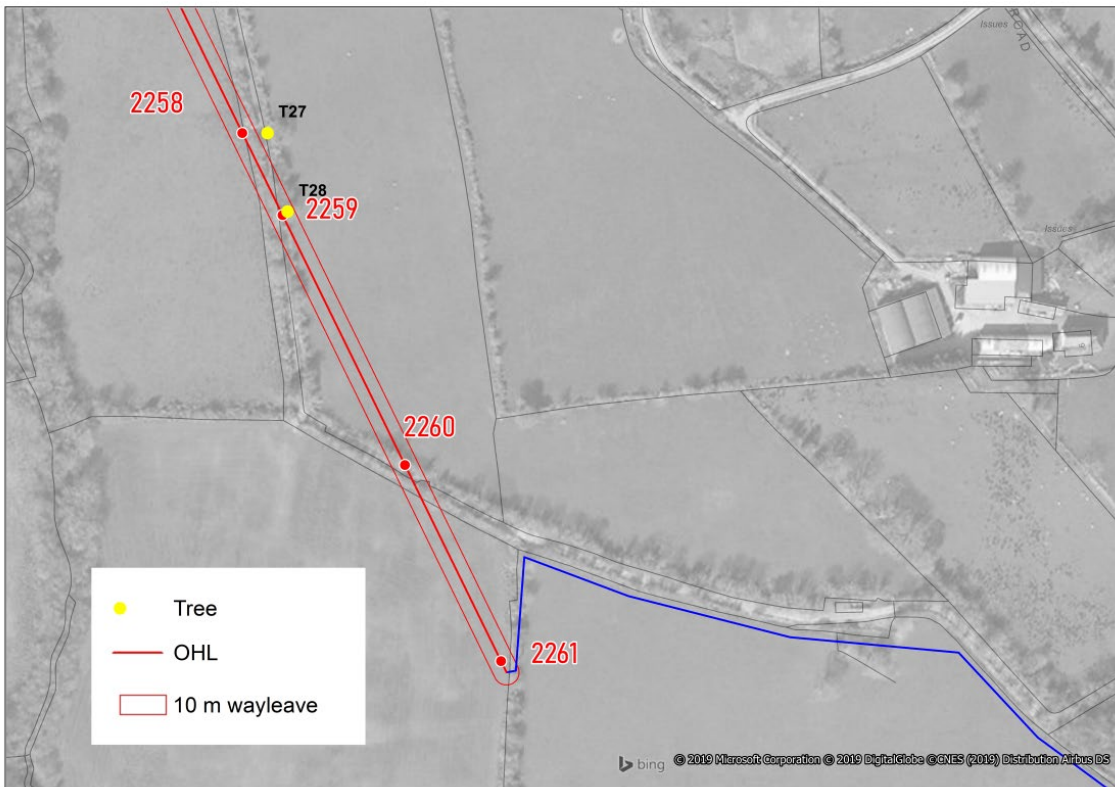
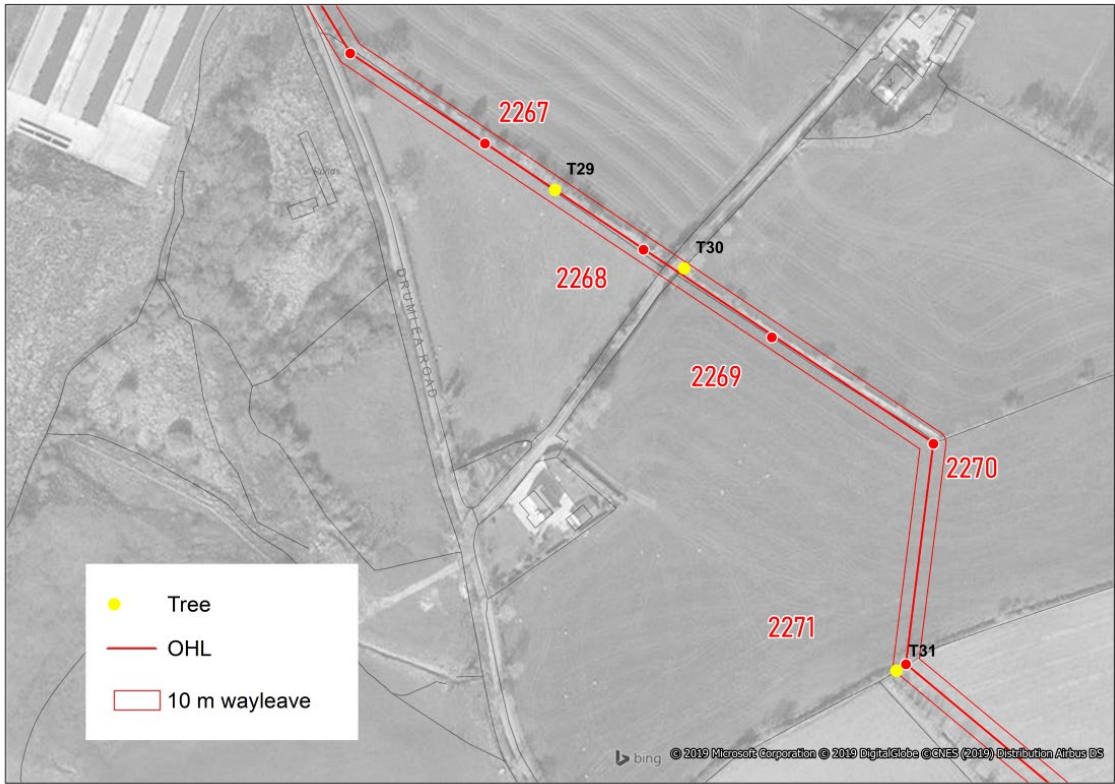
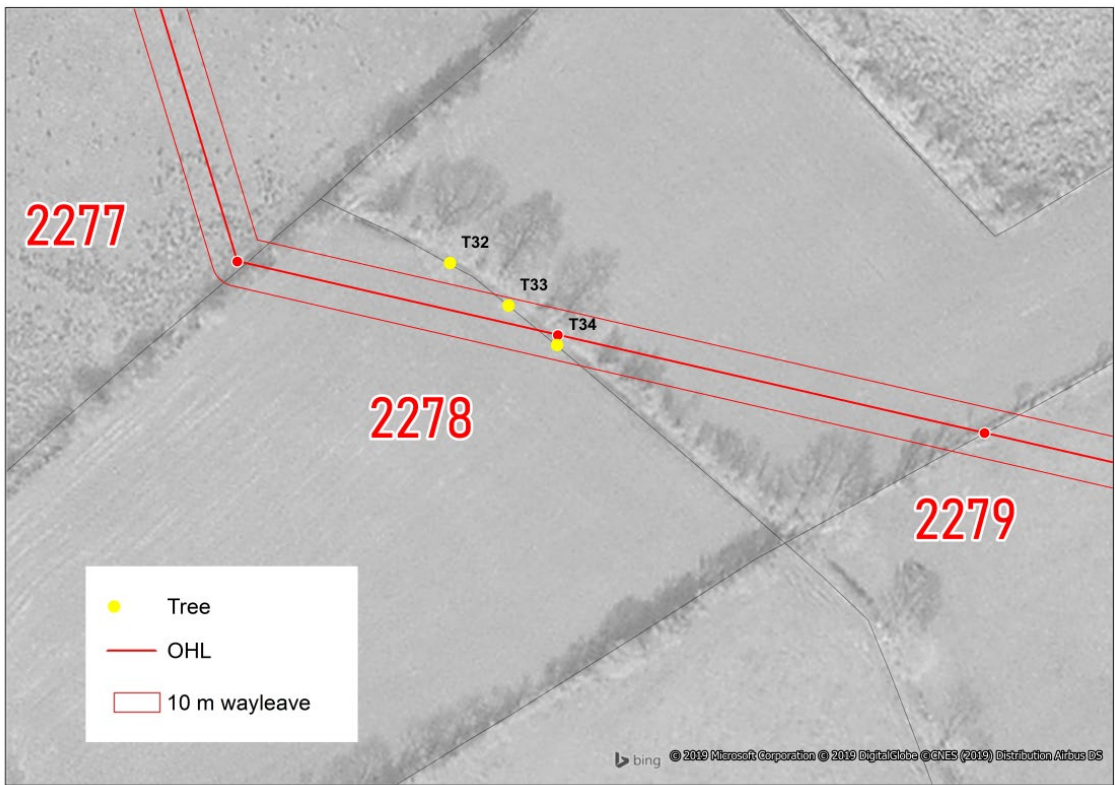
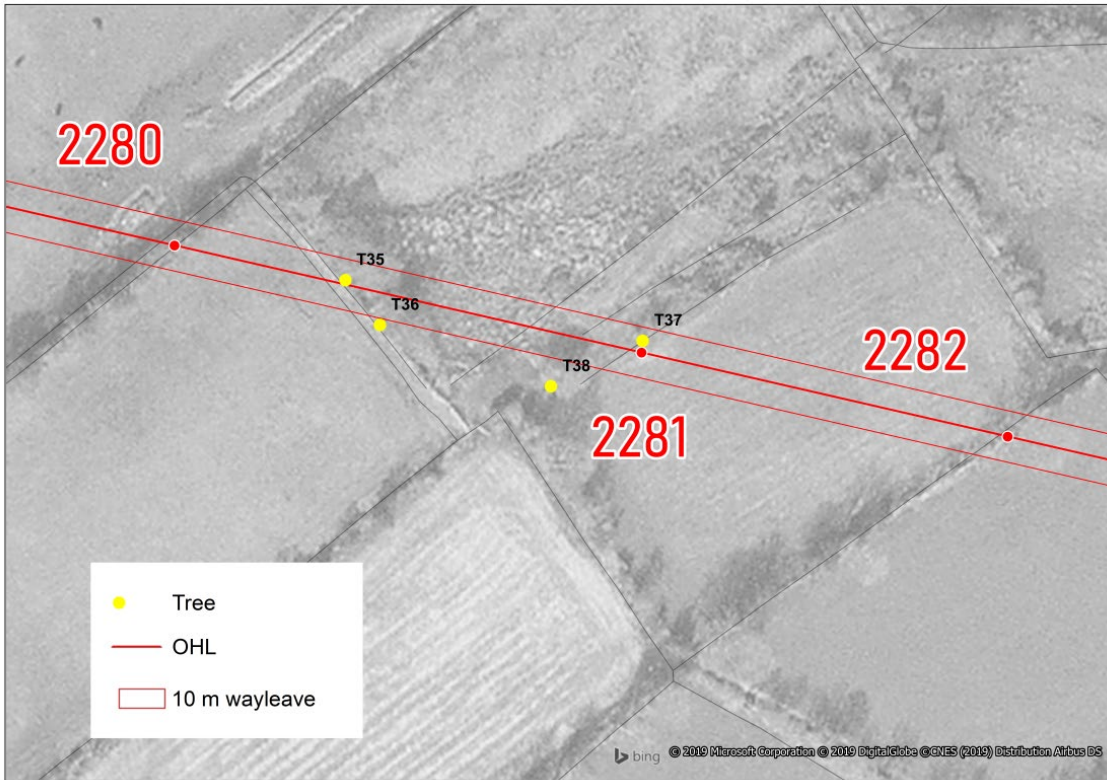
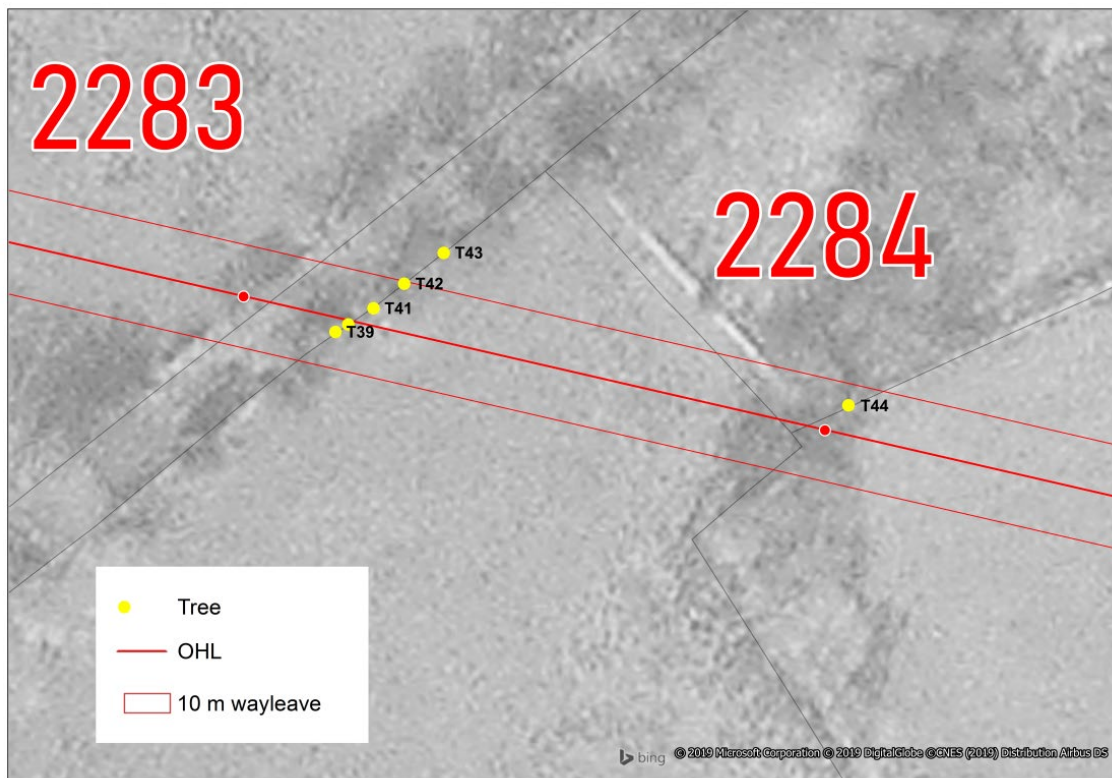
## Location of Pole Structures and Trees with Bat Roost Suitability

Note: Tree 24 represents multiple pine and spruce within and along the wayleave boundary
