**Curraghinalt Gold Project,  
County Tyrone,  
Northern Ireland**

**Bat Roost Characterisation Survey 2024/25**

**November 2025**

**Reference: DGL-25.001 v1.1**

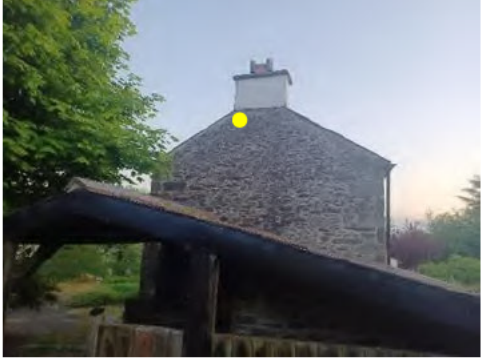
Date	Emergence / Re-entry	Re-entry
16/04/2024	<p><b>Emergence</b></p> <p>The first bat to emerge was a common pipistrelle at 21:08 (34 minutes after sunset) from a small hole in chimney on east elevation of Pollan Rua cottage.</p> <p>A further common pipistrelle emerged from the same location as the first bat at 21:12.</p>

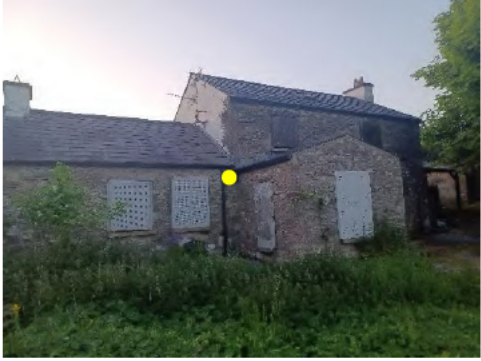
<p style="text-align: center;"><b>Pollan Rua Cottage South Elevation</b></p>

<p style="text-align: center;"><b>Pollan Rua Cottage East Elevation</b></p>
24/06/2024	<p><b>Emergence</b></p> <p>The first bat to emerge was a common pipistrelle at 22:34 (24 minutes after sunset) from under the eaves where the western gable end joins the main Pollan Rua cottage.</p> <p>At 22:48 a common pipistrelle emerged from a small hole in chimney on east elevation of Pollan Rua cottage.</p>

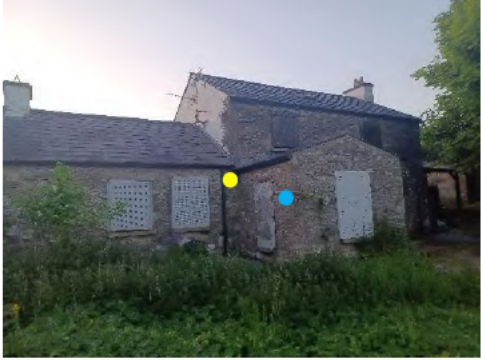
<p style="text-align: center;"><b>Pollan Rua Cottage South Elevation</b></p>

<p style="text-align: center;"><b>Pollan Rua Cottage East Elevation</b></p>
14/10/2024	<p><b>Emergence</b></p> <p>The first bat to emerge was a common pipistrelle at 19:00 (29 minutes after sunset) from under the eaves where the western gable end joins the main Pollan Rua cottage.</p> <p>At 19:01 (30 minutes after sunset) a Natterer's bat emerged from hole in wall right of window on the western gable end on the south elevation of the Pollan Rua Cottage.</p>

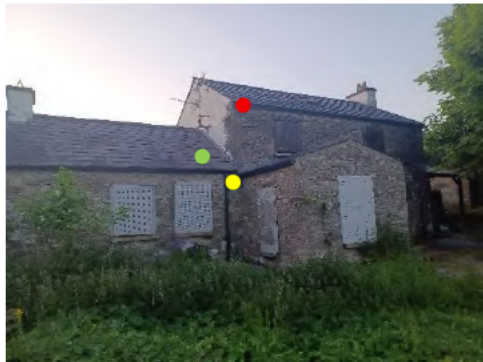
<p><b>Pollan Rua Cottage South Elevation</b></p>

Date	Emergence / Re-entry	Re-entry
18/06/2025	<p>The first bat to emerge was a Leisler's bat at 22:10 (7 minutes after sunset) from under eaves of the roof of the main part of the Pollan Rua cottage on the south elevation of the annexe to the main cottage.</p> <p>At 22:44 (41 minutes after sunset) a common pipistrelle emerged from under eaves of the roof where the western gable end joins the main Pollan Rua cottage.</p> <p>From 22:46 to 23:20 a total of 11 individual bats emerged from the missing tile in the annexe roof on the south elevation. Of these nine were non-echolocating however, all the bats exhibited the same behaviour of approaching but not flying from the exit for approximately 20 seconds before actually exiting to the bats identified at 22:51 and 23:20 whose calls were identified as brown long-eared bat.</p>

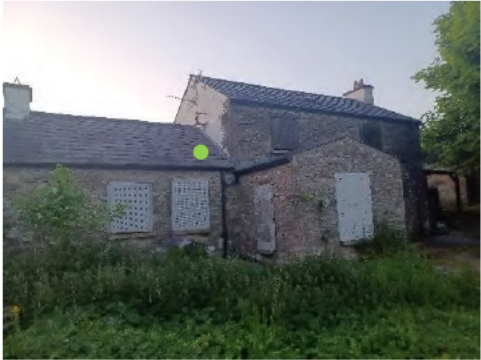
Date	Emergence / Re-entry	Re-entry
	<p><b><u>Re-entry</u></b></p> <p>At 23:20 a brown long-eared bat re-entered at the location of the missing tile on south elevation annexe roof.</p>

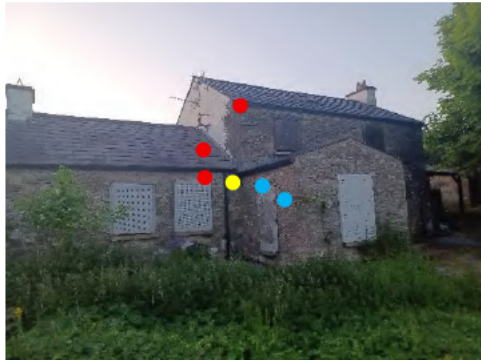
<p><b>Pollan Rua Cottage South elevation</b></p>

<p><b>Pollan Rua Cottage South Elevation</b></p>
19/06/2025	No bats observed emerging or re-entering	
27/08/2025	<p><b><u>Emergence</u></b></p> <p>The first bat to emerge was a Leisler's bat at 20:34 (at Sunset) from under the eaves of the roof on the south elevation of the annexe to the main cottage.</p> <p>Two non-echolocating bats also emerged at 20:34 from just above the window on the western side gable end on the south elevation of the main cottage. No corresponding recordings made at this time to confirm the species of these bats, but potentially Natterer's Bat based on flight pattern.</p> <p>At 20:40 a Leisler's bat emerged from under eaves of the roof of the main part of the Pollan Rua cottage.</p> <p>In addition at 20:40, four non-echolocating bats emerged from a hole in the wall right of the window on the western side gable end on the south elevation of the main cottage. No corresponding recordings made at this time to confirm the species of any of these bats, but potentially Natterer's Bat based on flight pattern.</p> <p>A common pipistrelle emerged from under eaves of the roof where the western gable end joins the main Pollan Rua cottage at 20:41 (7 minutes after sunset).</p> <p>A Leisler' bat emerged at 20:49 from the roof of the annexe where a tile is missing.</p> <p>Two further common pipistrelles emerged from a small hole in chimney on northern elevation of main part of Pollan Rua cottage at 21:22 and 21:24 (50 minutes after sunset)</p>

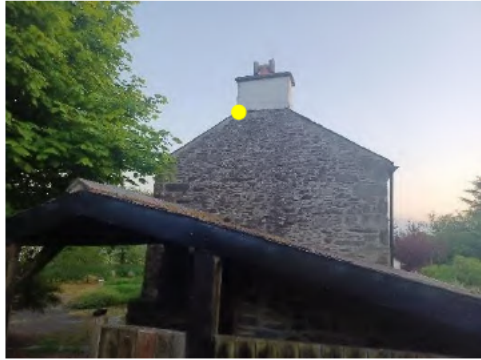
<p><b>Pollan Rua Cottage East Elevation</b></p>

Date	Emergence / Re-entry	Re-entry
	<p><b><u>Re-Entry</u></b></p> <p>At 21:28 a Leisler's Bat re-entered under eaves of the roof of the main part of the Pollan Rua cottage at the point a Leisler's bat emerged at 20:40.</p>

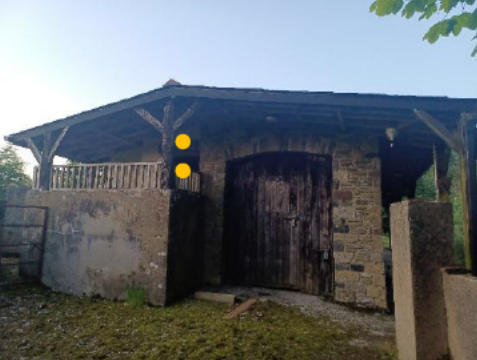
<p><b>Pollan Rua Cottage South Elevation</b></p>
<p>28/08/2025</p>	<p><b><u>Emergence</u></b></p> <p>At 20:39 (7 minutes after sunset) a non-echolocating bat emerged from open doorway on western elevation in livestock shed. No corresponding recordings made at this time to confirm the species of bat.</p> <p>At 20:44 another non-echolocating bat emerged from the open doorway on the western elevation of the livestock shed. No corresponding recordings made at this time to confirm the species of bat.</p>

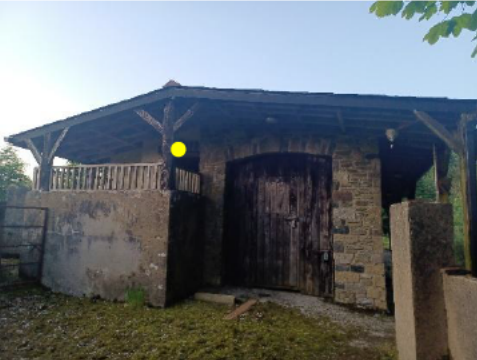
<p><b>Livestock Shed West Elevation</b></p>
	<p><b><u>Re-entry</u></b></p> <p>At 20:53 a common pipistrelle re-entered the livestock shed through open doorway on its western elevation.</p> <p>At 21:16 two common pipistrelles re-entered the livestock shed through the open doorway on its western elevation.</p> <p>At 21:18 four common pipistrelles swarming around chimney of east elevation of Pollan Rua cottage before entering a small hole in the chimney.</p>

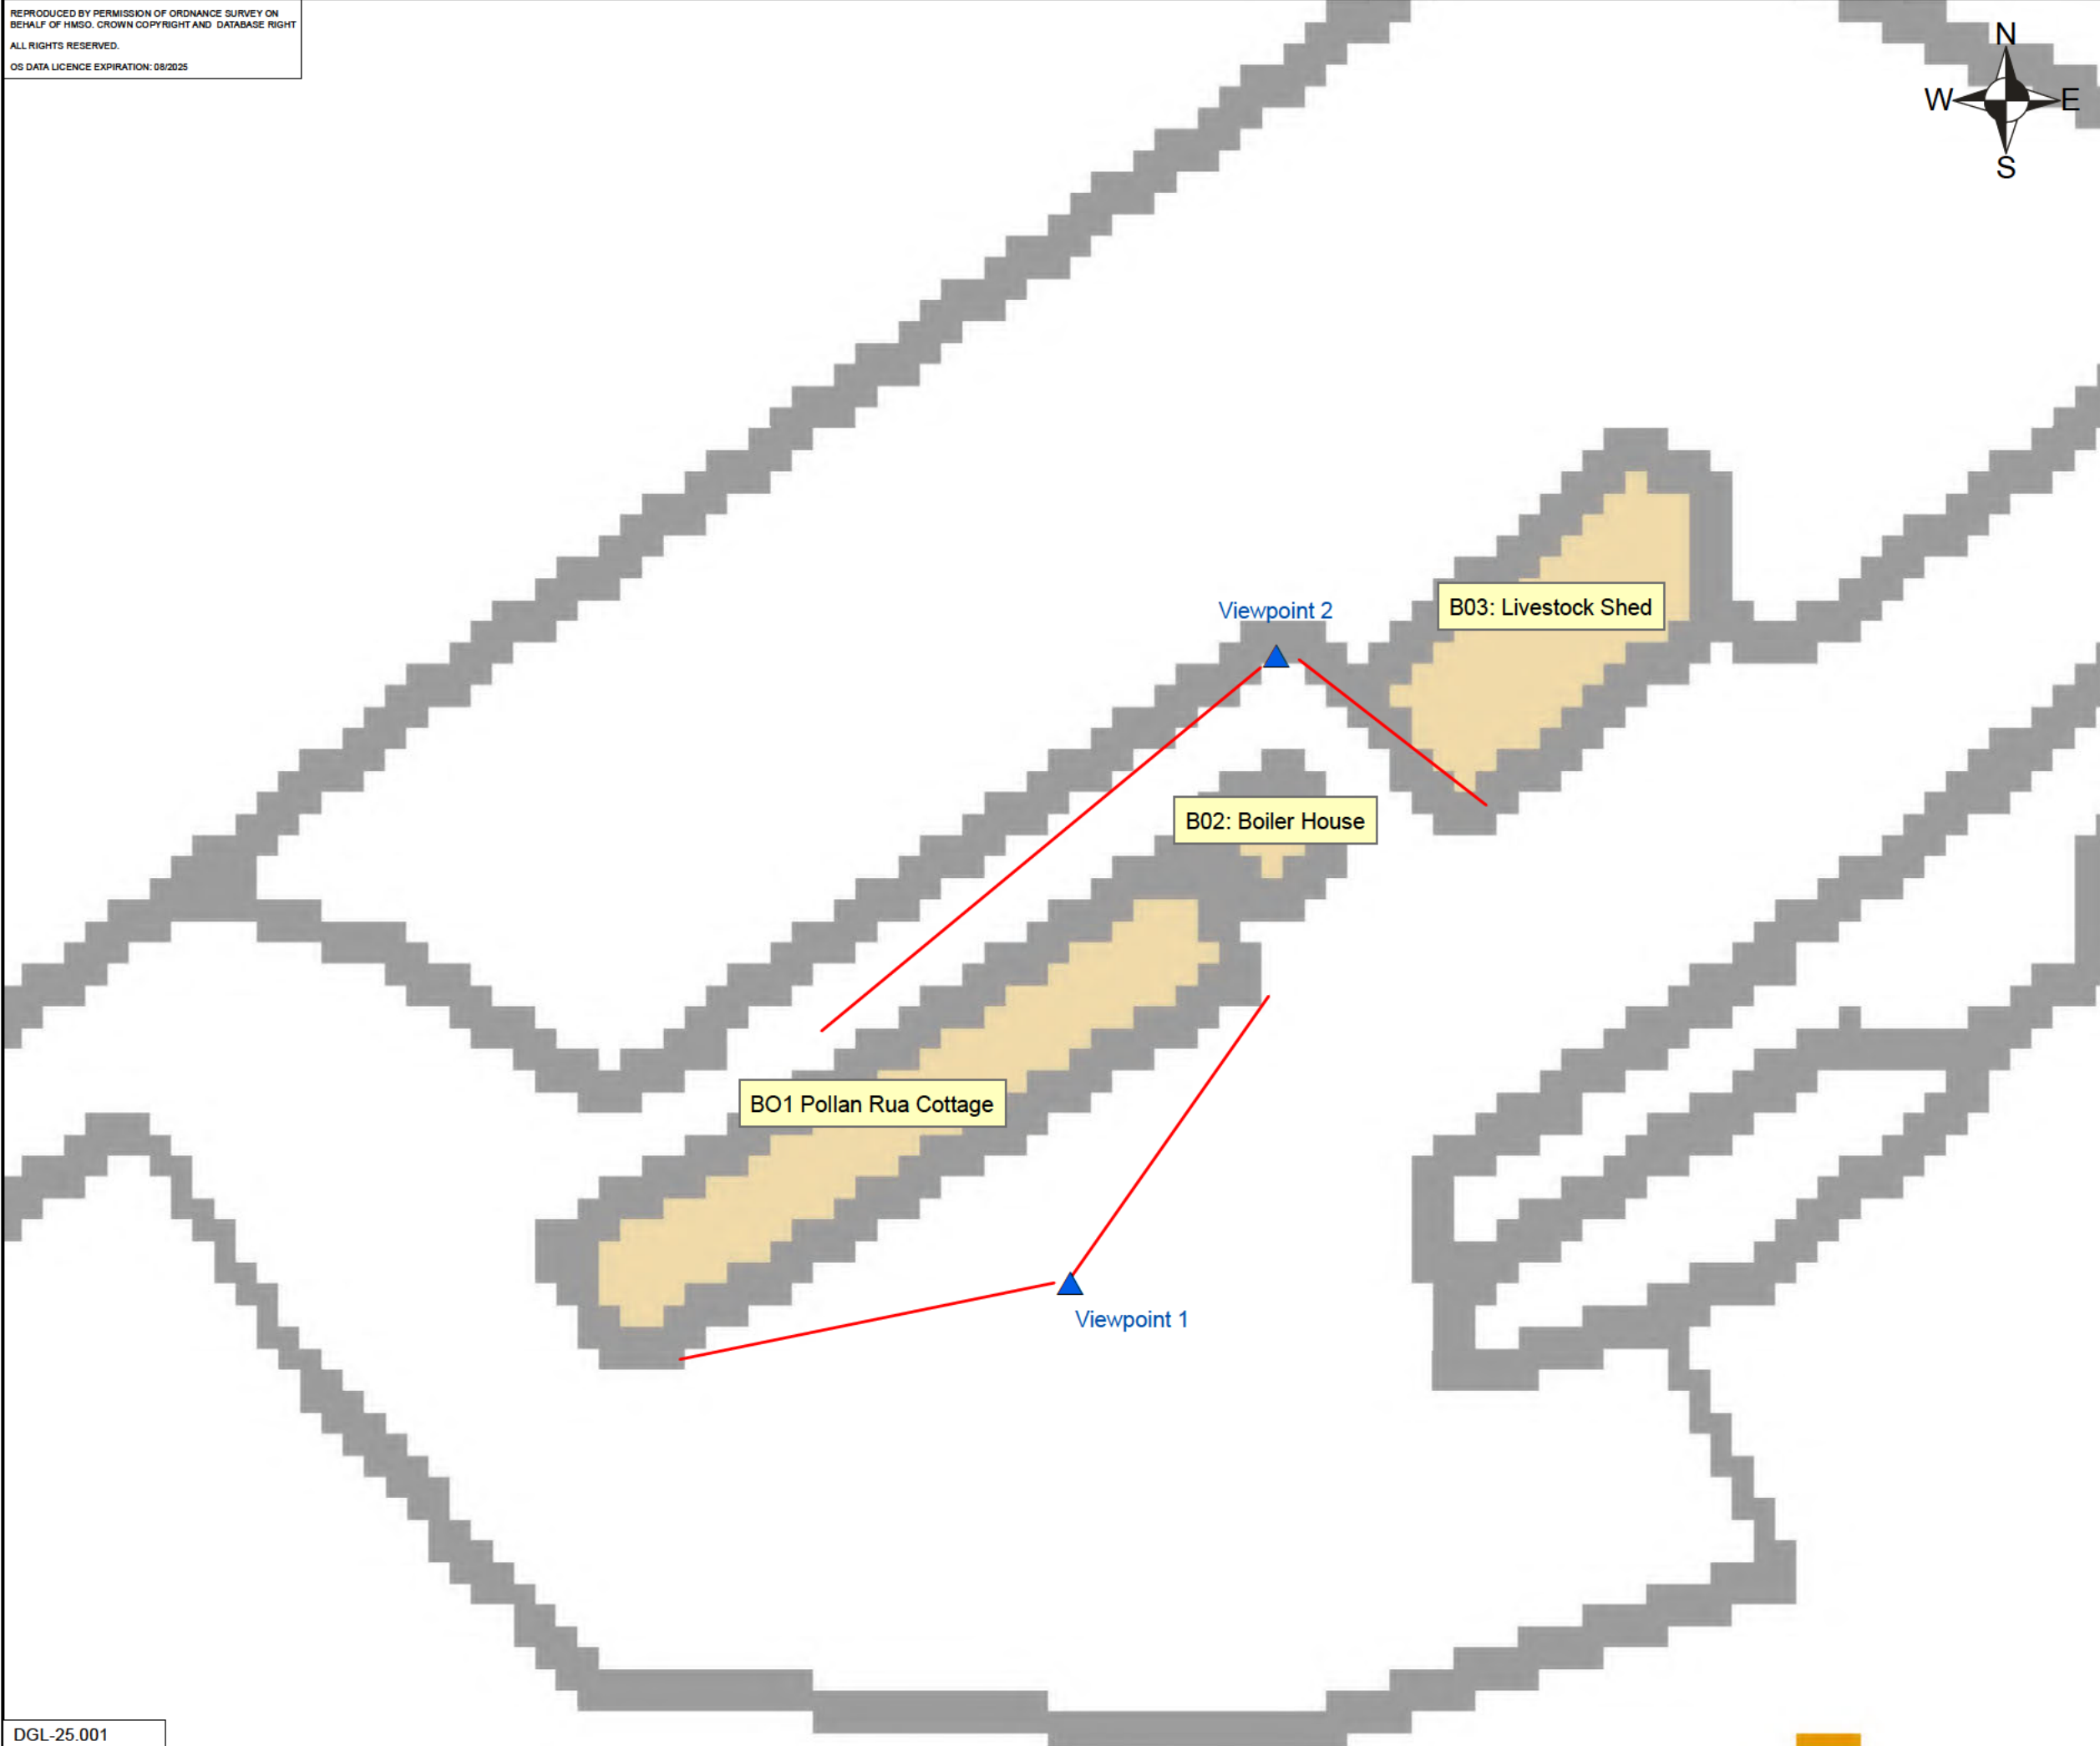
FIELD OF VIEW

Thermal camera viewpoint and sightlines used in the dusk emergence surveys were informed based on recorded features with the potential to be used by roosting bats and historically where bats have been observed as emerging and/or re-entering roosting features. The bat surveyor sightlines in 2024 and the thermal camera viewpoints in 2025 are shown in Figure 2 and Figure 3 respectively.

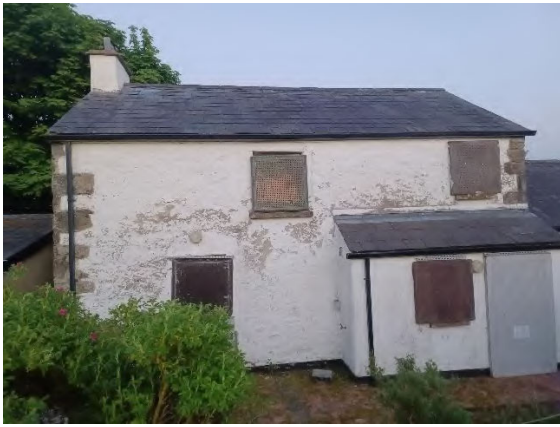
North Elevation of Main Pollan Rua Cottage

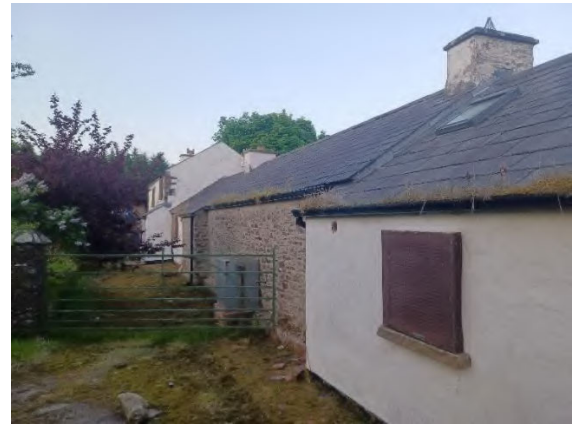
North Elevation of Pollan Rua Cottage Annexe

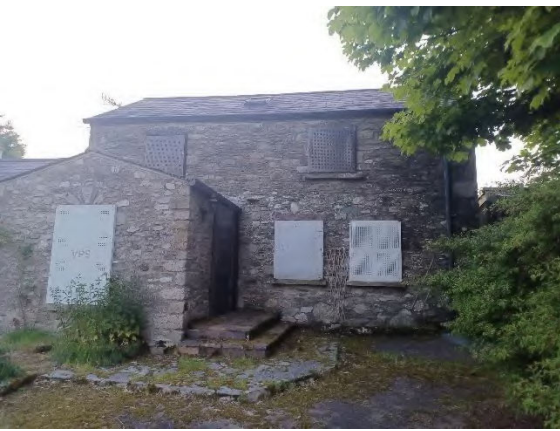
South Elevation of Main Pollan Rua Cottage

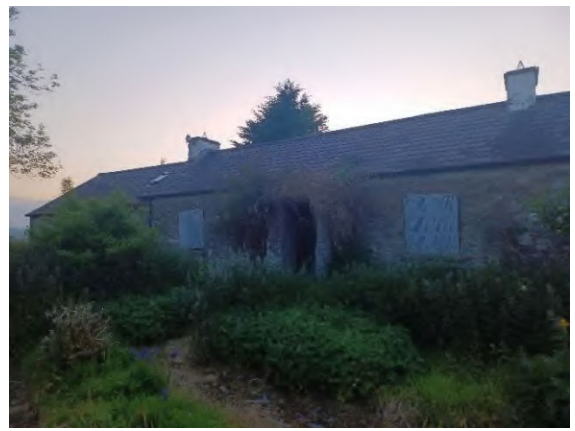
South Elevation of Pollan Rua Cottage Annexe

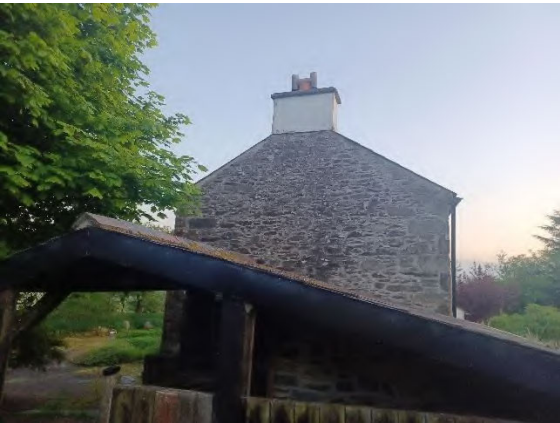
East Elevation of Main Pollan Rua Cottage

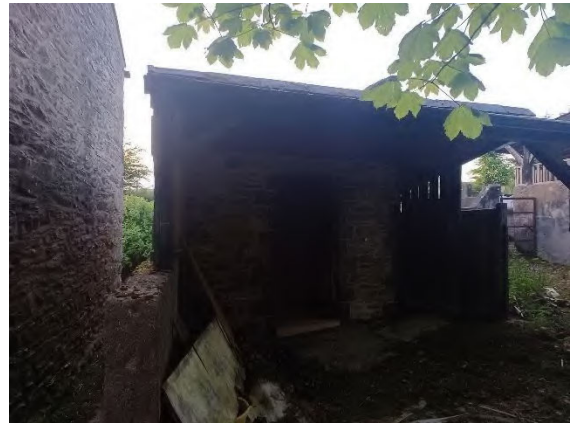
South Elevation of Boiler Shed

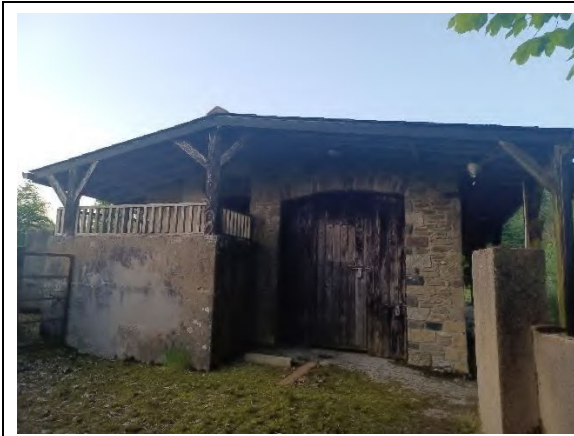
West Elevation of Livestock Shed

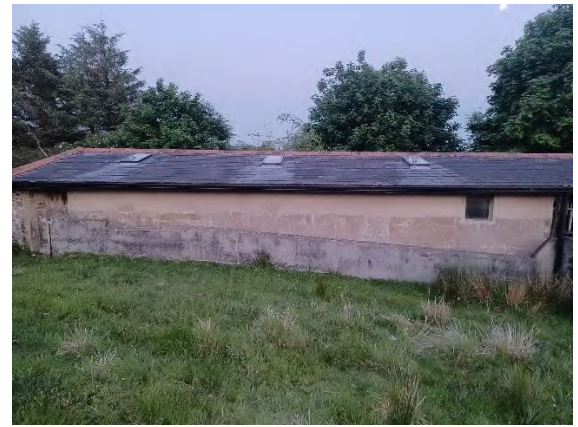
North Elevation of Livestock Shed
