**THE CROCKANBOY ROAD GREENCASTLE COUNTY TYRONE (ABANDONMENT) ORDER  
(NORTHERN IRELAND) 2021**

## 2.0 THE ASSESSMENT OF THE EXISTING ADOPTED TRACK

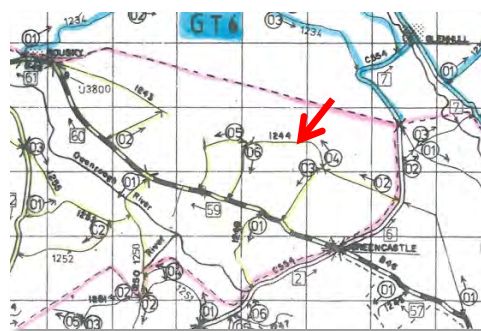
- 2.4 The Adopted Track forms part of the GT5 public road network, coloured yellow on the public roads map, and identified as 1244 (04). Fig. 01 below shows a clip from the said map with the location of the Adopted Track shown by my red arrow.

Clip from the public roads map in Appendix 03.

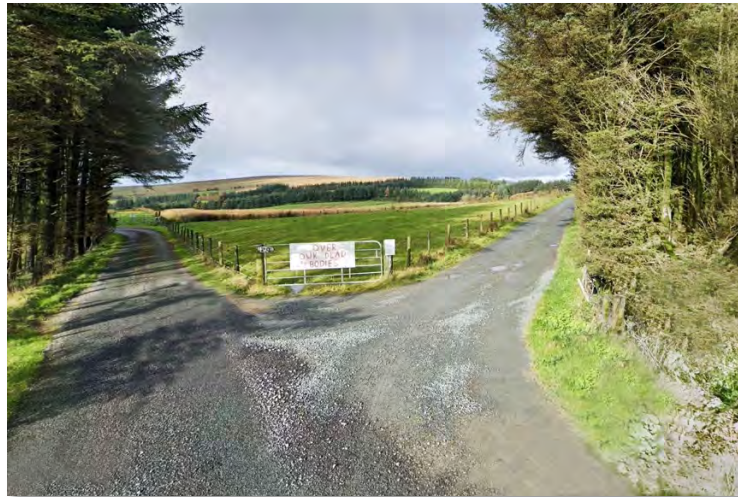
Fig. 02  
Point A

- 2.7 Fig. 02 above shows a 2021 Google street view image at Point A, where the adopted track (right) joints the Mullydoo Road. It can be seen how the tarmac surface of the Mullydoor Road is affected by loose stone migrating from the unbound adopted track.
- 2.8 The evidence suggests this end of the adopted track has been in frequent use for access to lands in the immediate area.
- 2.9 During my inspection, on Wednesday 29 November 2023, my movement was predominantly in an easterly direction, i.e, from Point O towards Point A, and so many of my images are looking eastward, unless otherwise noted.

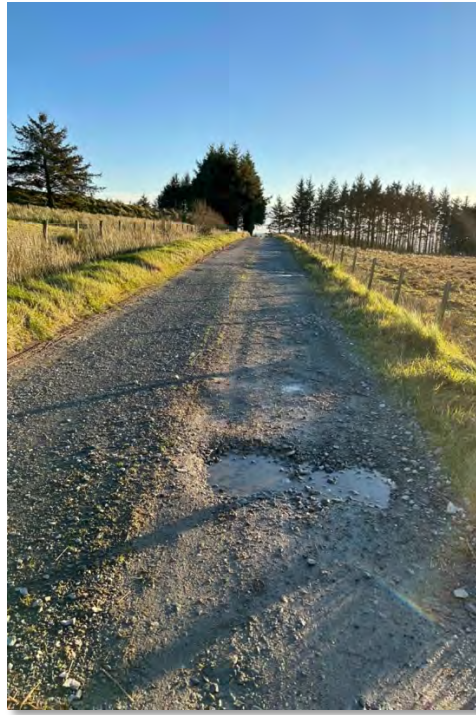
Fig. 03 Looking towards A

- 2.10 Fig. 03 above shows the final straight of the adopted track approaching the Mullydoo Road. The nature of the unbound compacted surface is evident as are the pot-holes. Fig. 04 above shows the adopted track looking from Point C. Again, the surface is in poor condition.

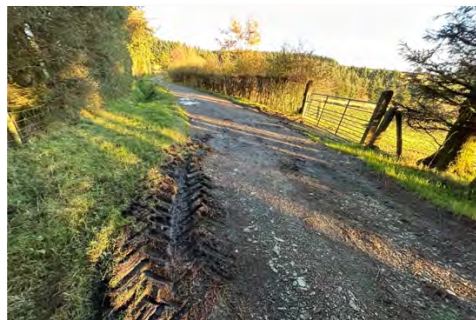
Fig. 05 Point D

- 2.11 Fig. 05 above shows a field gate at Point D. The evidence of tractor tyres tracks in the soft verge, indicates the adopted track is used by agricultural machinery to access fields via the farm gate at Point D.
- 2.12 Fig. 06 above shows dry stone walls to the sides of the adopted track at Point E. The top of wall to the right of the picture is in poor condition

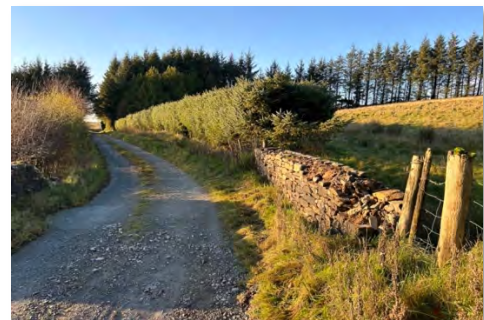
Fig. 06 Point E

whereby the dry stone is eroding adjacent to the grass verge. There are several bad bends in the track here where forward visibility is limited.

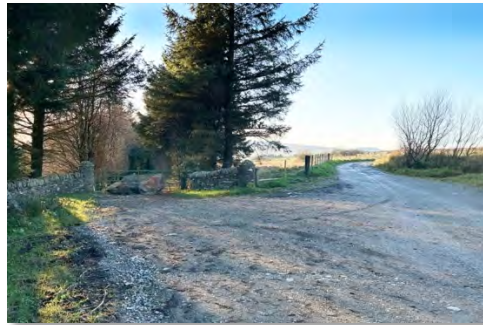
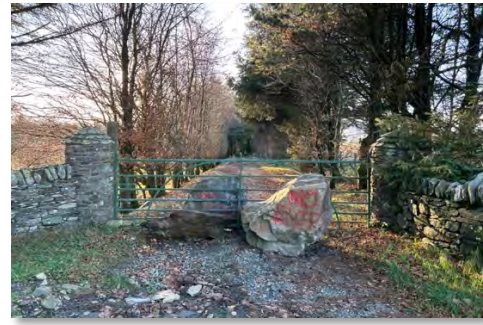
- 2.13 Figs. 07 & 08 show the access to the property known as 80 Mullydoo Road, a former shepherd's hut. Today, the gate is blocked by large stone boulders. I have indicated the location of the property as Point F1 and adjacent farm building as F2 on the maps in the Appendices.

- 2.14 80 Mullydoo Road is a vacant residential property now owned by Dalradian Gold Ltd. It was the only property that would have benefitted from the adopted track, out of necessity, for access to and from the Mullydoo Road, and so today the need for the track is nil. The context of this isolated former dwellinghouse is clear from orthophotography flown 2020, in Appendix 05.

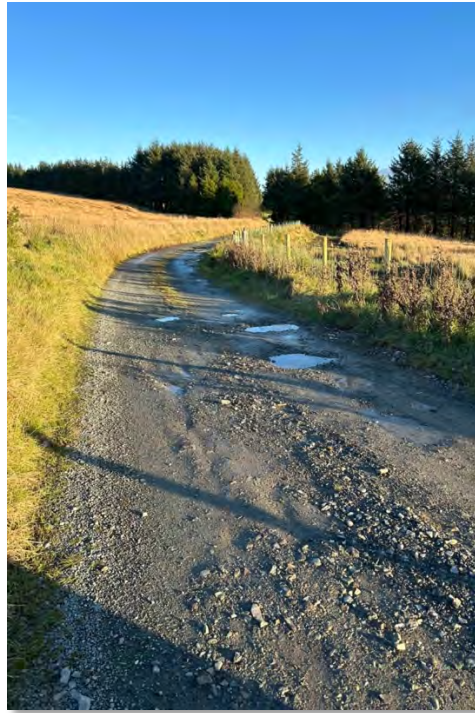
2.16 Fig. 09 shows the condition of the adopted track at Point G and Fig. 10 likewise, looking towards Point H at Sarah B's cottage ruin. The image in Fig. 10, again, shows the impression of tractor tyre tracks in the surface of the adopted track.

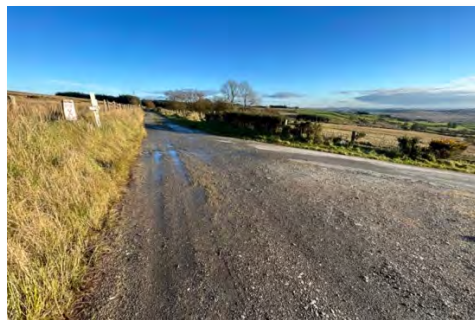
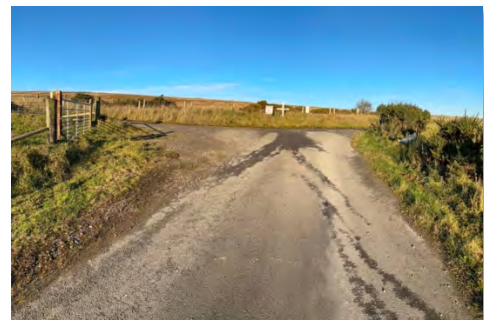
2.17 Figs. 11 & 12 are both at the junction of adopted road 1244 (06) and the Adopted Track 1244 (04), at Point J. The impression of both car and tractor tyres are evident in the surface of the adopted track.

- 2.18 Fig. 12 shows the approach from the Crockanboy Road to the south. Here, the road 1244 (06) has a tarmacadam surface, which is in fair condition.

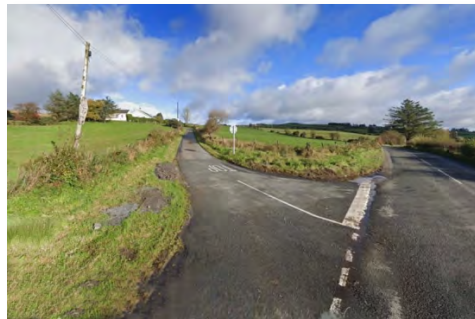
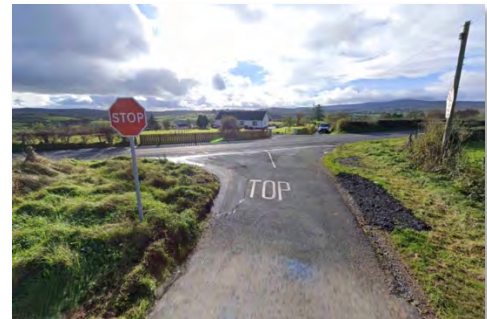
- 2.22 Figs. 13 and 14 above are 2021 Google street view images, showing the position on the ground, both at Point R, where road 1244 (06) joins the Crockanboy Road.
- 2.23 Here, the 1244(06) has a tarmacadam surface and the junction is defined by white line paint, including a “STOP” sign and warning on the road surface, albeit the “S” has been lost due to a localised repair.

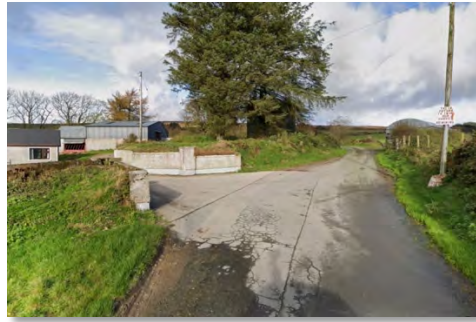
Fig. 15 Point S

2.24 Moving up road 1244(06), Fig. 14 above shows the entrance to a farm settlement at point S. Here, the tarmac road connects the farm with the Adopted Track to the north and the Crockanboy Road to the south. This farm has direct access southwards to the Crockanboy Road at Point R, and is not reliant on the adopted track, out of necessity.

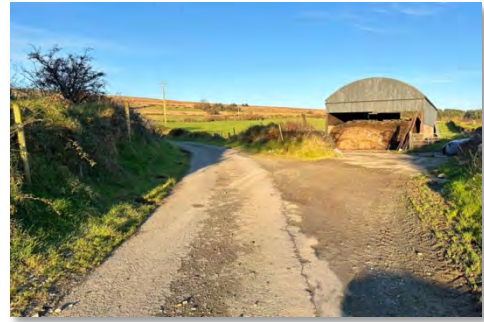
Fig. 16 Point S

2.25 Fig. 16 above shows the tarmac road passing an agricultural barn to the northwest of the farmhouse.

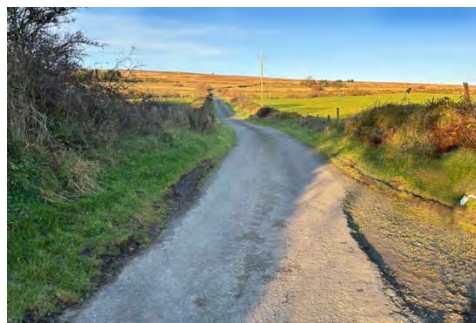
Fig. 17 Point S

2.26 Fig. 17 above shows the tarmac road extending north, uphill, where it meets the Adopted Track at Point J. The edge of the tarmac road surface has broken away, most likely due to the movement of heavy agricultural machinery to the barn side of the road.

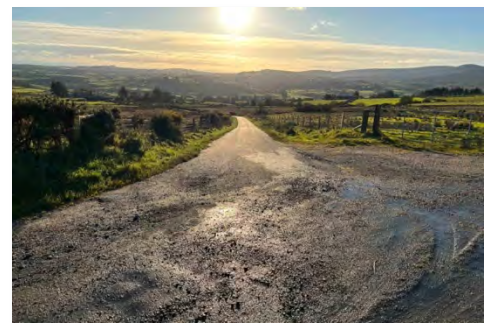
Fig. 18 Point J

2.27 Fig. 18 above is the view from the north end of road 1244(06) at Point J. The loose stone from the surface of the unbound Adopted track has migrated onto the tarmac surface of the road coming up the hill. The image shows surface water draining over the surface of the adopted track from the higher ground, behind the viewpoint of the camera.

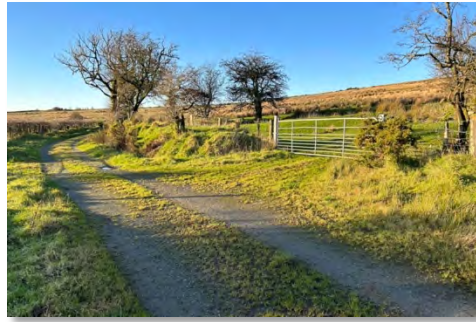
Fig. 19 Point K

2.28 Moving westward from Point J on the upper road 1244 (05), Fig. 13 shows another farm gate where occasional access to agricultural lands is made from the Remaining Road at Point K.

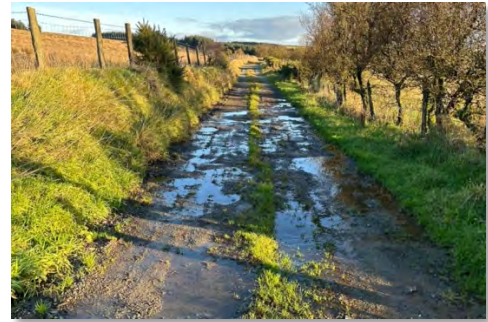
Fig. 20 Point L

2.29 Fig. 14 shows the Remaining Road at Point L. Here the surface is subjected to water run-off from higher ground and appears to be liable to ponding at times of inclement weather.

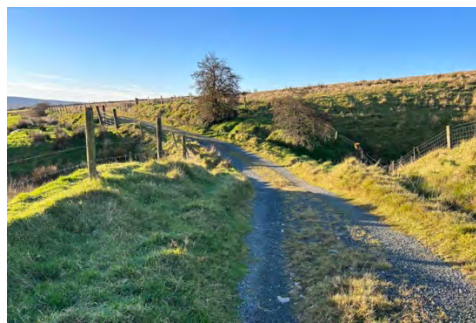
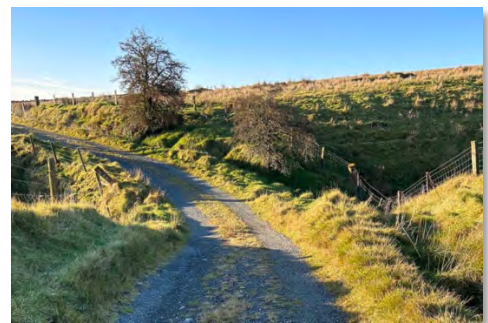
2.30 Figs. 21 & 22 show the position at Point M. Here, the topography undulates as the adopted track crosses a culvert at a deep gully formed by a natural watercourse.

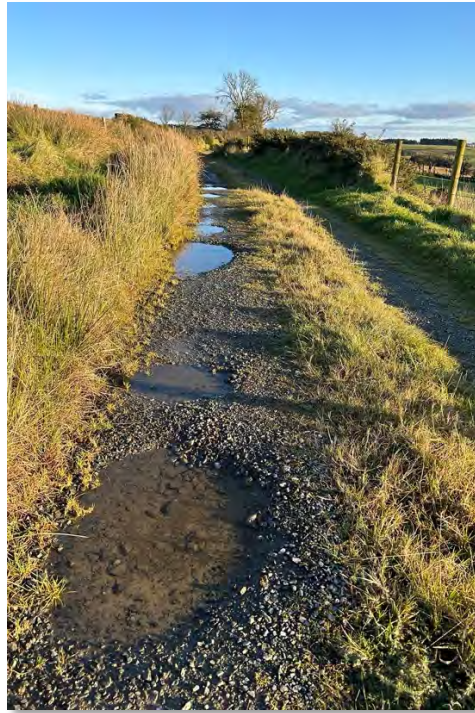
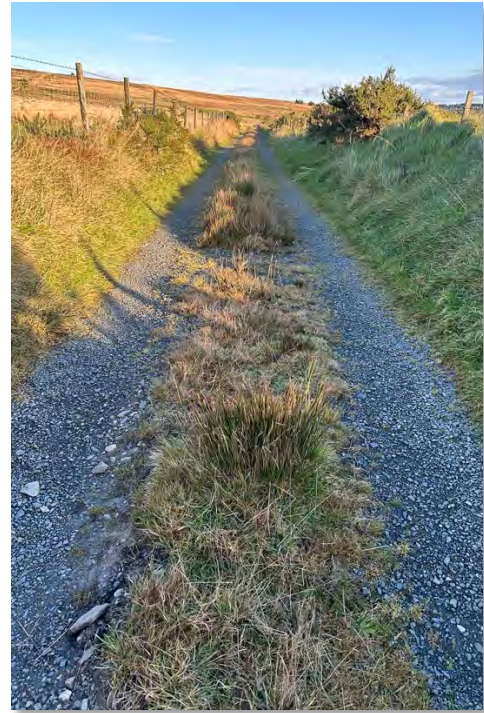
- 2.31 Figs. 23 and 24 above show how the surface of the Remaining Road is degrading, through less frequent use than between Points J & O, where vegetation, including reed grass, is established between the wheel tracks.

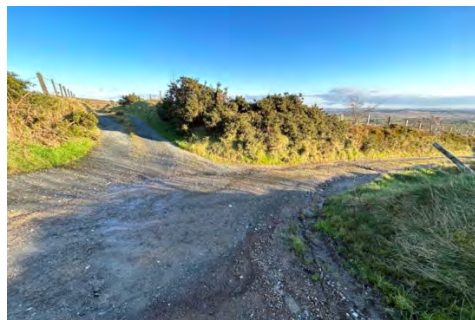
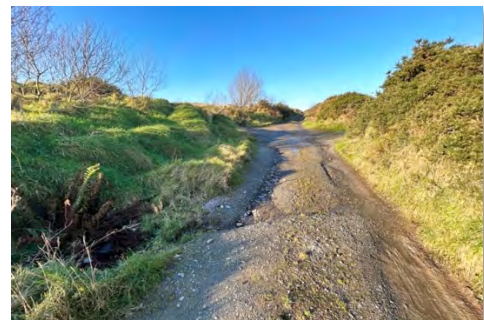
- 2.32 Figs. 24, 25 and 26 above and Figs. 27 and 28 below show the position on the ground at and around Point O. Historically, this was a crossroads; however, the western leg did not form part of GT5 public road network 1244 map, shown in Appendix 04. Point O is the western end of the adopted road around the top.

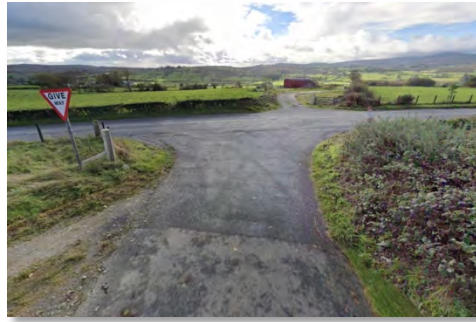
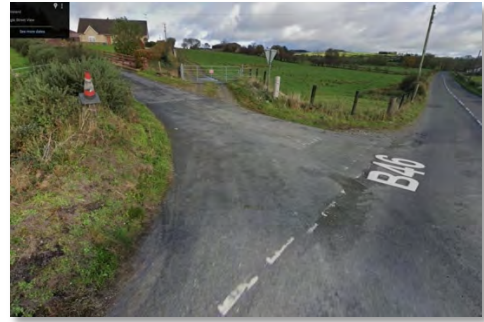
2.33 Well south of Point O, the road 1244(05) joins the Crockanboy Road at Point T. Figs. 27 & 28 above are 2021 Google street view images of this road junction.

2.34 A surface dressing has been applied to the “bell-mouth” of the road surface here, which has in part, covered the white line paint on the tarmac surface defining the road junction. There is a give-way sign on the near side of the minor road and a white triangle painted on the road surface, approaching the junction.

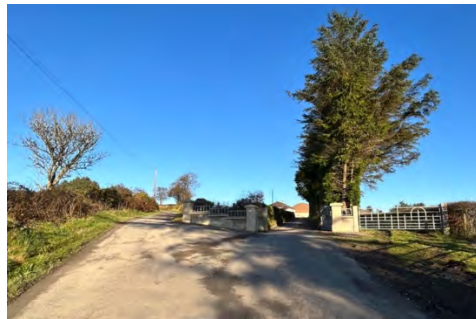
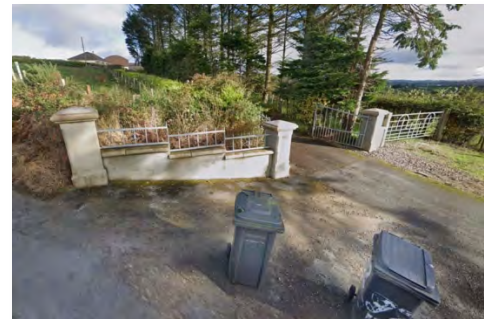
2.35 The public road 1244(05) extends north from Point T. At Point U is the entrance to No. 204 Crockanboy Road.

2.36 Significantly, the 2021 Google street view image in Fig. 30 above, has captured a wheelie bin with the number “208” painted thereon, outside the gate of No. 204 Crockanboy Road.

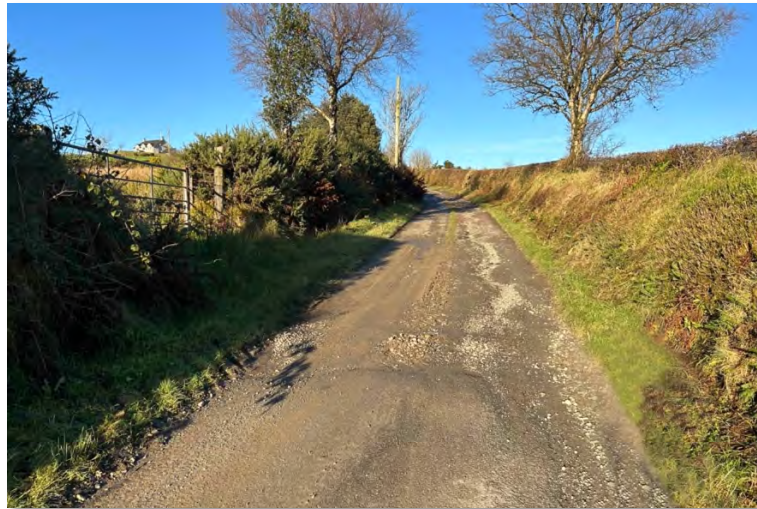
Fig. 31  
Point V

- 2.37 The surface of the public road 1244(05) from Point T to Point U is tarmacadam. In fact, the tarmacadam surface extends approximately 70m north of Point U to Point V, where it stops, as shown in Fig. 31 below.

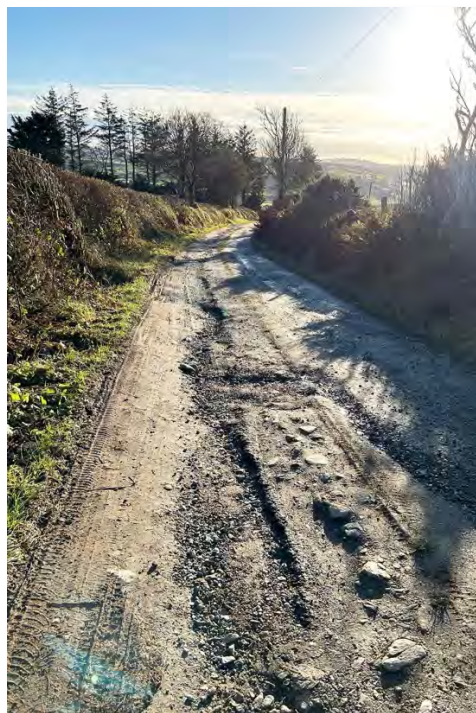
Fig. 32 Between Points V - W

- 2.38 Moving northwards from Point V, the public road 1244(05) is an unbound metalled roadway. Fig. 32, looking south, shows the condition of the road surface.

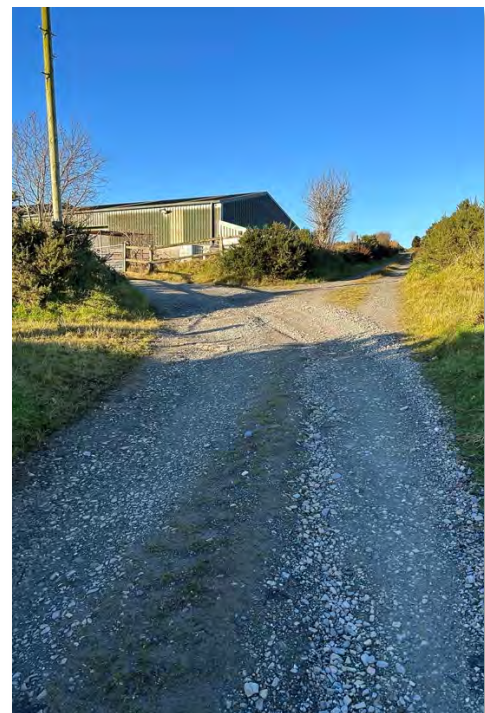
Fig. 33 Approaching Point W

- 2.39 Fig. 33 shows the approach to No. 208 Crockanboy Road, at Point W. The metalled road surface is conditioned by vehicle movements into the farm settlement. The evidence clearly shows the dominant and habitual use of the public road 1244(05), between Point U and Point W, is to access and egress from No. 208 Crockanboy Road.
- 2.40 The condition of the metalled road between between Point V and Point W, as shown in Fig. 32 above, perhaps explains why the wheelie bin belonging to No. 208 Crockanboy Road had been drawn down to and left on the tarmacadam surfaced area outside No. 204 Crockanboy Road, for collection.
- 2.41 Whilst the public road 1244(05) extends north of Point W, the condition of the metalled road surface at Point W suggests only infrequent but nevertheless vehicle movements occur beyond this point.

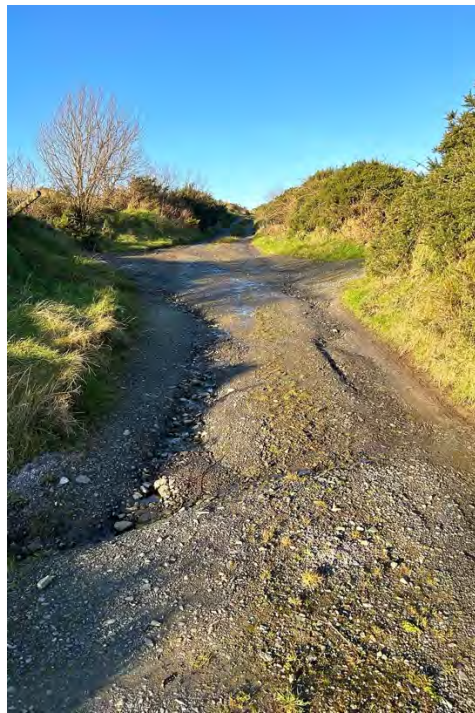
Fig. 34 Point O

- 2.42 Moving north of Point W, the surface of the public road 1244(05), approaching Point O, is in poor condition.

- 2.43 Fig. 34 above shows the rutted surface of the unbound metalled road eroding due to storm water. Fig. 35 above, shows an alternative view of the diagonal channel, evident in Fig. 32 above, across the width of the adopted track.

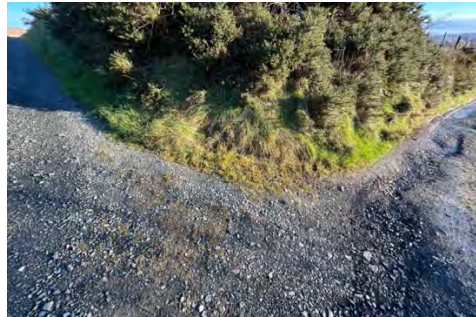
Fig. 36  
Point O

- 2.44 Fig. 36 above, perhaps illustrates the nature of the blind turn awaiting drivers of vehicles intending to negotiate the corner at Point O. The fair condition of the existing grass verge, at what can only be described as a "tight" radius, suggests little vehicle movements occur here.
