# Hydromorphology Assessment Owenkillew and Owenreagh Rivers

**Gortin, Co. Tyrone, Northern Ireland**

**Dalradian Gold Ltd**

24 November 2025

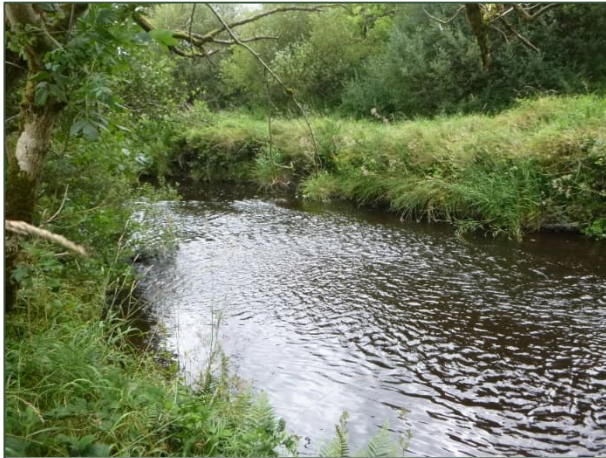
**Photograph 1:**  
Channel bank profile

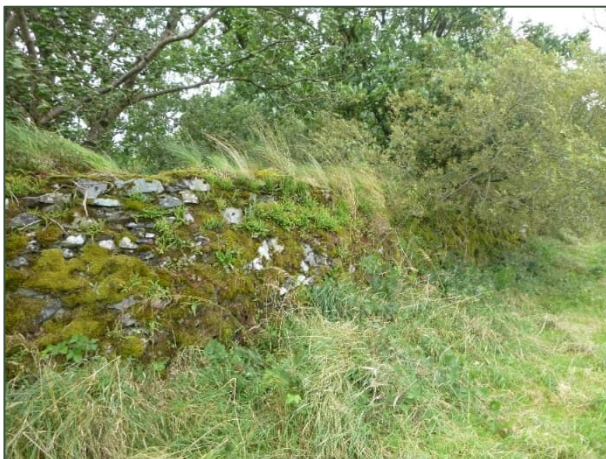
**Photograph 3:**  
Bank flood protection wall (land side)

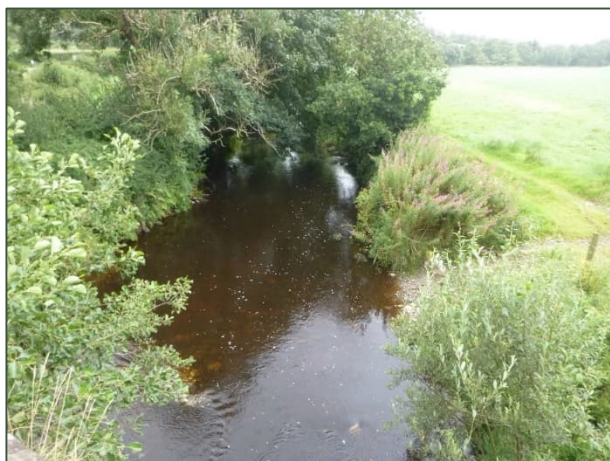
**Photograph 1:**  
Channel alignment at Drumlea Br. with floodplain on RHB

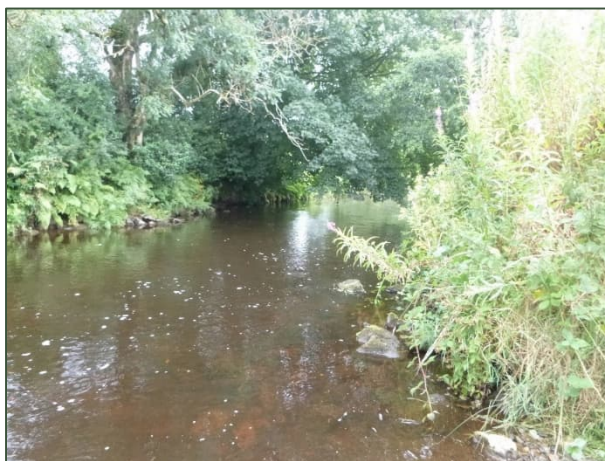
**Photograph 2:**  
Channel flow with bank vegetation and invasive species (Himalayan balsam)

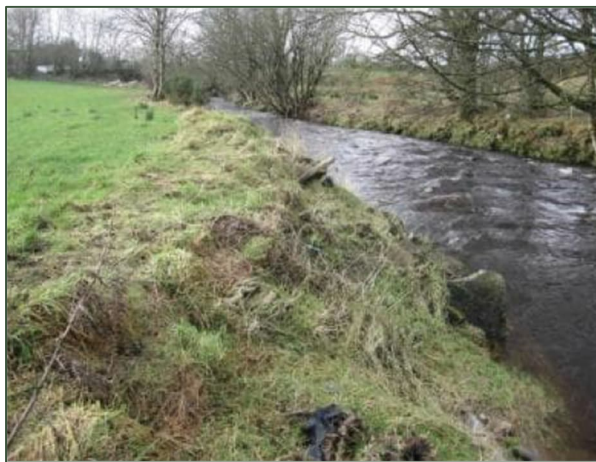
**Photograph 4:**  
Channel bank and riparian landuse

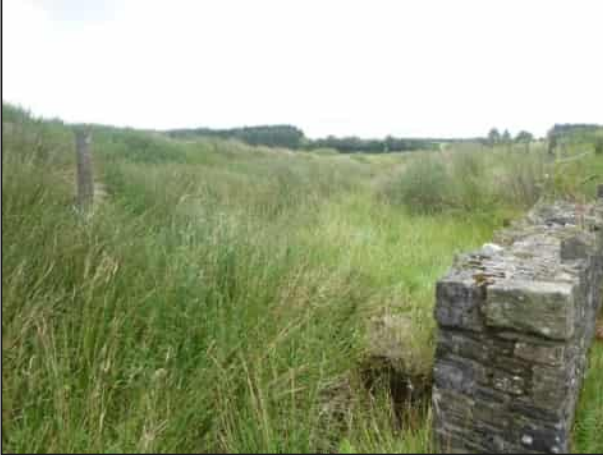
**Photograph 5:**  
**Channel downstream end of reach**
