Risk Review, Risk Assessment & Risk Management Plan

40062 Moylinn East Footbridge

CO402011-AMEY-SBR-XX-RP-CB-000001 Rev 1

18/08/2022

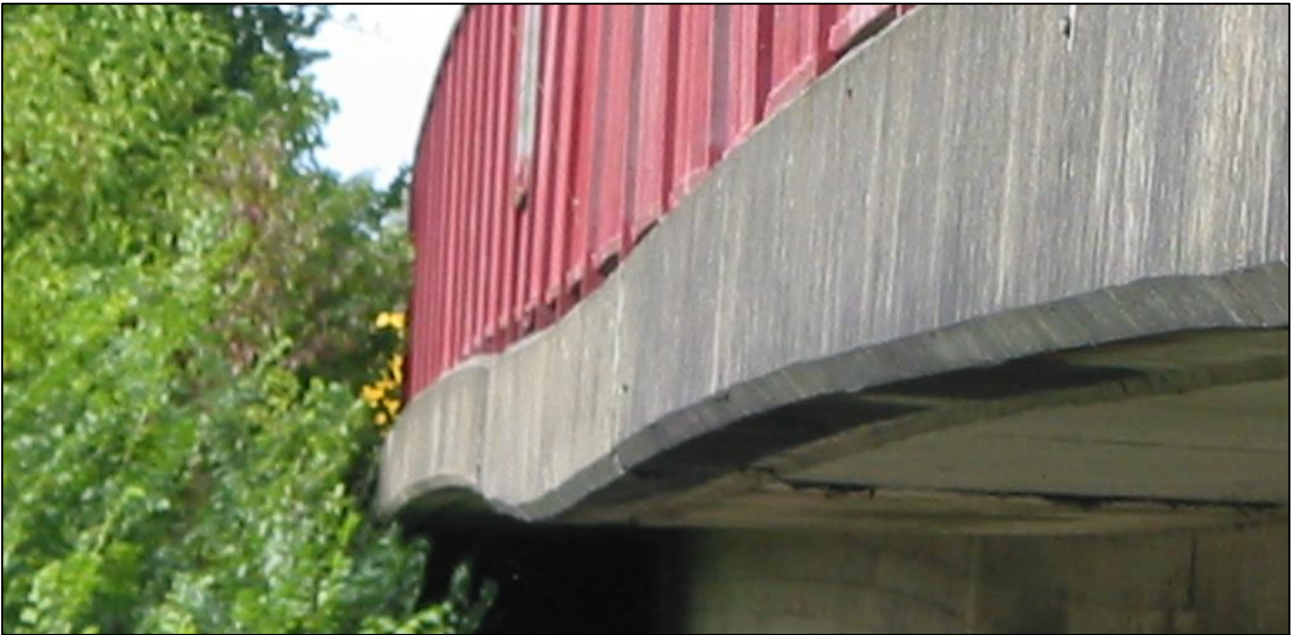
Figure 11: Looking across the deck from the abutment (2002 PBI)

- 2.7.3 The suspended span of the of the footbridge exhibits a pronounced 'sag' which has been a cause for concern. The May 2006 Half Joint Special Inspection Report referenced an inspection completed in 1980 to investigate the sag in the centre span. A series of level surveys were carried out by Roads Service in the early 1980's confirmed that the whole of the centre span, including the post-tensioned cantilevers, was sagging by 175 mm below design level at midspan. In 1998, a level survey of the central span was completed as part of the PTSI Phase 2 and confirmed the sagging profile of the cantilever and in situ reinforced concrete suspended

span and indicates that the sag at midspan has increased from a maximum of 175 mm in 1980/82 to 200 mm presently in 1998. In addition, the report stated that the gradients along the structure increase rapidly from the piers along the cantilevers to the scarf joints, suggesting there is a loss of residual prestress over the piers.

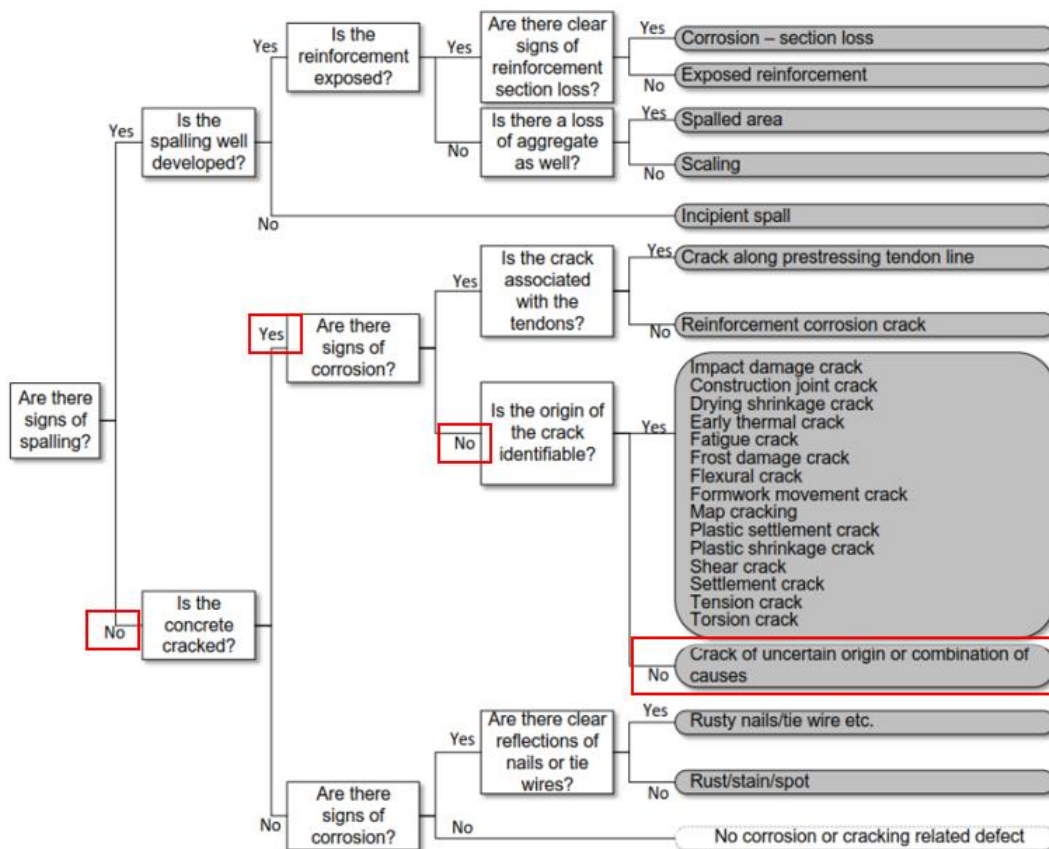
Figure 18: Defect Decision Diagram - CS 466 Figure C.1

5.2.2 From the Defects decision diagram Figure 18, the origin of the cracking at the half-joints is of uncertain origin.

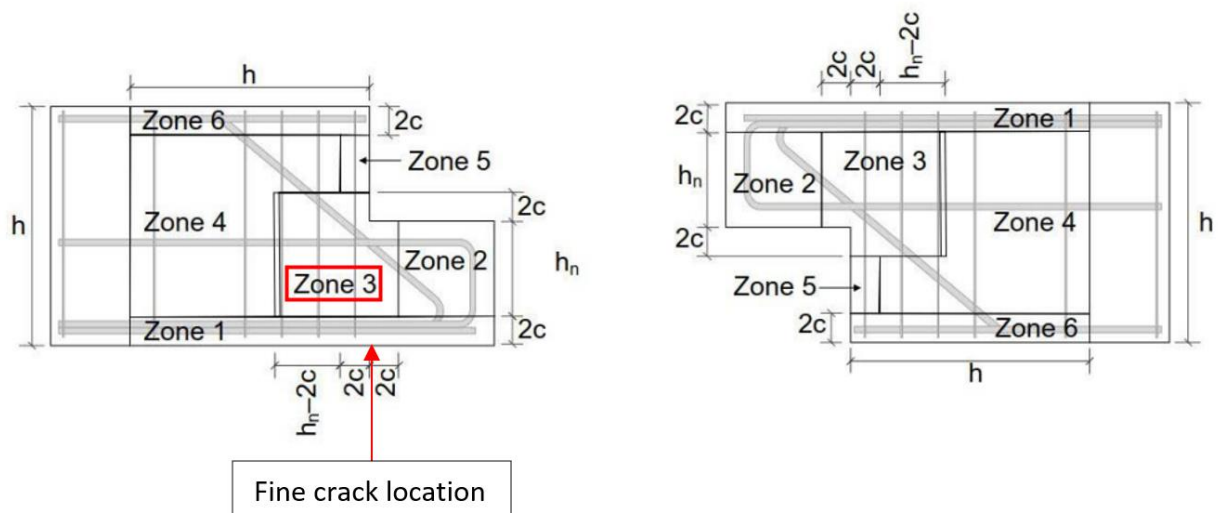
Figure 19: Defect Zone - CS 466 Figure C.2

5.2.3 The cracking to the suspended span half joint falls within Zone 3 as per CS 466 Figure 6.2.

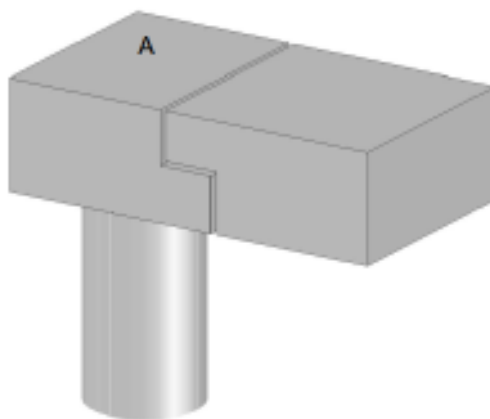
Figure 22: Type A half-joint (Extract from CS 466 Figure C.3)

5.5.5 From Figure C.3 the half-joint is Type A, solid or box slab with no access to the bearing shelf.

5.5.6 From Table C.10; Type A joints are a solid or box slab with no access to the bearing shelf with a score of **7**.

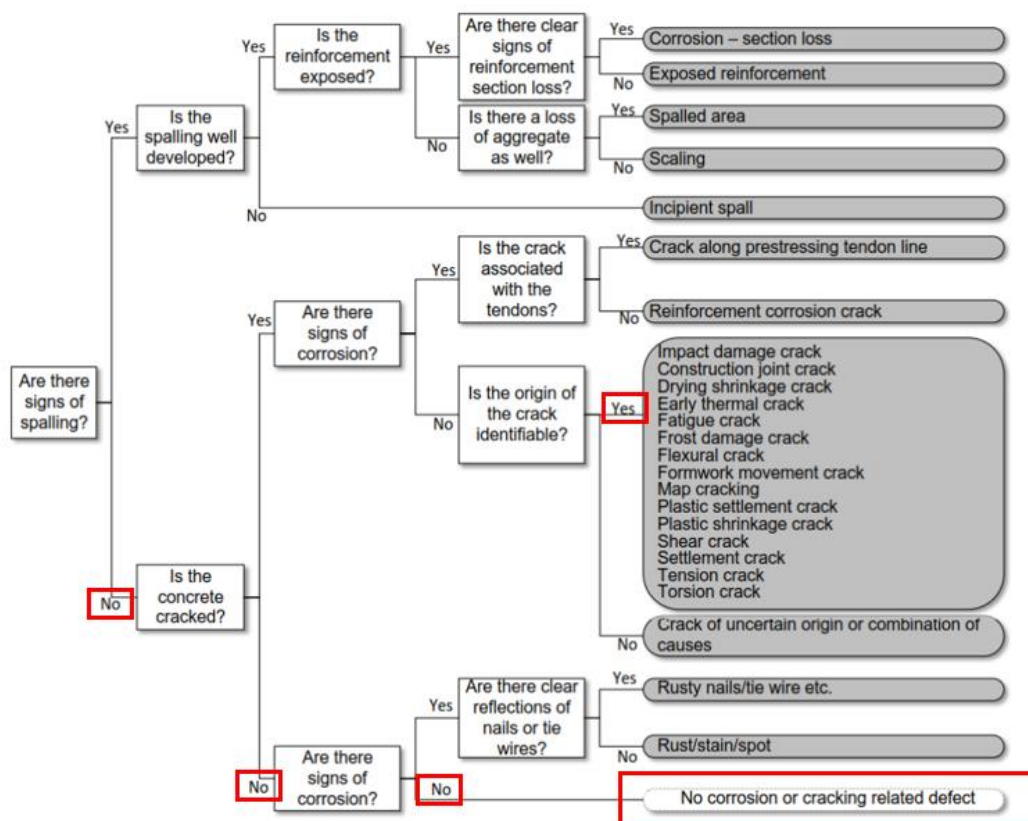
Figure 24: Defect Decision Diagram - CS 466 Figure C.1

6.2.2 From the Defects decision diagram Figure 24, there are no signs of defects to the abutment half joint. However, as the half joint is concealed, the presence of concrete defects is uncertain.

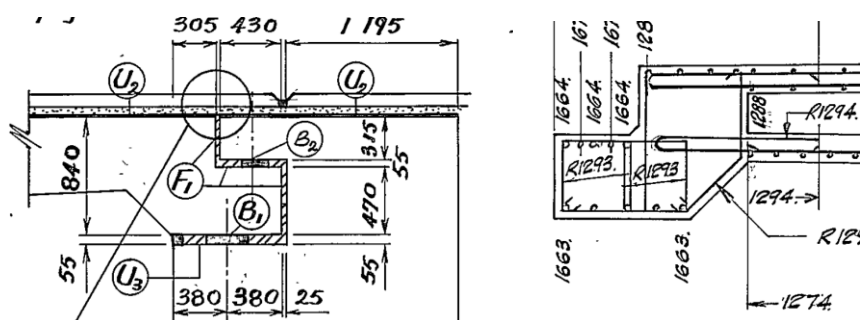
Figure 26: Half-joint reinforcement detailing

6.3.1 The reinforcement details of the holding upper abutment holding down nib are not known. The detailing of the lower nib is shown in Figure 26 below and shows a well anchored horizontal nib bar. Detailing risk from CS 455 Table C.5 is **Medium** as detailing allows a single clear load path through the half-joint with adequate anchorage – no diagonal bar. It must be noted that the half joint at the abutment is a holding down nib, therefore it is likely that the forces are not as onerous as a suspended span.
