# Hydromorphology Assessment Owenkillew and Owenreagh Rivers

**Gortin, Co. Tyrone, Northern Ireland**

**Dalradian Gold Ltd**

24 November 2025

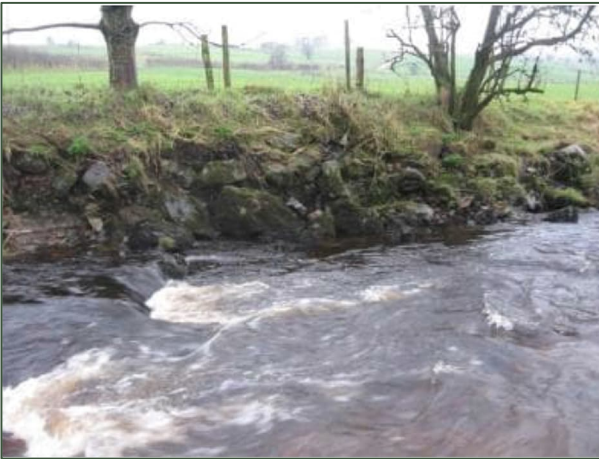
**Photograph 1:**  
**Bank protection and riparian vegetation**

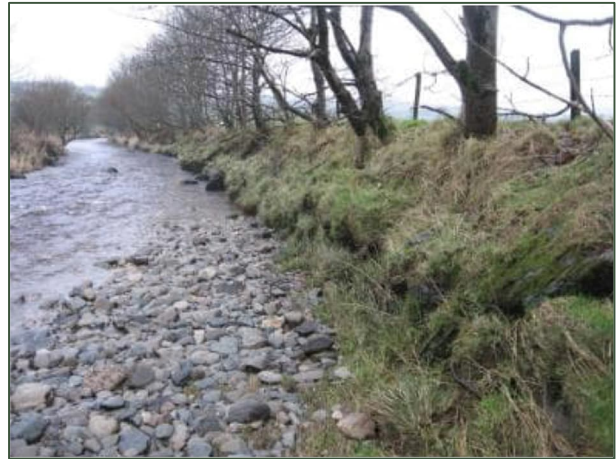
**Photograph 2:**  
**Channel Bar and bank vegetation**

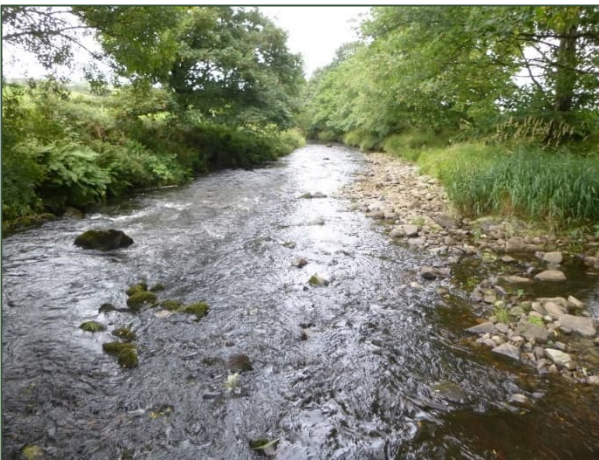
**Photograph 3:**  
**Channel bedload and bank vegetation**

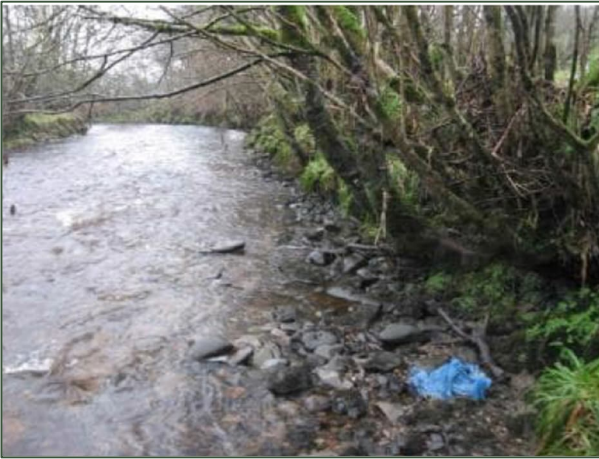
**Photograph 1:**  
Channel and bank profile with vegetation

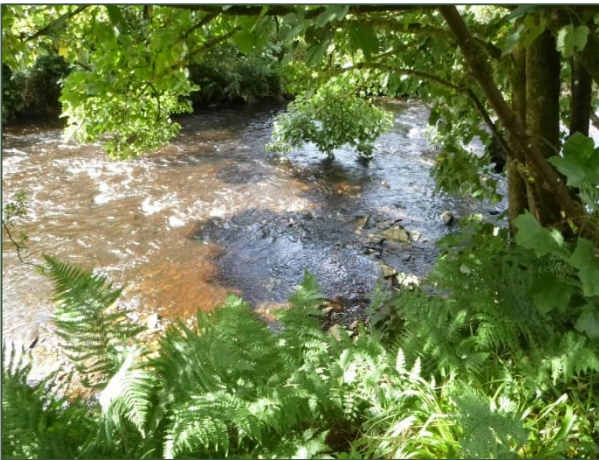
**Photograph 3:**  
Channel bedload and bank vegetation

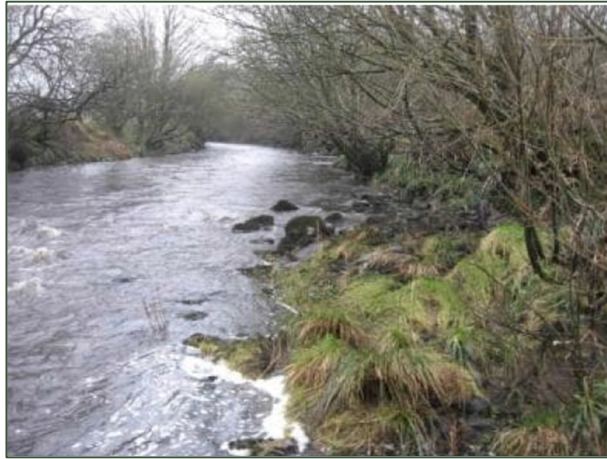
**Photograph 1:**  
Channel and bank with vegetation

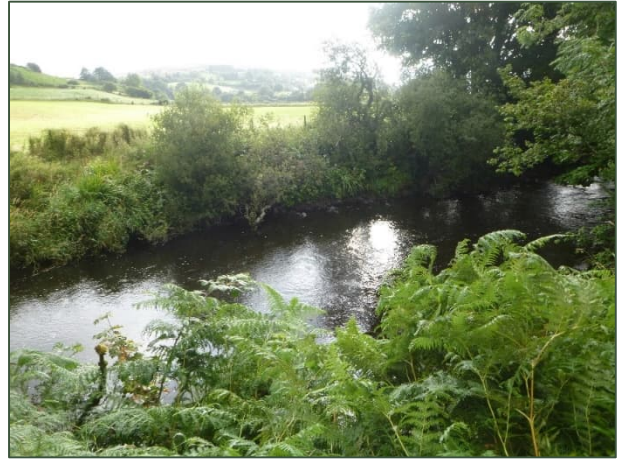
**Photograph 2:**  
Channel profile and landuse

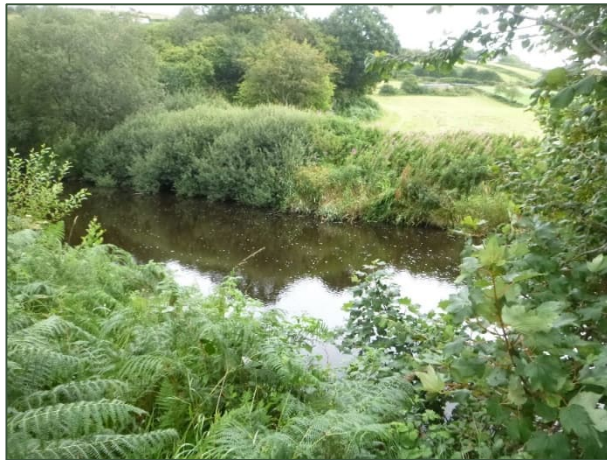
**Photograph 3:**  
Channel profile and bank vegetation

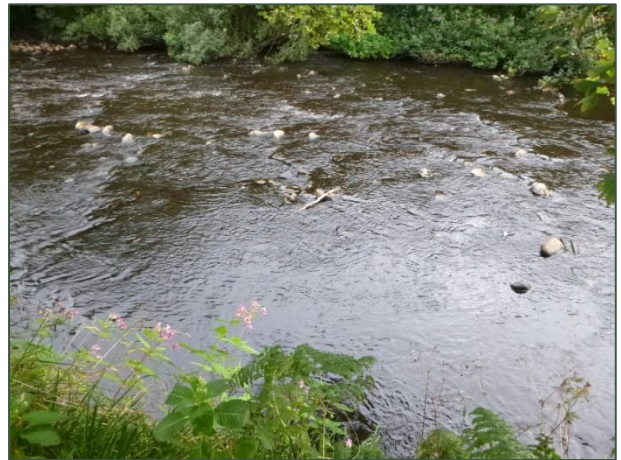
**Photograph 4:**  
Channel riffle and bedload

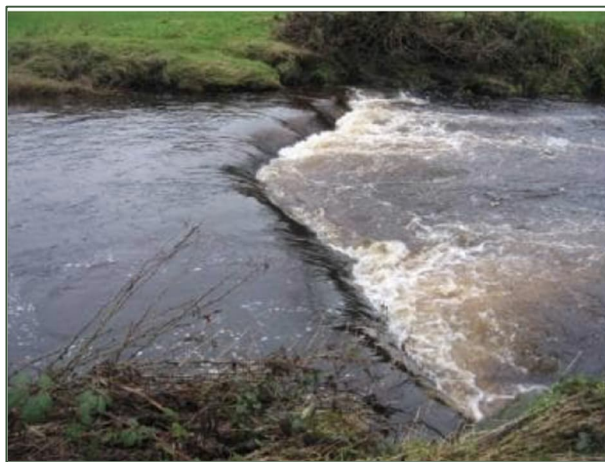
| ATTRIBUTE | SCORE <sup>a,b</sup> | NV | COMMENTS |
|---|---|---|---|
| <b>4. Barriers to continuity</b><br>Sheet 1. Desk top GIS observations, B. Channel substrate artificial or silt, channel modifications, and L. Resource use (Mill, DAM or HEP). | 2 | | <p>The boulder weir has raised the water level upstream. There was a significant cascade at the weir under current flow condition (January 2016).</p> |

**Photograph 1:**  
**Weir structure**

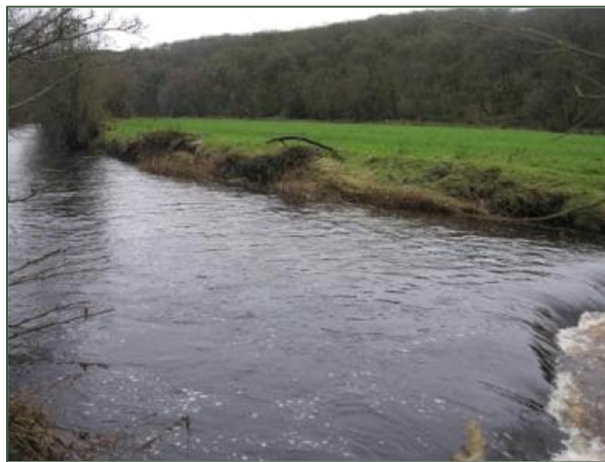
**Photograph 2:**  
**Bank erosion (2016)**

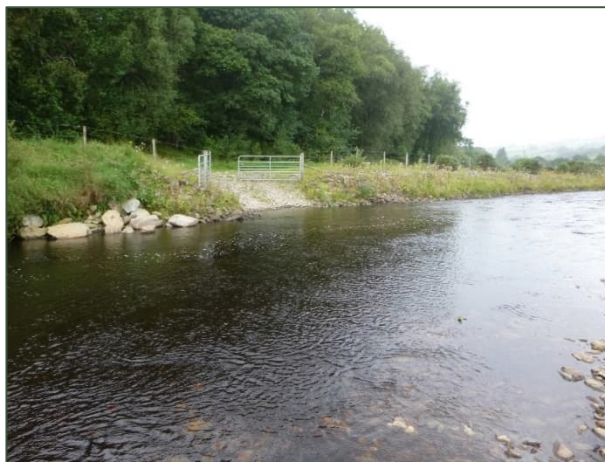
**Photograph 3:**  
**Channel bank protection and ford access with Himalayan balsam invasive species**

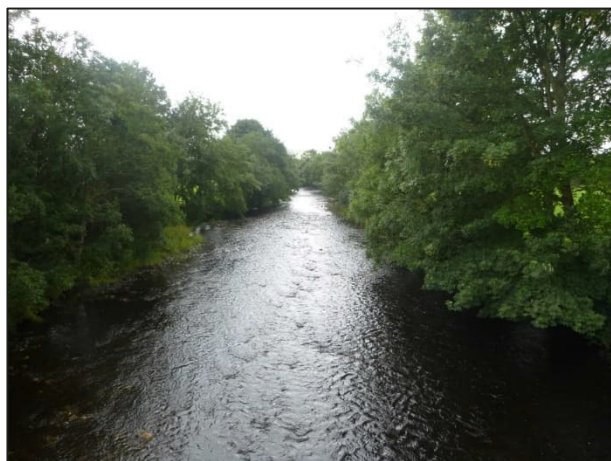
**Photograph 1:**  
Owenkillev channel with riffle and bank vegetation

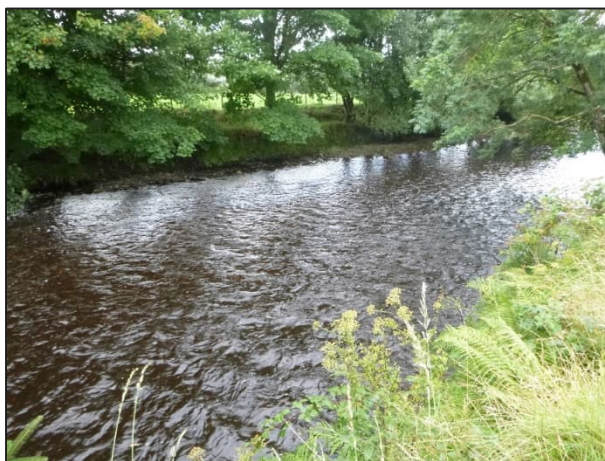
**Photograph 2:**  
Owenkillev channel with riffle and bank vegetation

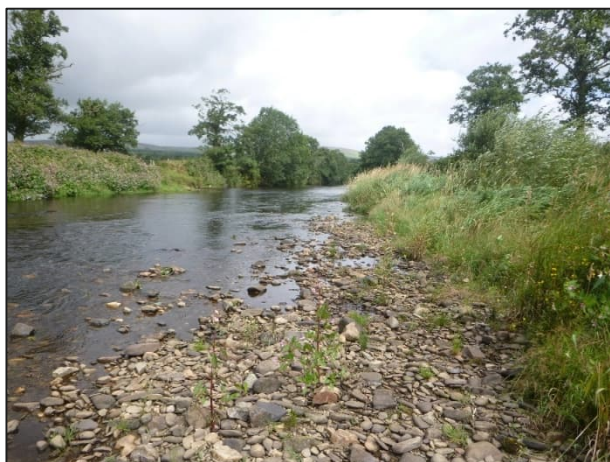
**Photograph 1:**  
Owenkillew channel and bed substrate

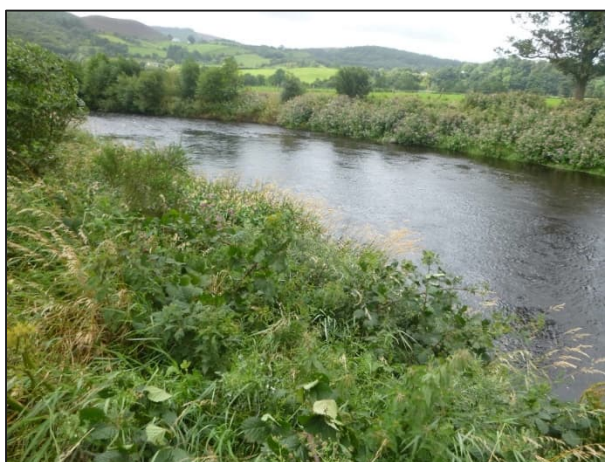
**Photograph 2:**  
Owenkillew channel and banks with vegetation

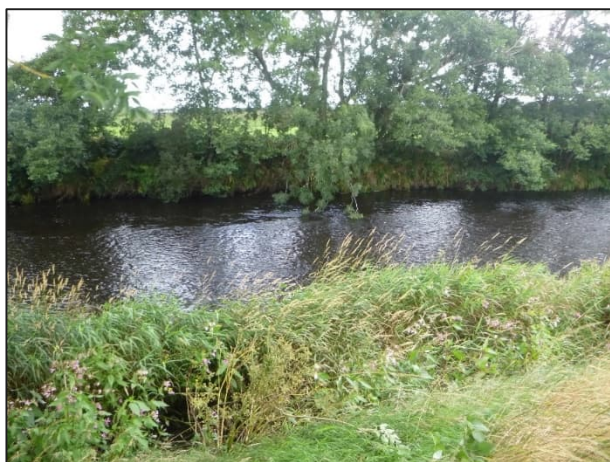
**Photograph 3:**  
Owenkillew bank planted with trees

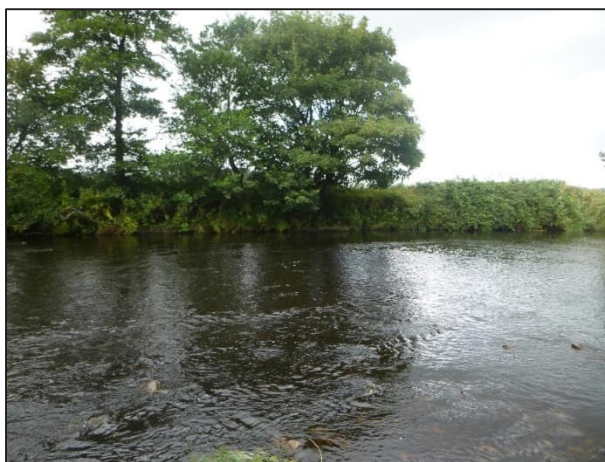
**Photograph 4:**  
Owenkillew channel

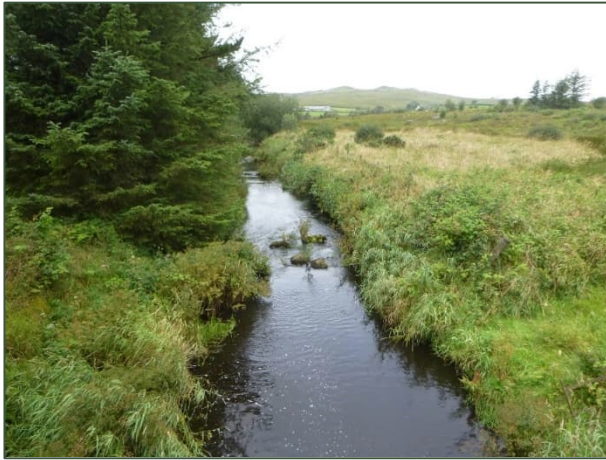
**Photograph 1:**  
Channel alignment and character

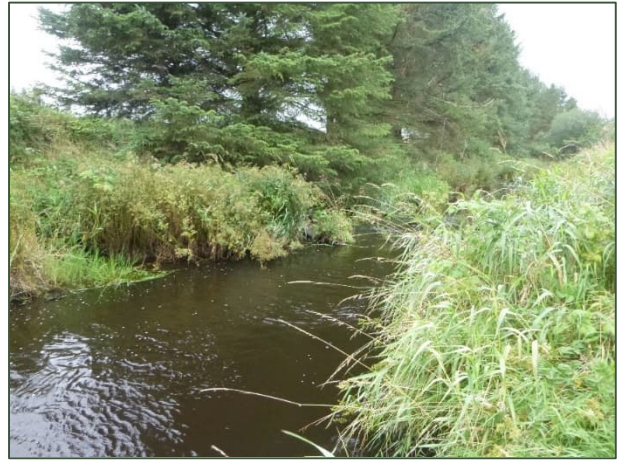
**Photograph 2:**  
Bank vegetation and coniferous trees

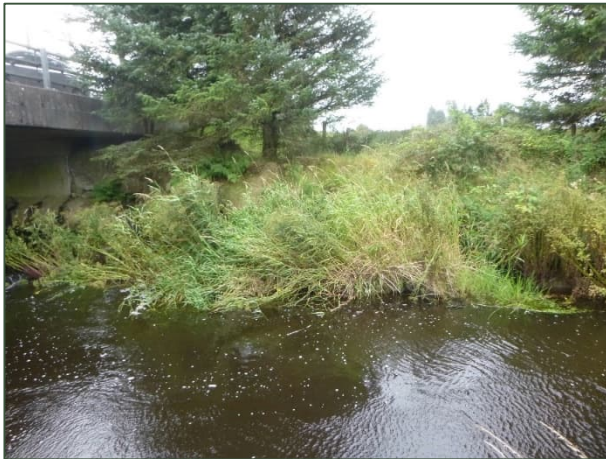
**Photograph 3:**  
Channel cross section and bank vegetation

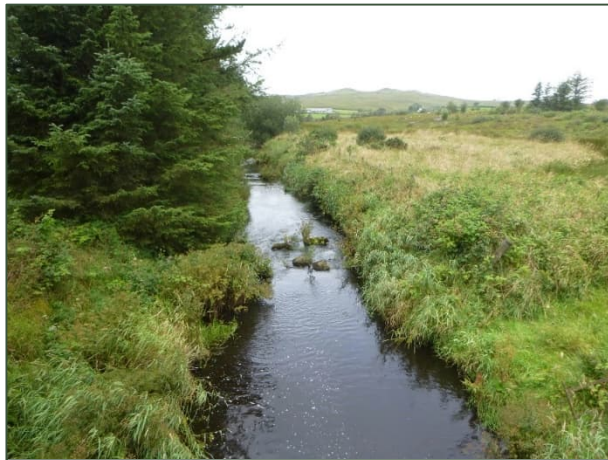
**Photograph 1:**  
**Channel alignment and character**

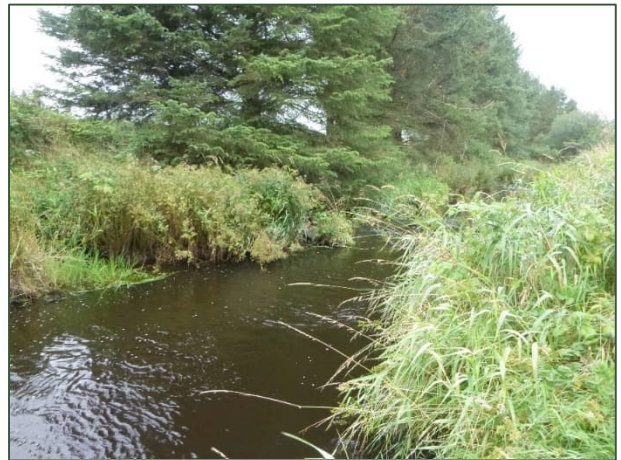
**Photograph 2:**  
**Bank vegetation and coniferous trees**

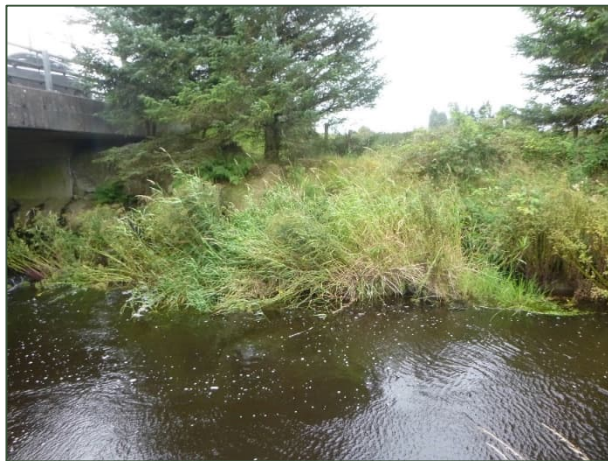
**Photograph 3:**  
**Channel cross section and bank vegetation**

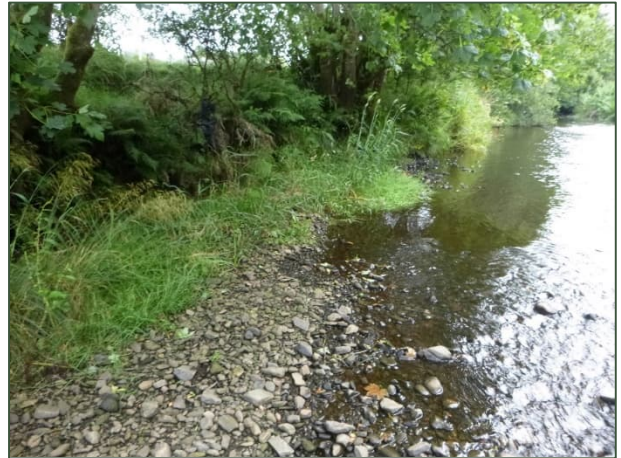
**Photograph 2:**  
Substrate with vegetated channel bank

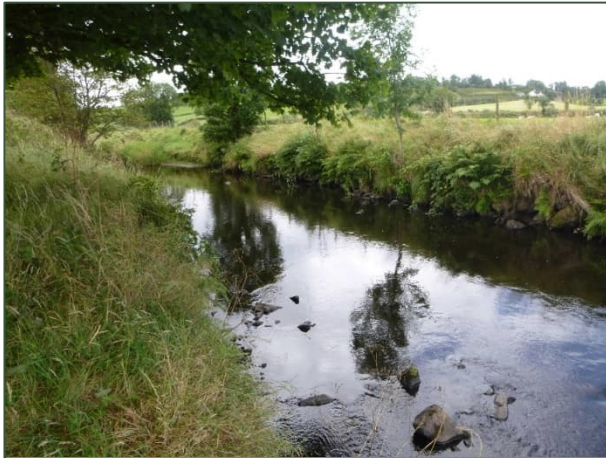
**Photograph 1:**  
Channel and bank profile

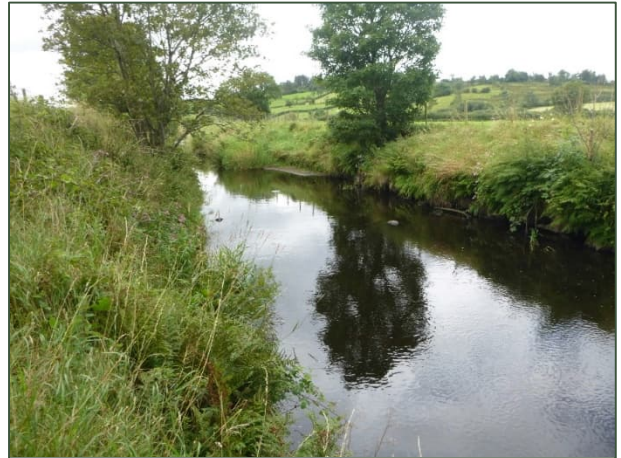
**Photograph 2:**  
Channel and bank profile

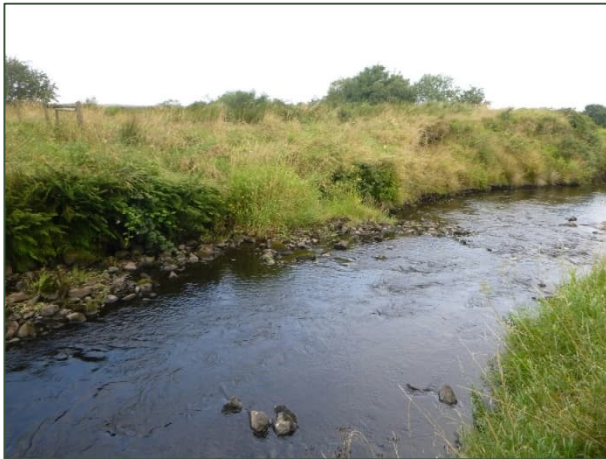
**Photograph 3:**  
Channel profile and riffle with substrate

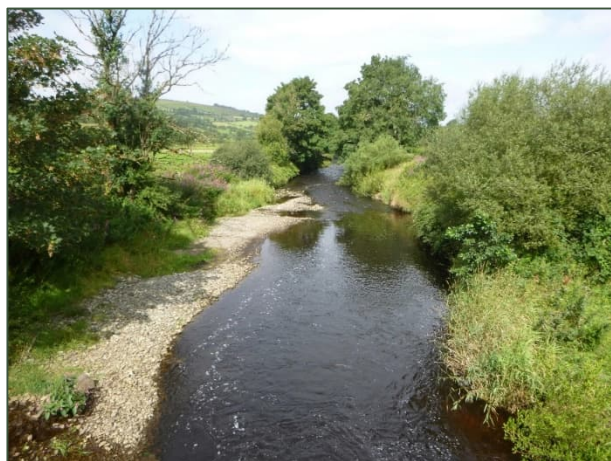
**Photograph 1:**  
Channel with bed substrate and bank vegetation

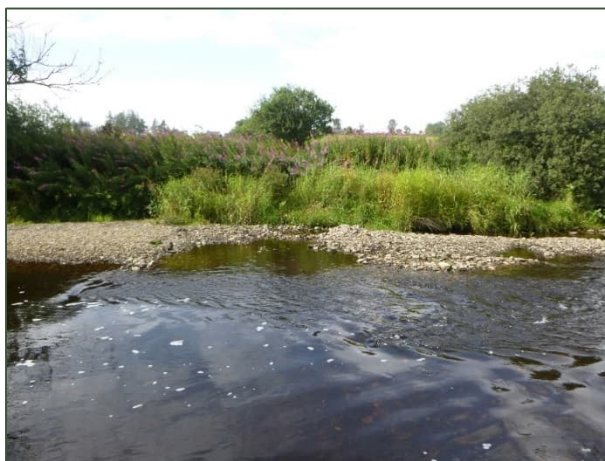
**Photograph 2:**  
Removal of gravels, bank with invasive species (Himalayan balsam)

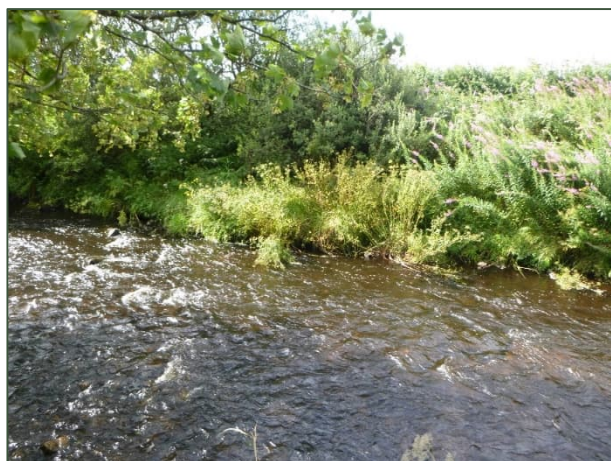
**Photograph 3:**  
Channel riffle bank with invasive species (Himalayan balsam)

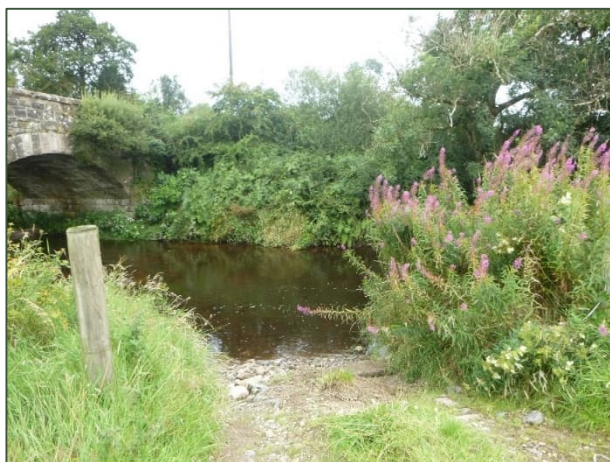
**Photograph 3:**  
Ford access with invasive species (Himalayan balsam)

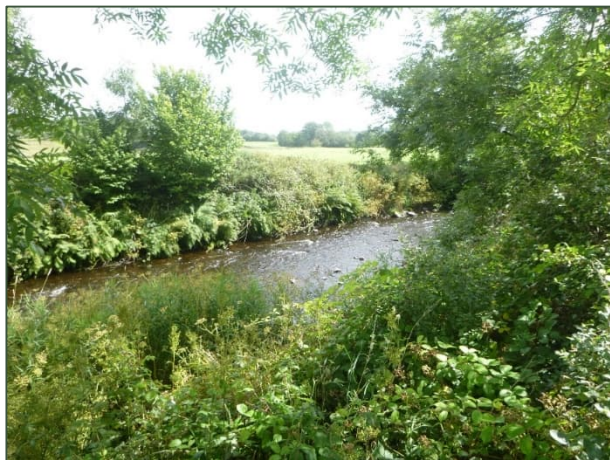
**Photograph 1:**  
Channel profile, banks and riparian landuse

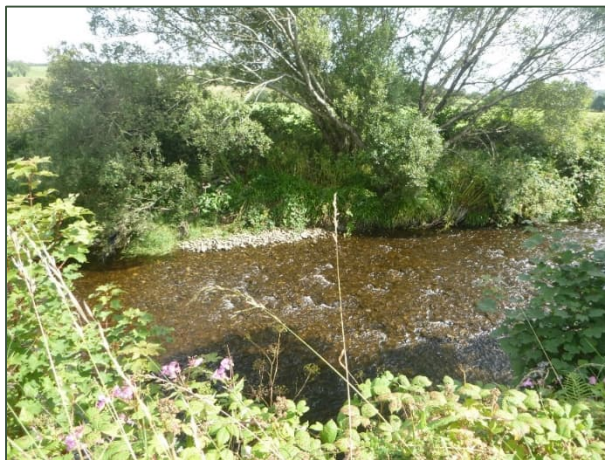
**Photograph 2:**  
Channel riffle and bedload

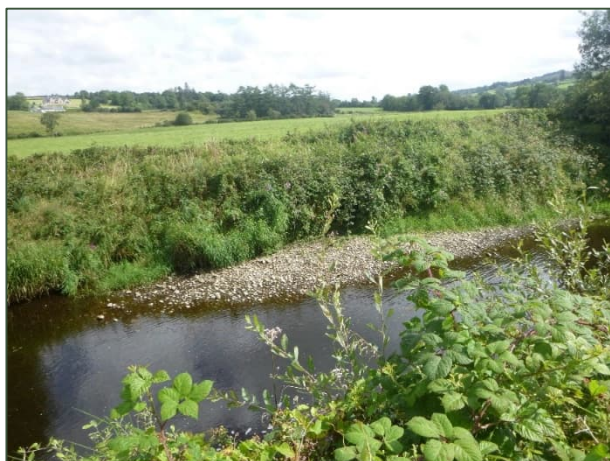
**Photograph 3:**  
Channel bank vegetation and gravel bar

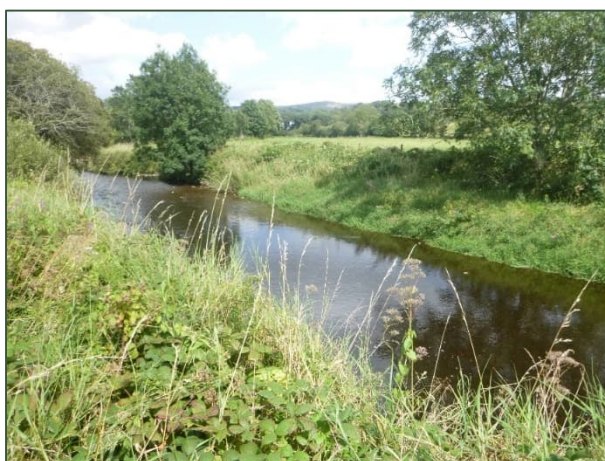
**Photograph 4:**  
Channel profile, glide section and bank vegetation

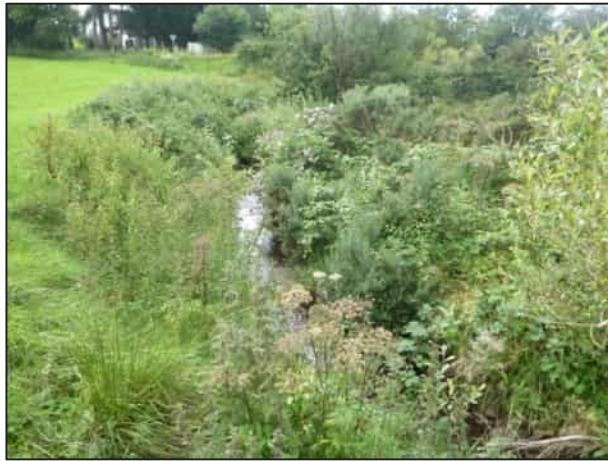
**Photograph 1:**  
Crockanboy Road Br.

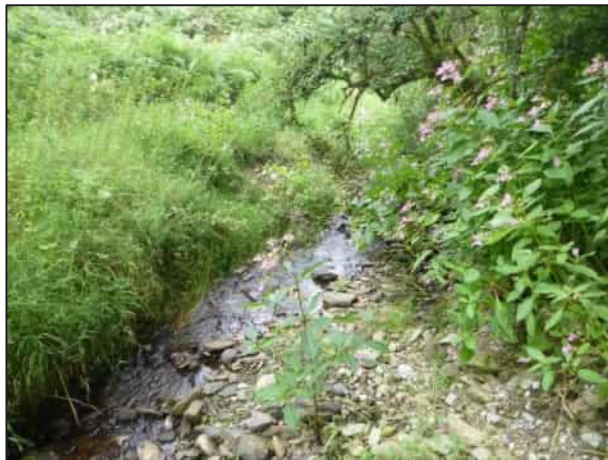
**Photograph 3:**  
Natural planform and bedload with invasive plant species

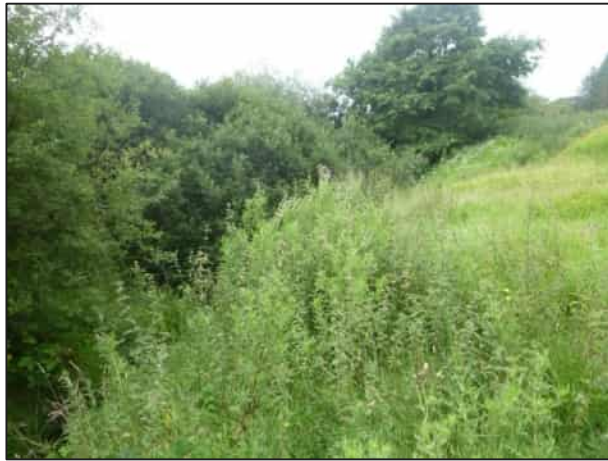
**Photograph 1:**  
Channel with grazing to right bank

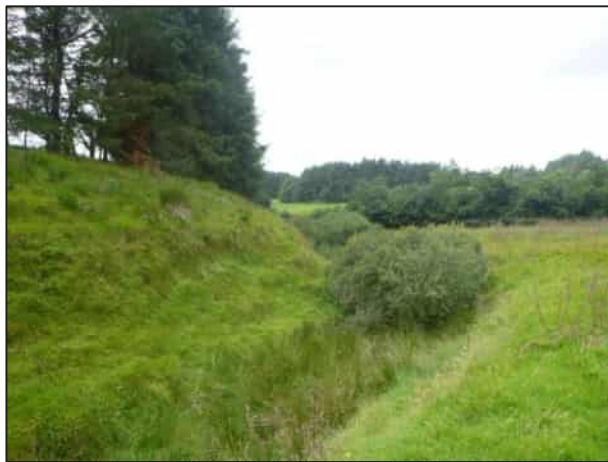
**Photograph 3:**  
Grazed land to channel

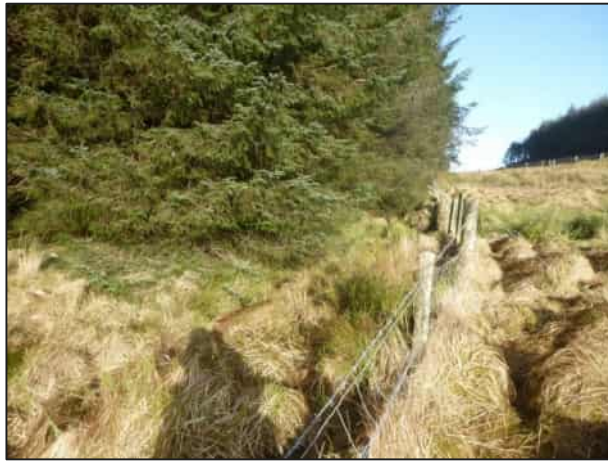
**Photograph 1:**  
**Straightened channel long plantation**

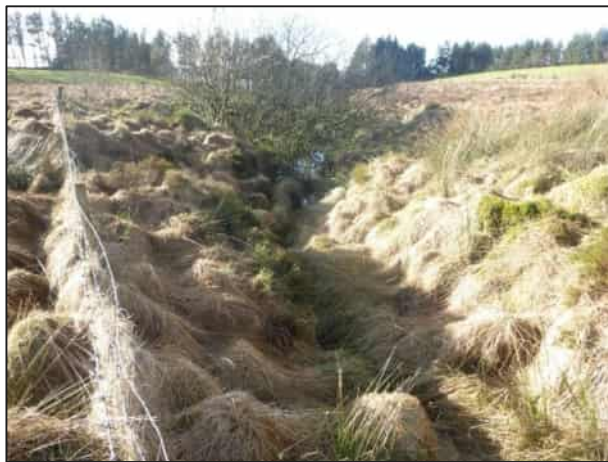
**Photograph 3:**  
**Channel at downstream edge of valley mire**

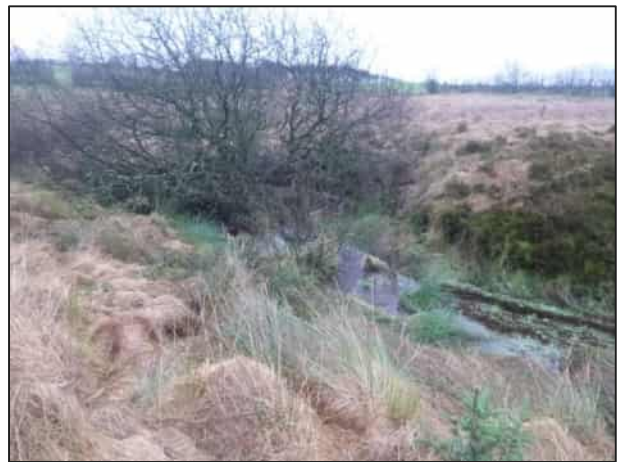
**Photograph 4:**  
**Channel downstream of valley mire**

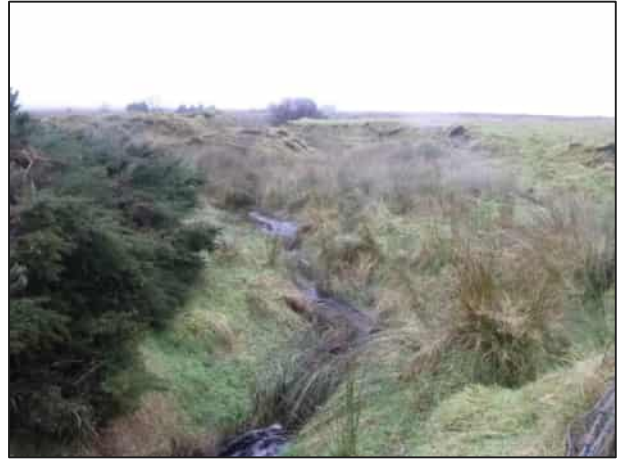
**Photograph 2:**  
**Channel with rough grazing to bank**

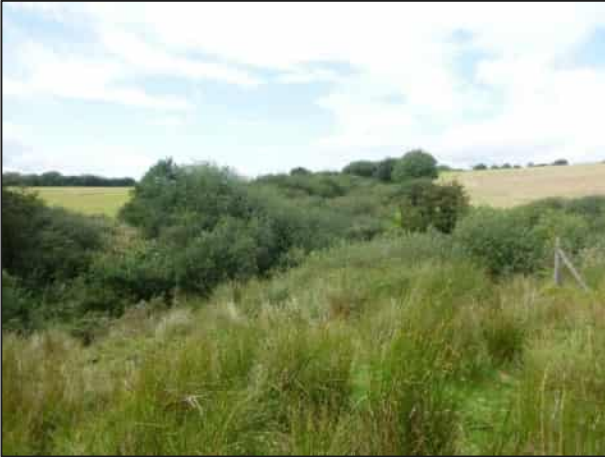
**Photograph 5:**  
**Lower section of Reach 4 downstream of culvert section with thick tree cover in incised channel valley**

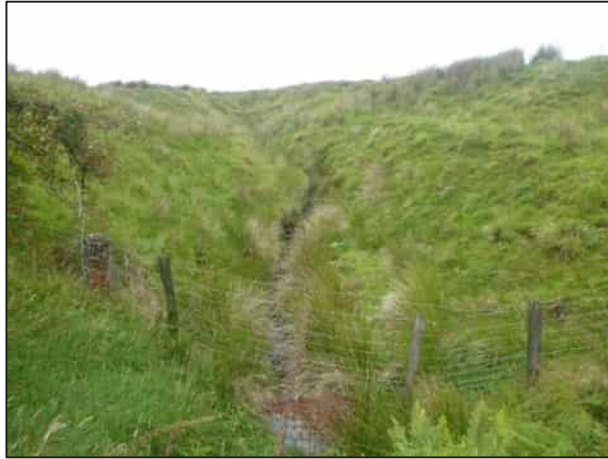
**Photograph 1:**  
Cascade pool section of burn

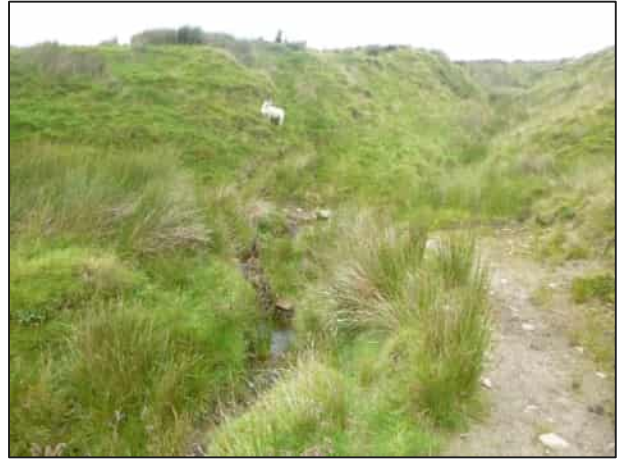
**Photograph 2:**  
Channel with rough grasing to bank

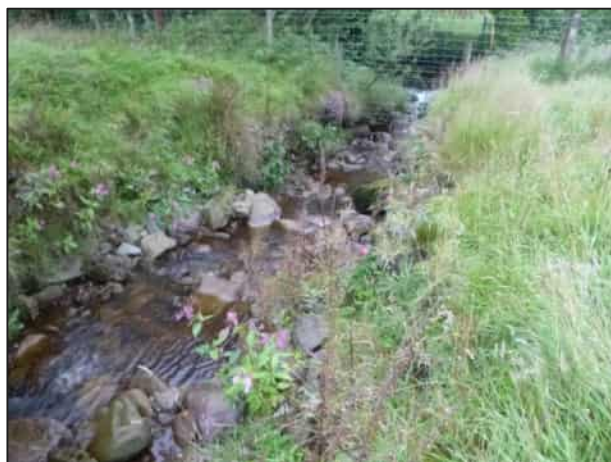
**Photograph 1:**  
Valley floor of Owenkillev River and Burn.

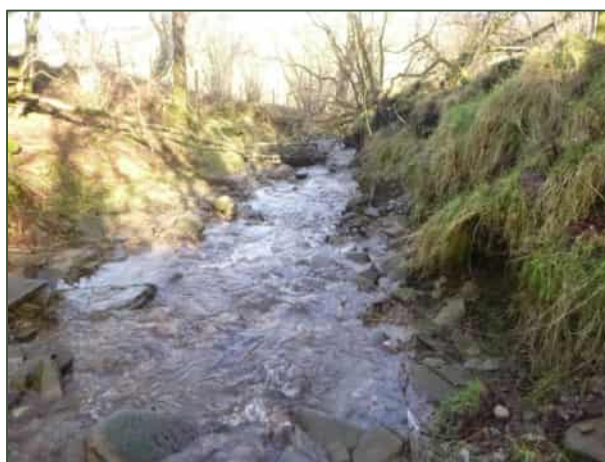
**Photograph 2:**  
Channel in natural woodland with bank erosion

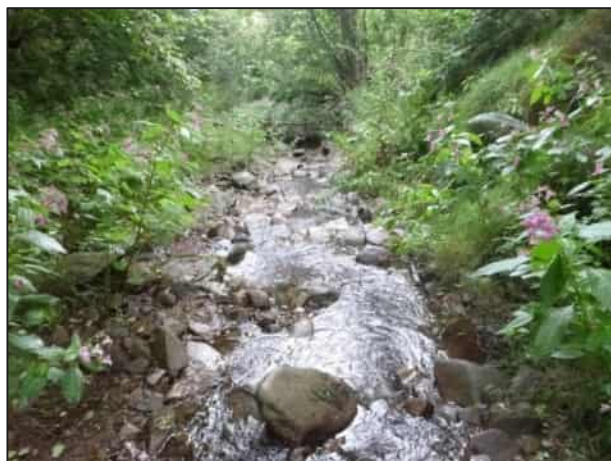
**Photograph 3:**  
Channel in natural woodland with invasive species

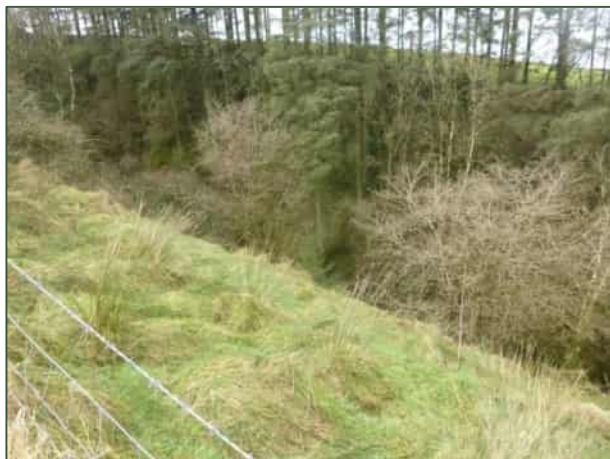
**Photograph 5:**  
**Burn in deep ravine with coniferous plantation**

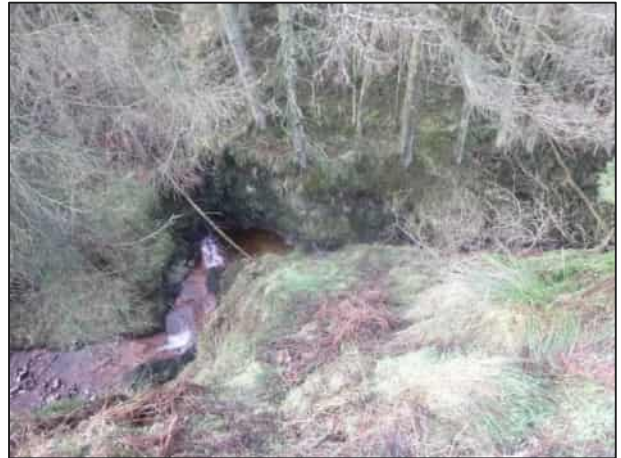
**Photograph 2:**  
Bedrock cut channel section in ravine

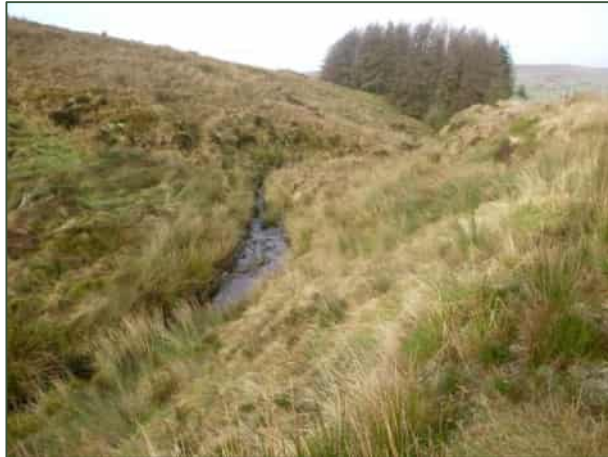
**Photograph 3:**  
Channel with rough grazing and rushes to channel bank

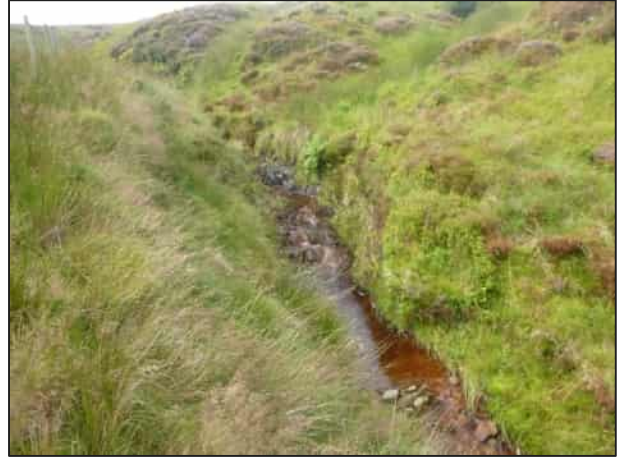
**Photograph 4:**  
Cascade pool section with bedrock

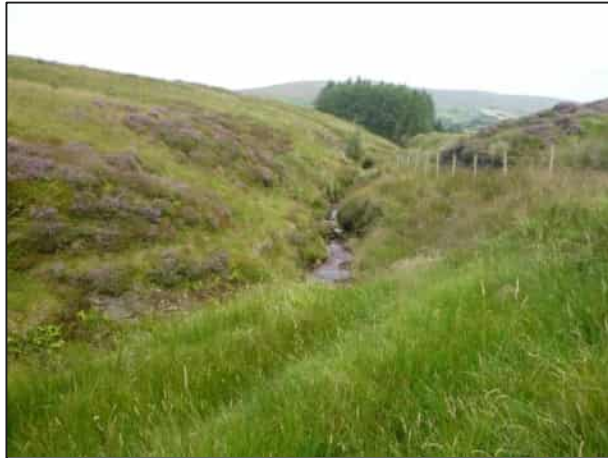
**Photograph 1:**  
Ravine section of burn with channel in bedrock

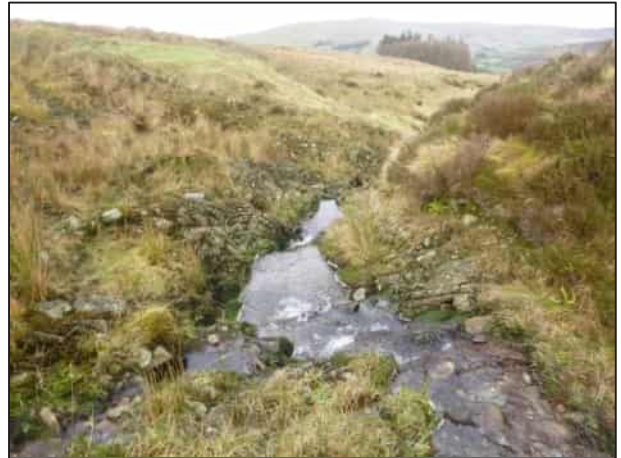
**Photograph 2:**  
Bedrock section with cascade pool channel type

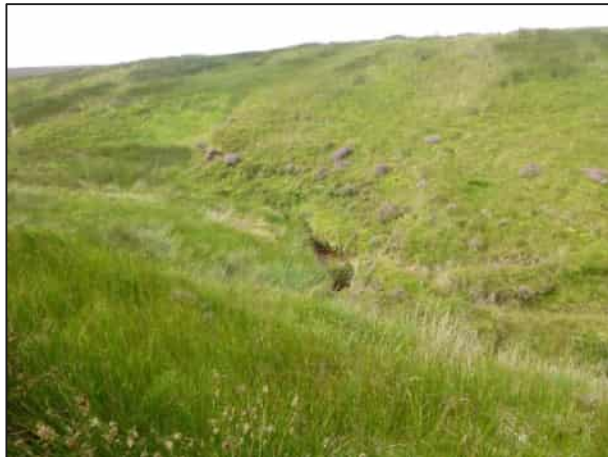
**Photograph 3:**  
Channel with rough grazing and rushes to channel bank

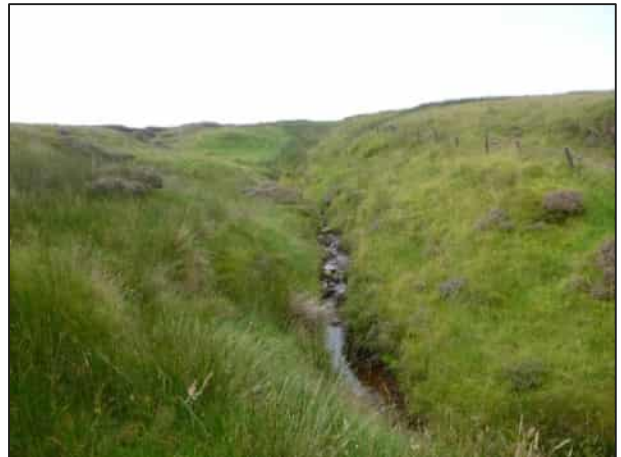
**Photograph 4:**  
Upper channel with rough grazing and rushes

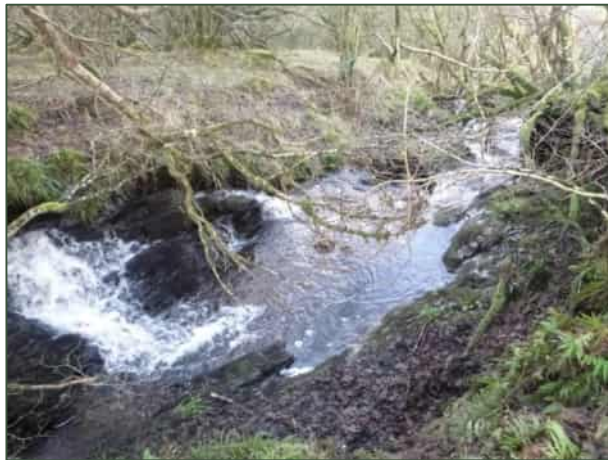
**Photograph 1:**  
Cascade pool channel in bedrock

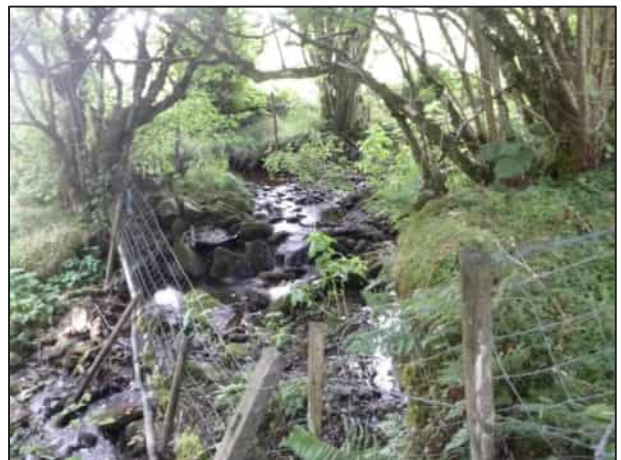
**Photograph 2:**  
Cascade pool channel in bedrock with  
hazel trees

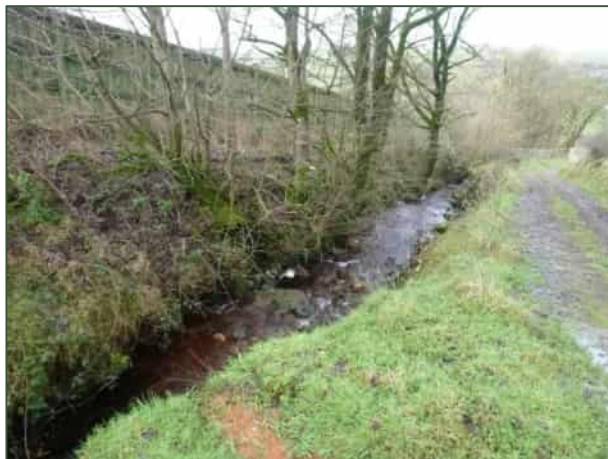
**Photograph 3:**  
Protected channel bank along farm access  
track

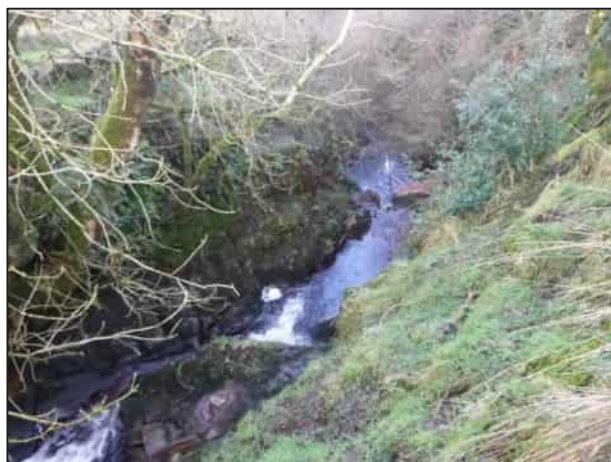
**Photograph 1:**  
**Deep ravine section above Camcosy Road**

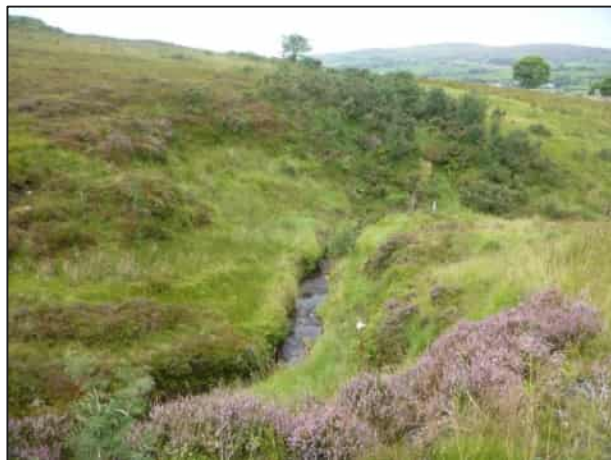
**Photograph 1:**  
Channel with rough grazing and rushes to bank

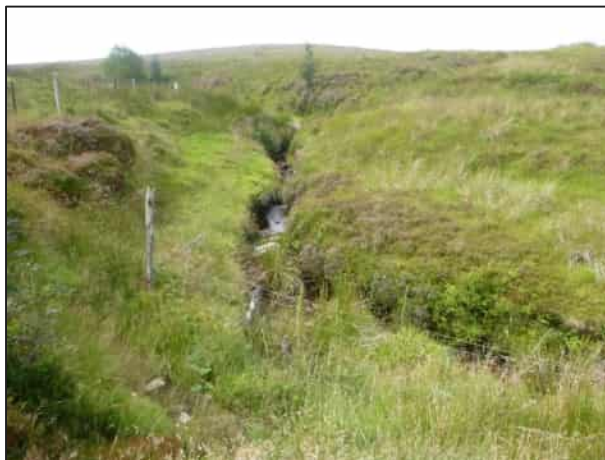
**Photograph 2:**  
Channel with rough grazing and rushes to bank

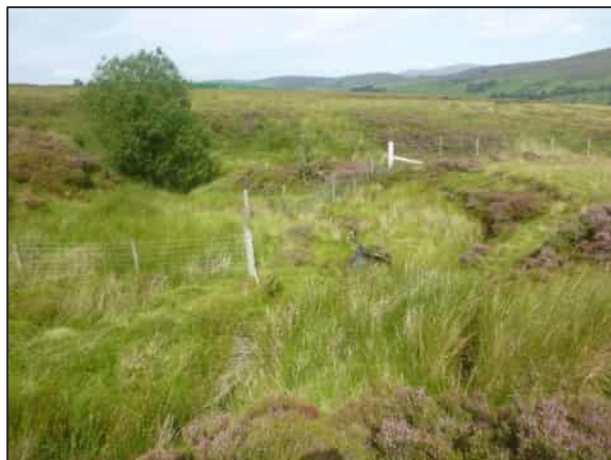
**Photograph 3:**  
Channel with rough grazing and rushes

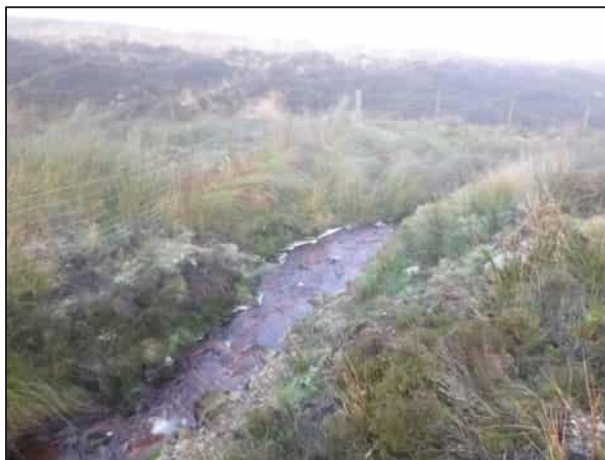
**Photograph 4:**  
Channel in ravine natural bedload material

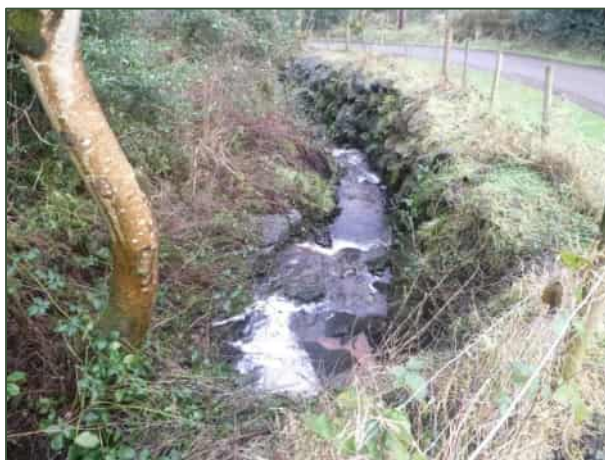
| ATTRIBUTE | SCORE <sup>a,b</sup> | NV | COMMENTS |
|---|---|---|---|
| | R = 0.5 | | Banks are in natural condition with erosion in glacial till where present and stable banks where channel is in bedrock.<br><br>Section of modified bank along farm access track where the bank has been altered and protected against erosion. |

**Photograph 2:**  
Channel bank protection along farm access road

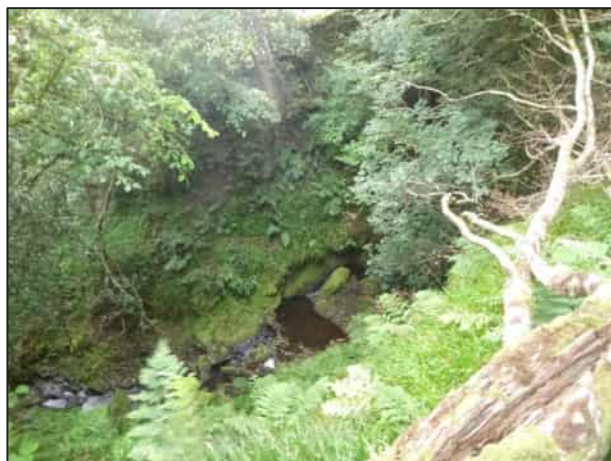
**Photograph 3:**  
Steep ravine section with cascade over bedrock

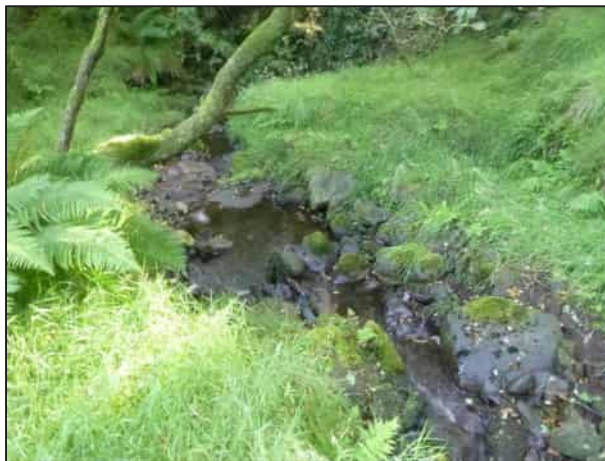
**Photograph 4:**  
Channel in ravine natural bedload material

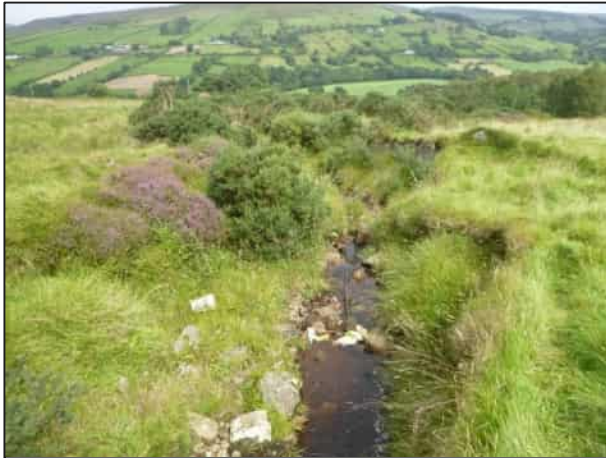
**Photograph 1:**  
Channel with bank erosion and natural bedload material

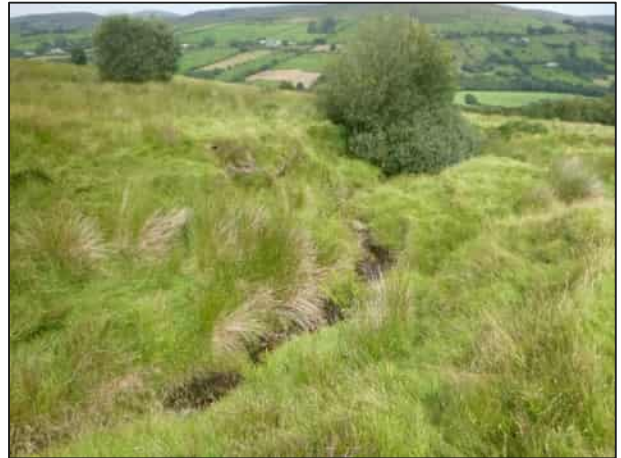
**Photograph 2:**  
Channel with grazing and rushes to bank
